MERRIMACK RIVER BASIN
MANCHESTER, NEW HAMPSHIRE

MASSABESIC LAKE DAM
NH 00103

PHASE I INSPECTION REPORT
NATIONAL DAM INSPECTION PROGRAM

AUGUST 1978

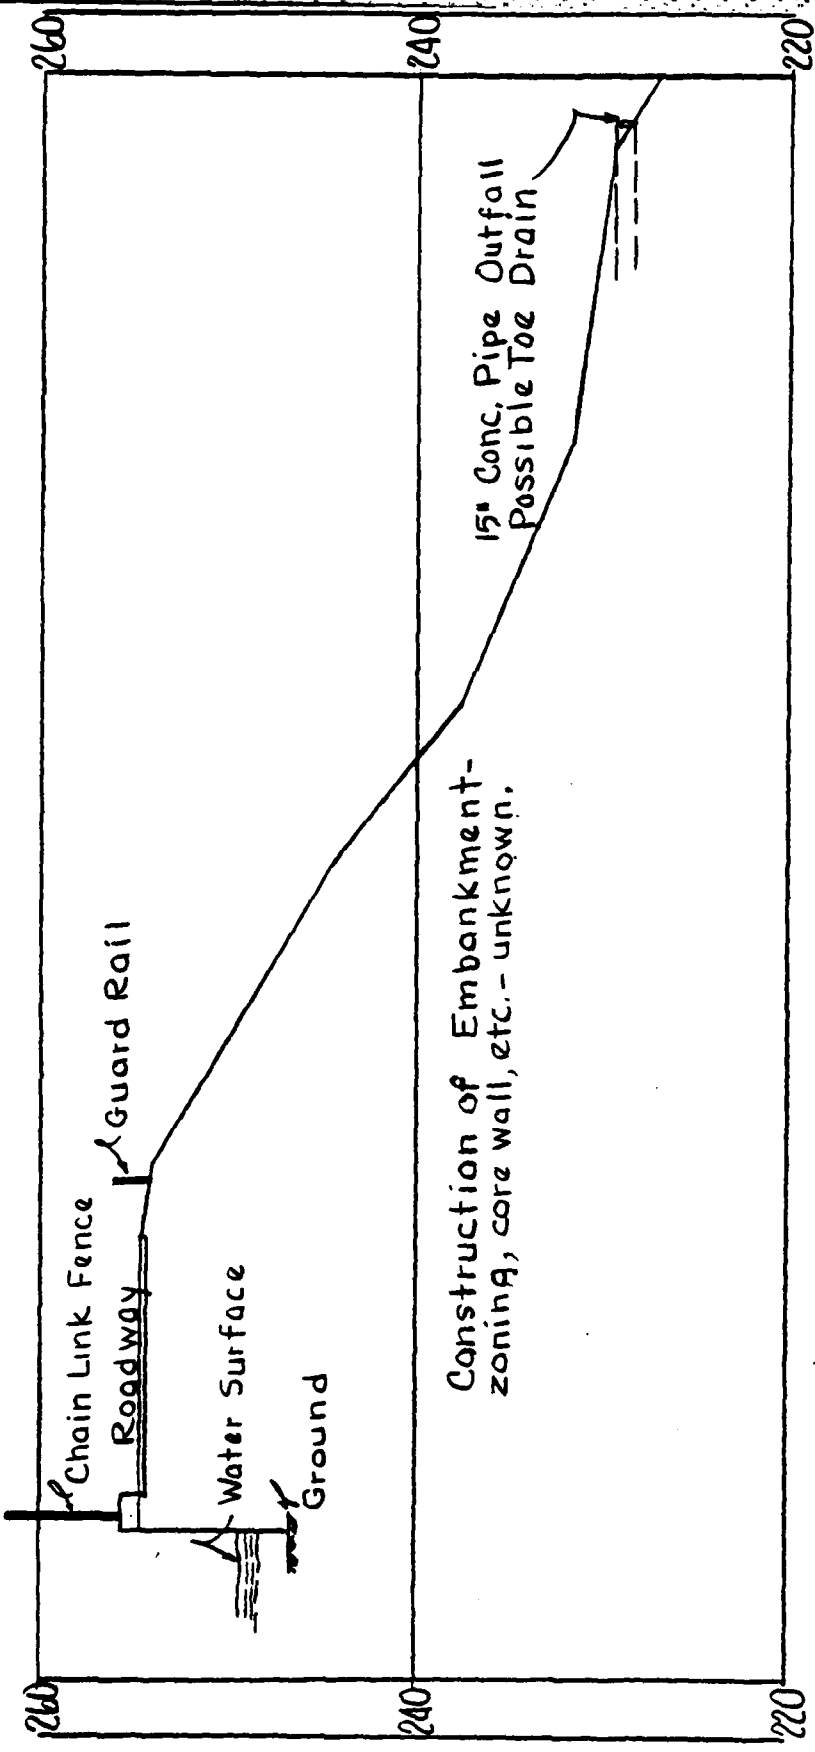
SECTION B
TYPICAL EMBANKMENT SECTION
 1" = 10'

Construction of Embankment-zoning, core wall, etc. - unknown.
