MERRIMACK RIVER BASIN
NASHUA, NEW HAMPSHIRE

HARRIS POND DAM
NH 00122
NHWRB 165.05

PHASE I INSPECTION REPORT
NATIONAL DAM INSPECTION PROGRAM

FEBRUARY 1979

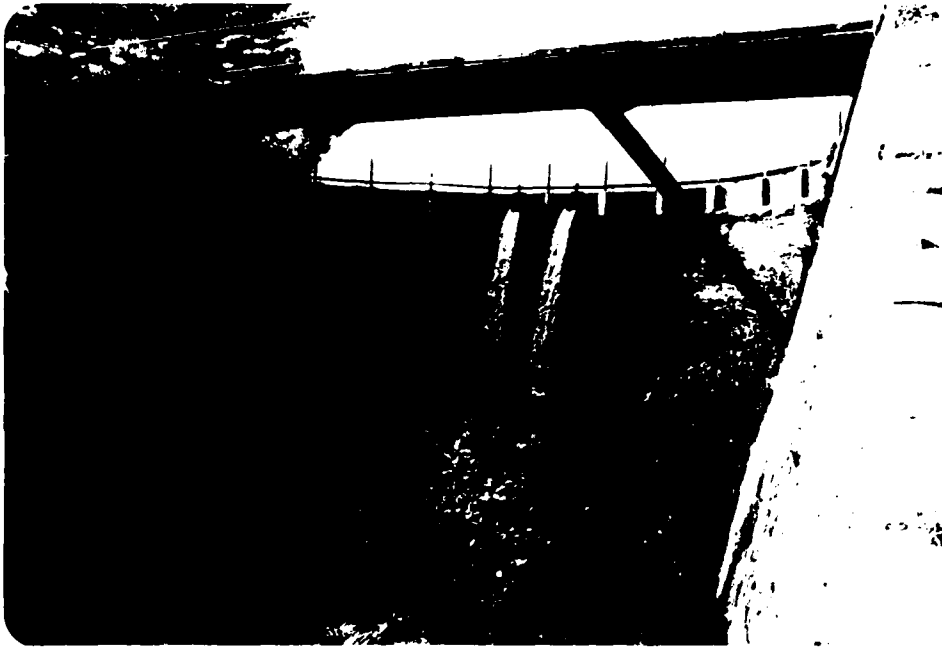
Overview of dam from downstream channel

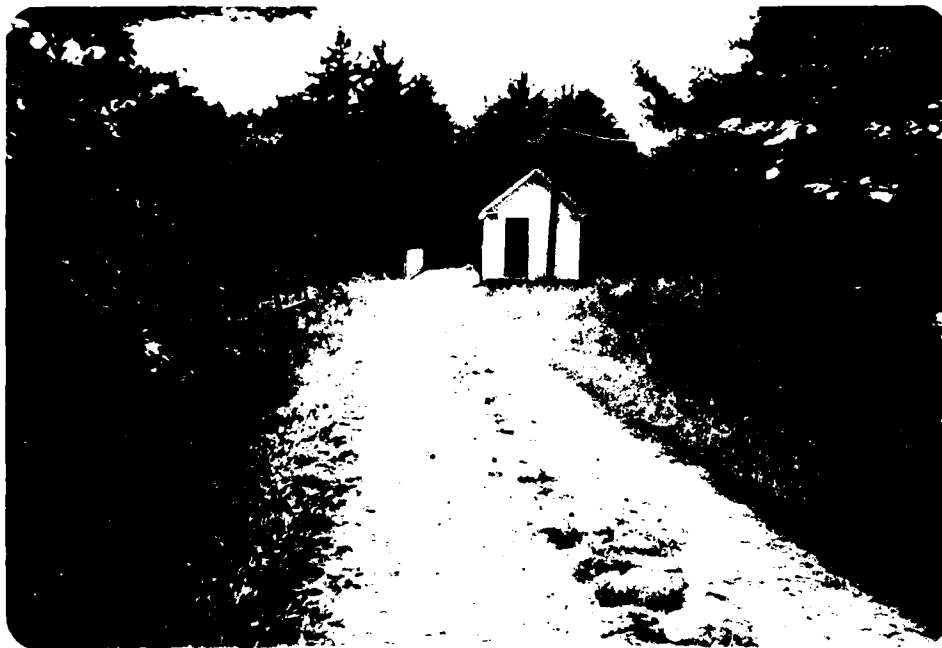
Overview of top of dam from left abutment

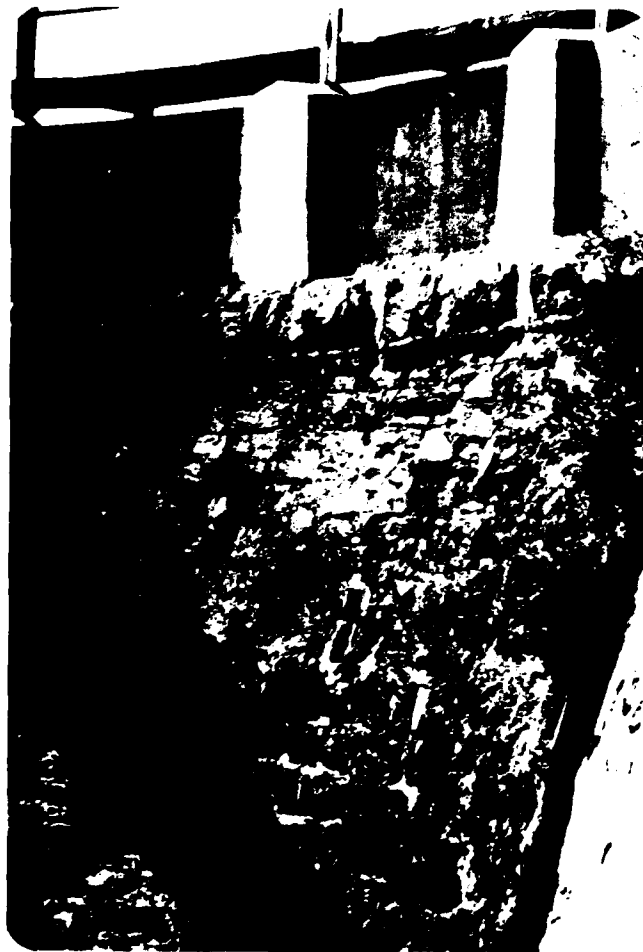
Observations of the cemented stone arch type spillway with its 2.9 foot high concrete cap have revealed seepage between the bottom of the concrete cap and the top of the cemented stone masonry. In some instances there is seepage through the open joints of the stone masonry. It is estimated that at least 50% of the joints in the spillway are void of mortar. The condition of the concrete cap of the spillway is good. The sluice gates are well maintained. The catwalk around the perimeter of the spillway is in good condition. This catwalk is not a debris catcher. The two-inch P.V.C. water pipe which is used to aerate the reservoir surface to prevent ice build up is broken and separated adjacent to the left abutment.

2. View from left downstream training wall of leakage between top of original dam and newer concrete spillway

The Harris Dam is in FAIR condition at the present time. This structure requires repointing of the open joints on the downstream face of the spillway and training walls and positive measures to control seepage through the right embankment to ensure its long-term safety and use.

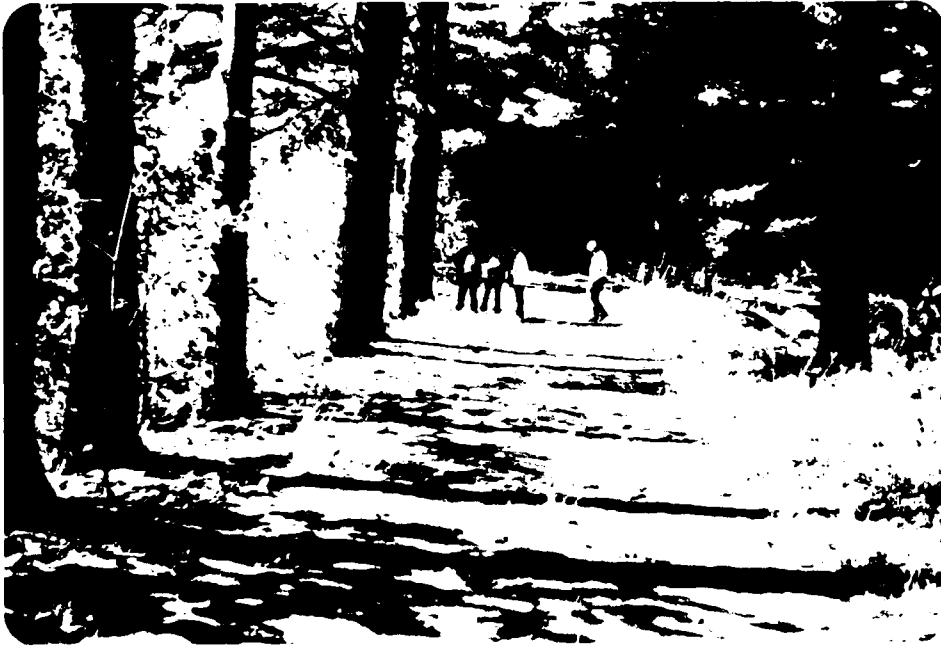
The general condition of the west dike is good. No deficiencies in the vertical and horizontal alignment were noted. No seepage, sloughing, or erosion of the slopes was noted. However, heavy growth, including trees up to 24 inches in diameter, was noted on both the upstream and downstream slopes.

3. View of dike on right side of reservoir to fill in natural low area
