MERRIMACK RIVER BASIN

WHEELER DAM  
ARLINGTON MILL RESERVOIR  
NH 00028

PHASE I INSPECTION REPORT  
NATIONAL DAM INSPECTION PROGRAM

AUGUST 1978

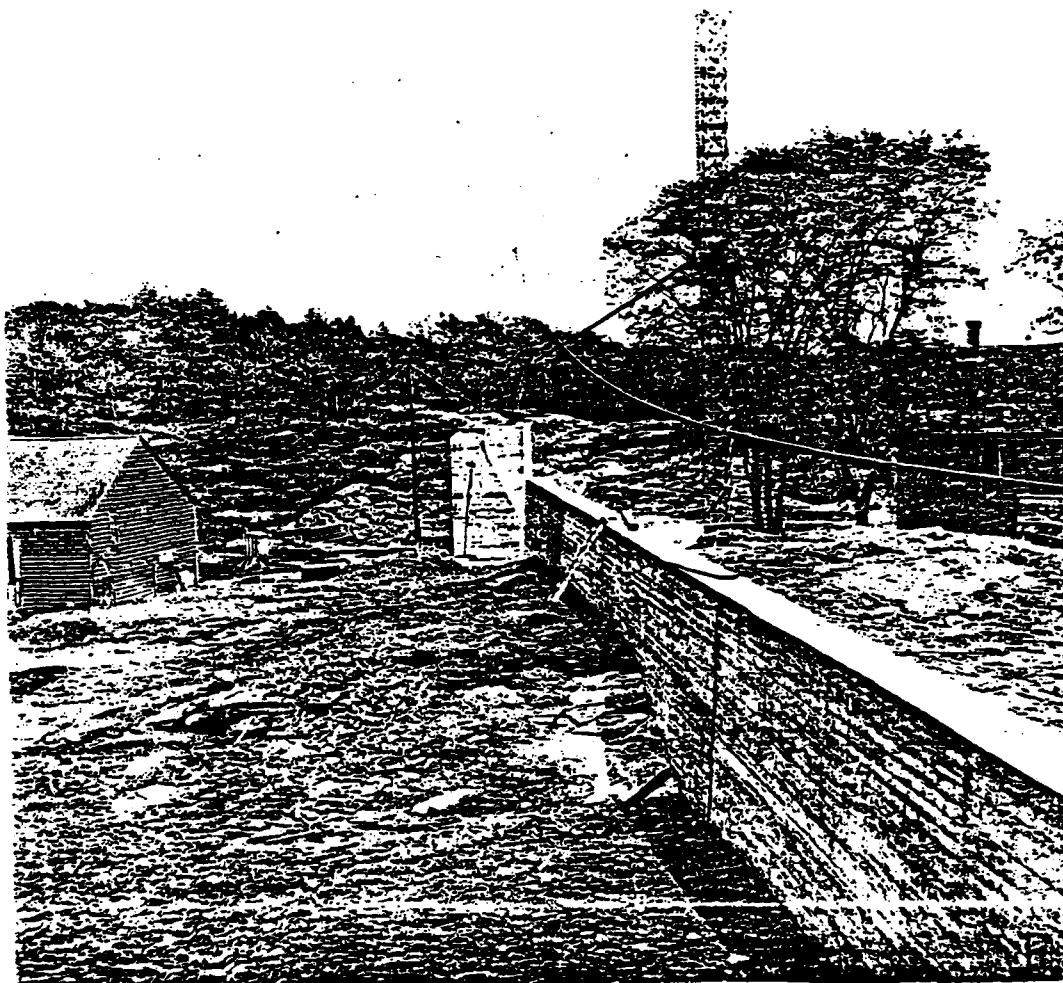
General View of Main Dam
