AD-A156 127

NATIONAL PROGRAM FOR INSPECTION OF NON-FEDERAL DAMS
MERRIMACK VILLAGE DAM. (U) CORPS OF ENGINEERS WALTHAM
MA NEW ENGLAND DIV FEB 79

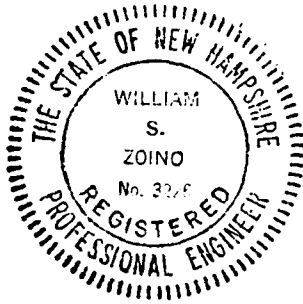
William S. Zoino
William S. Zoino
N.H. Registration 3226

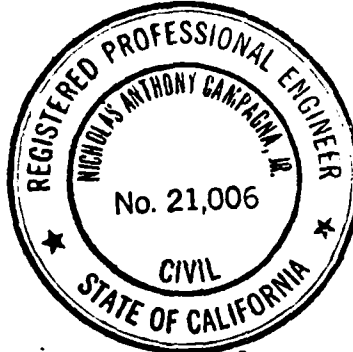
Nicholas A. Campagna, Jr.
Nicholas A. Campagna, Jr.
California Registration 21006

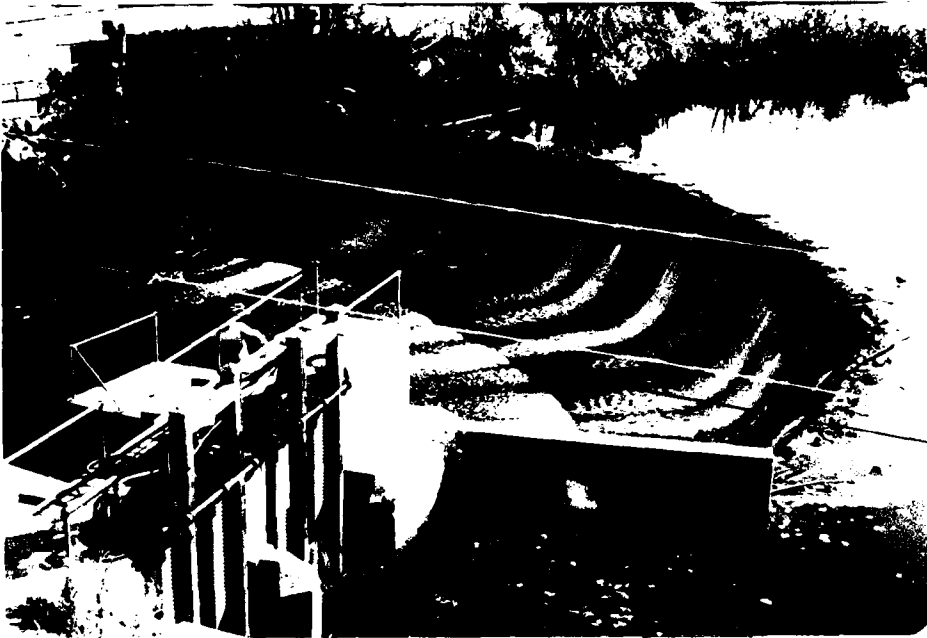
Overview of dam from fire station
on left abutment

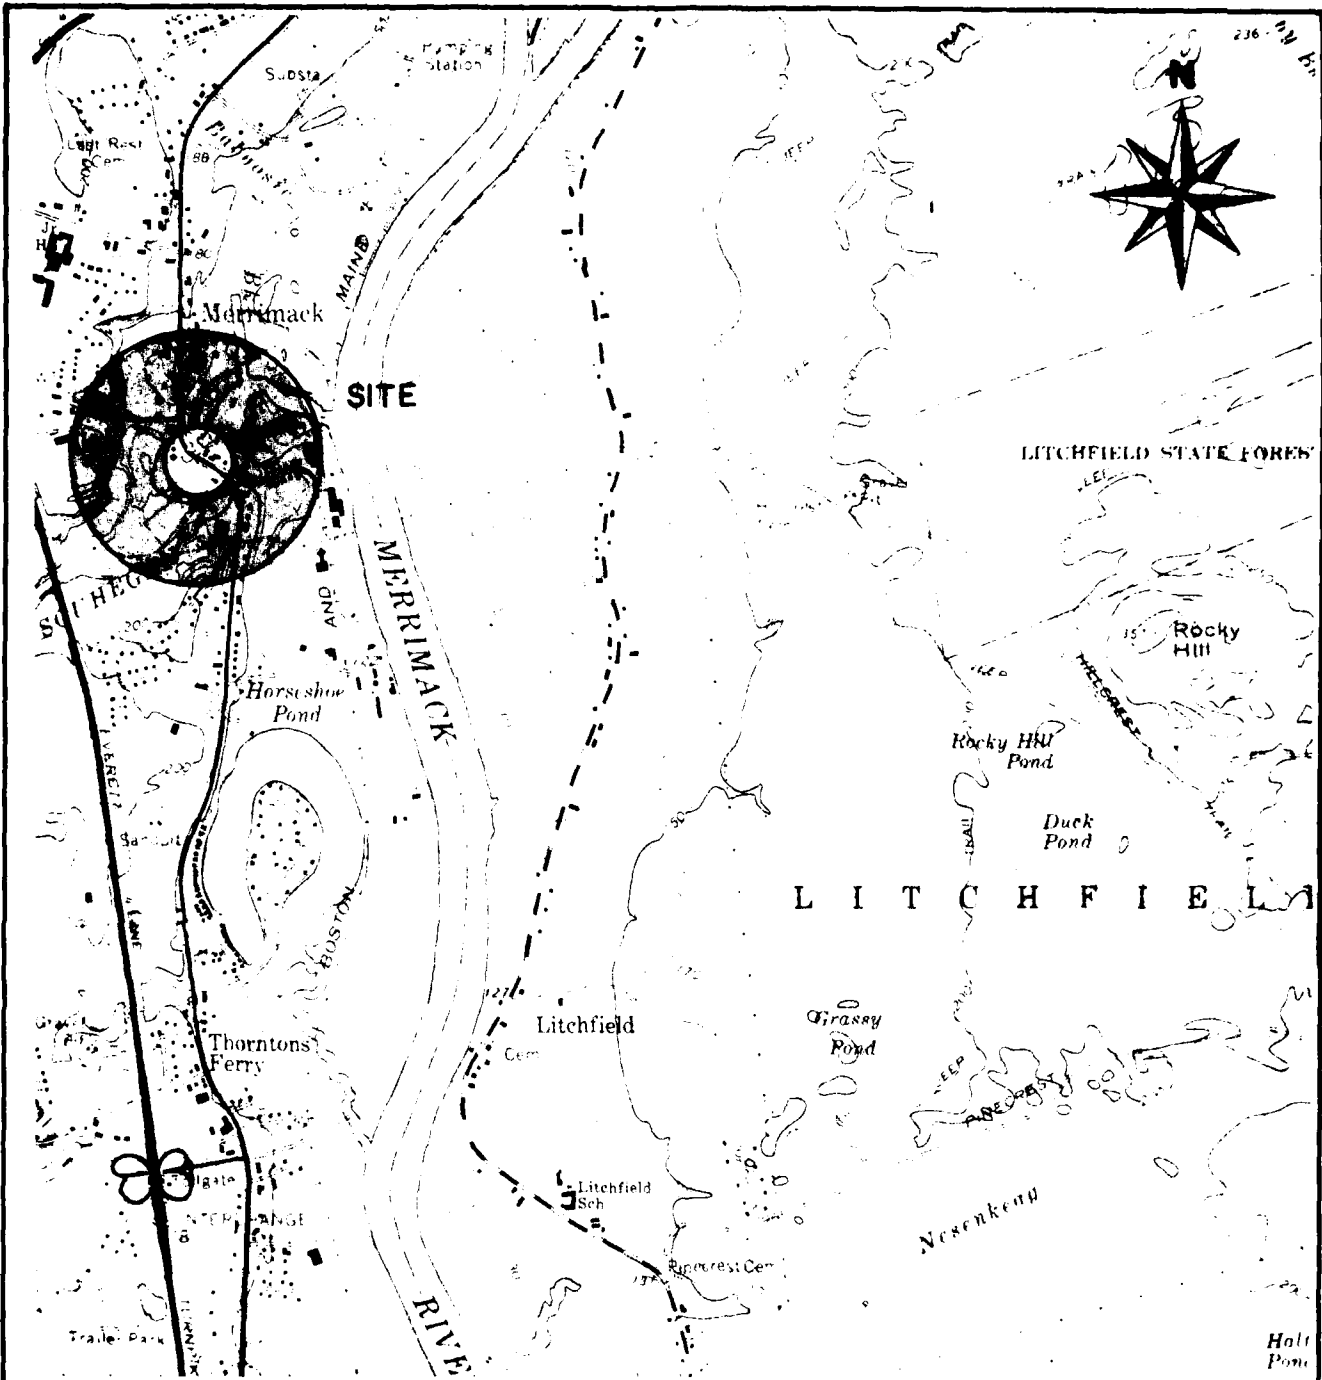
FROM: USGS NASHUA NORTH, N.H. QUADRANGLE MAP

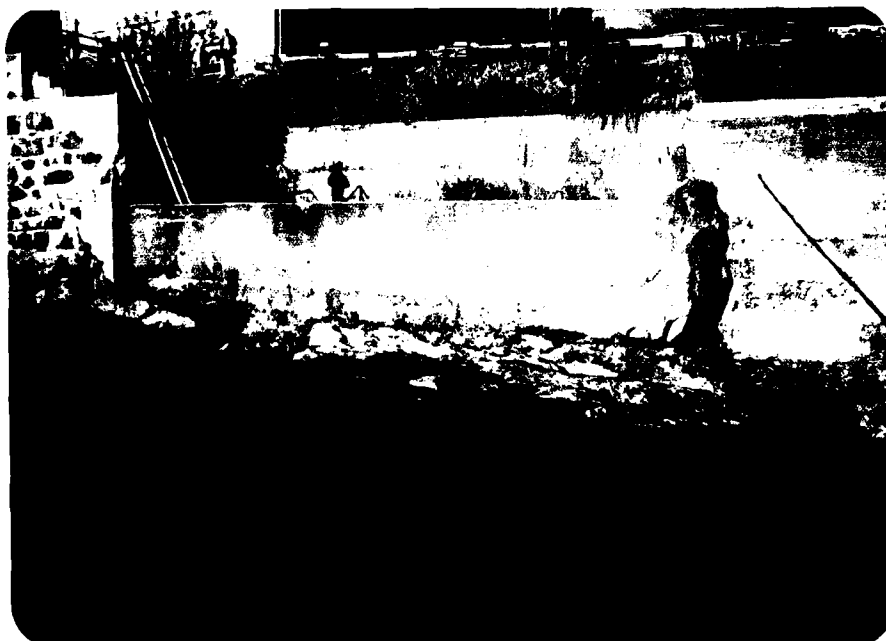
6. View of deterioration of concrete and seepage at base of diversion channel wall from the downstream channel

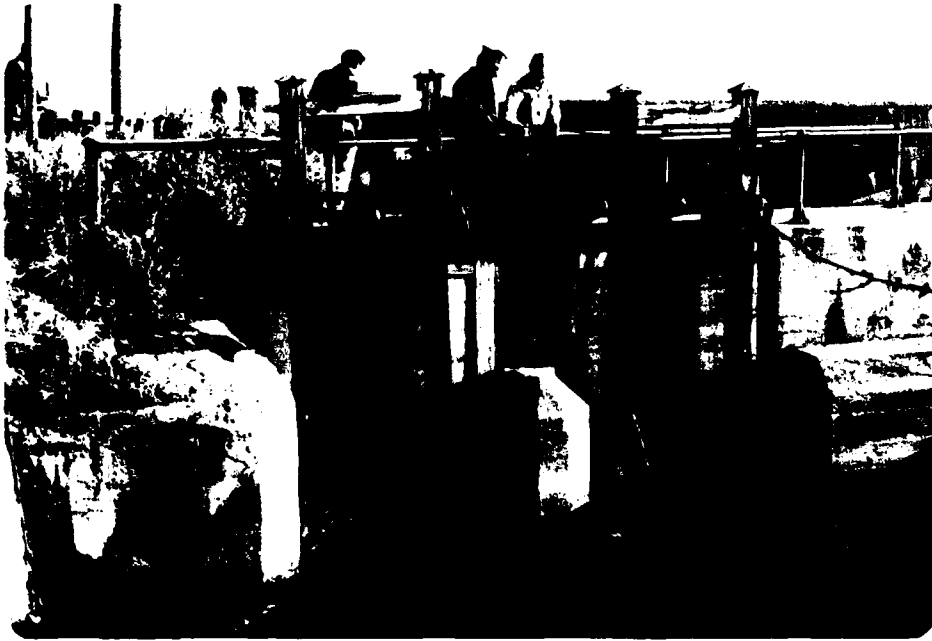
3. View from upstream left side of gate structure

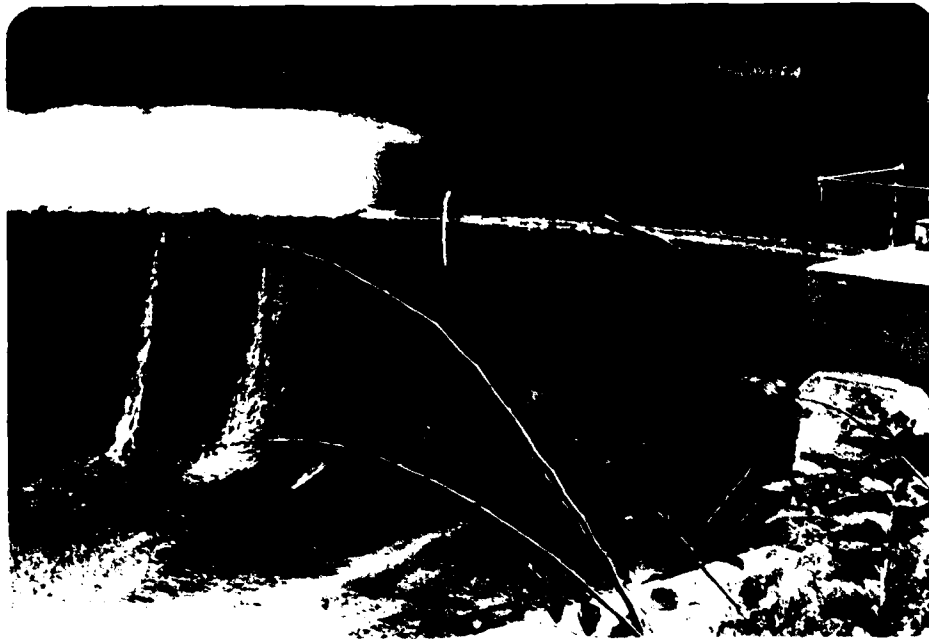
2. View of spillway from left side of downstream channel showing horizontal cracks and flow through pressure relief openings at the toe

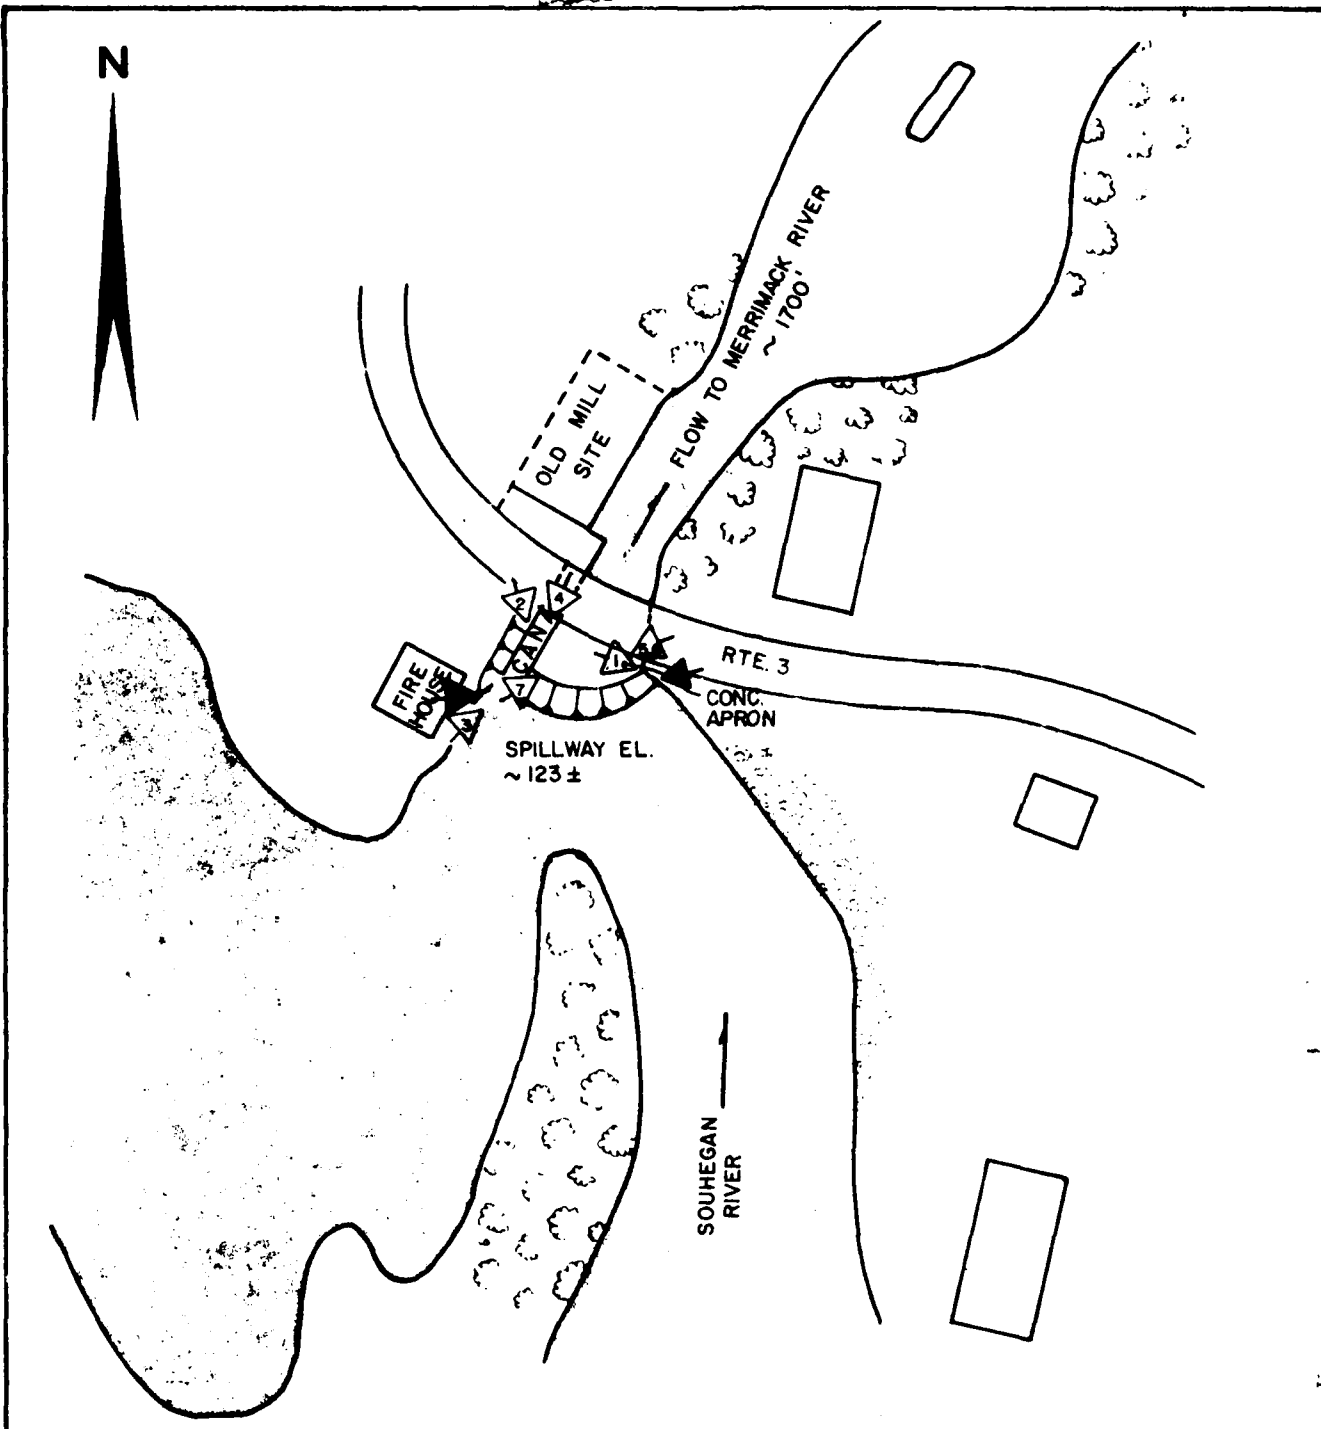
- OVERVIEW
- ◁ APPENDIX C

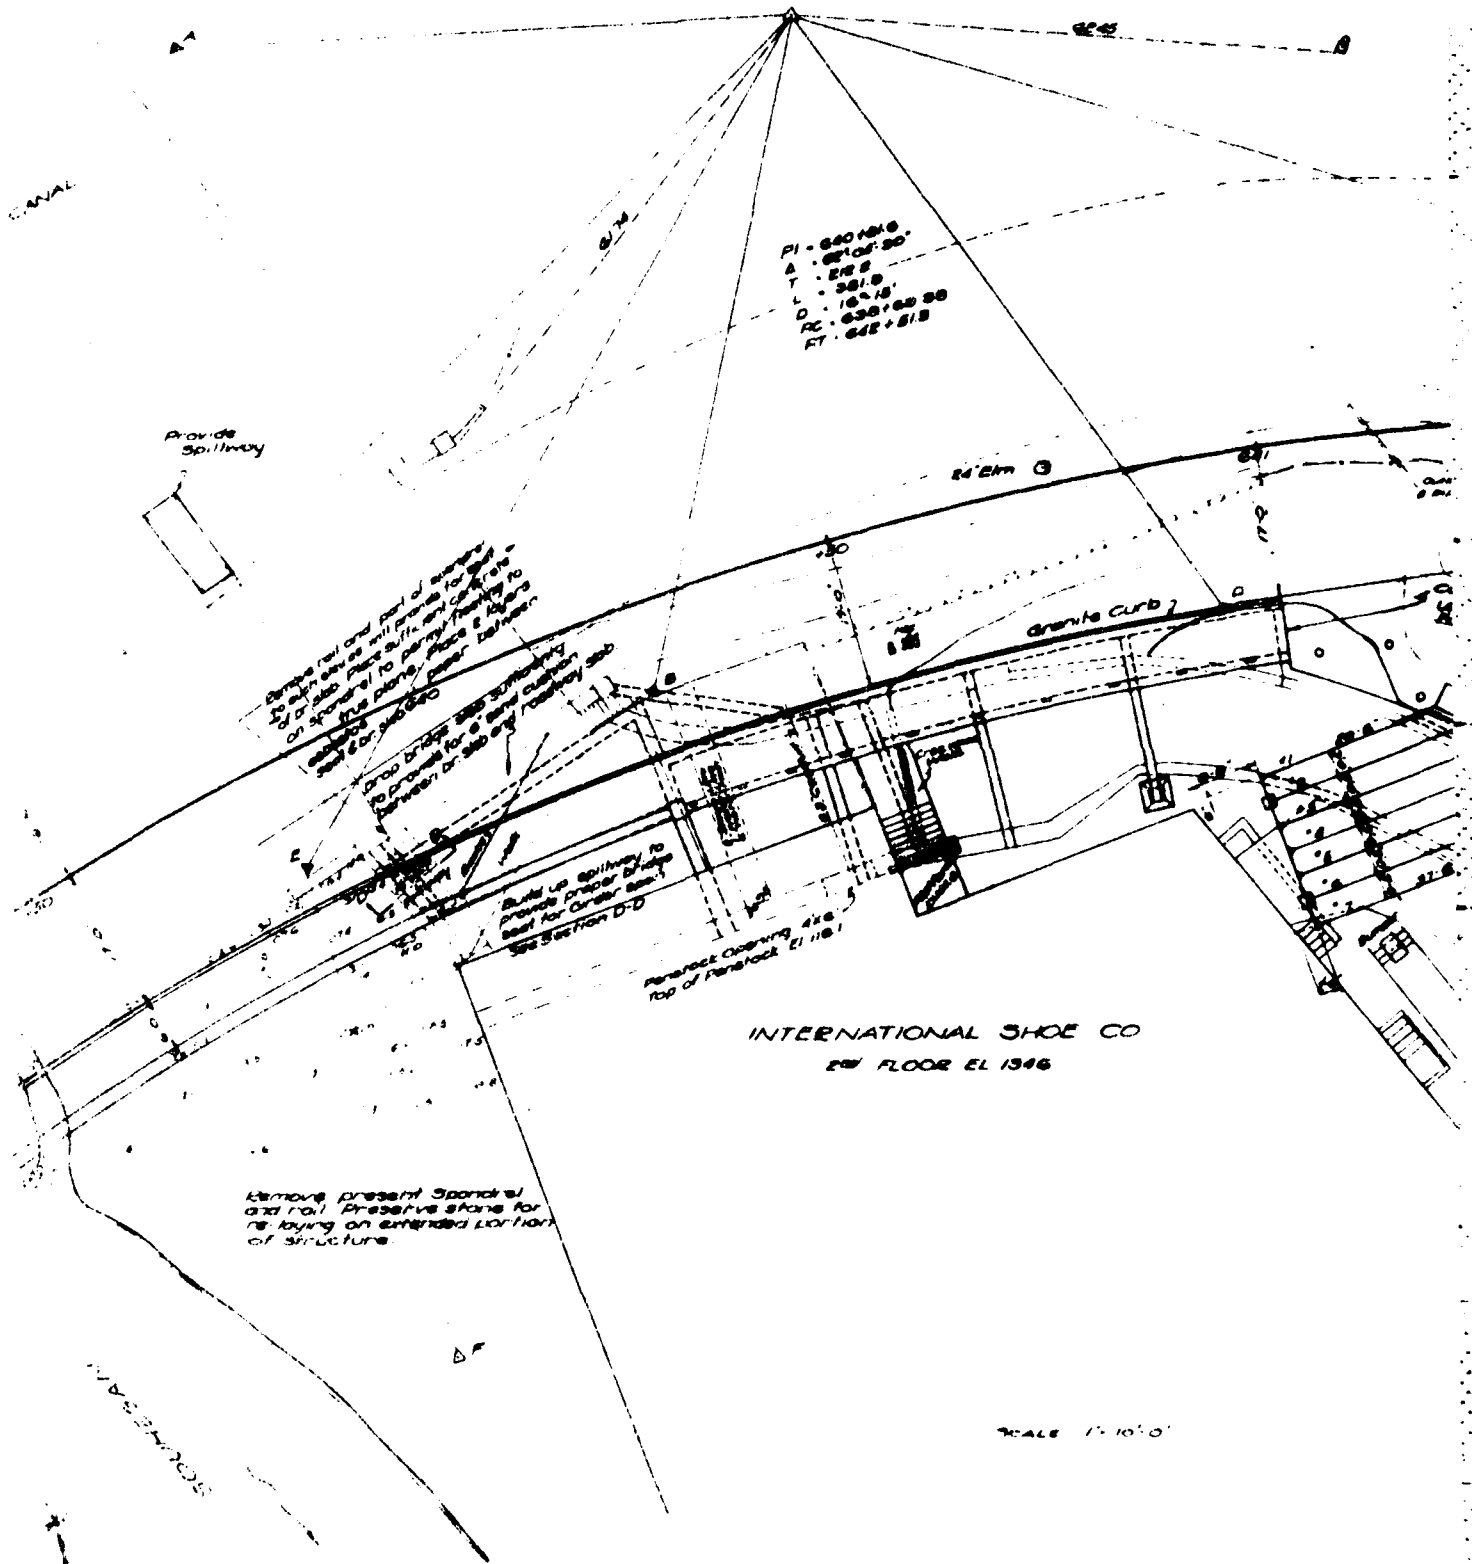
1. A 1975 letter from NHWRB to Pennichuck Water Works describing repairs that need to be made at the dam.
2. Several inspection reports performed by NHWRB and the New Hampshire Water Control Commission.
3. Inventory reports of the New Hampshire Water Control Commission and the NHWRB.
4. A questionnaire from the New Hampshire Public Service Commission on the proposed changes to the dam circa 1934.

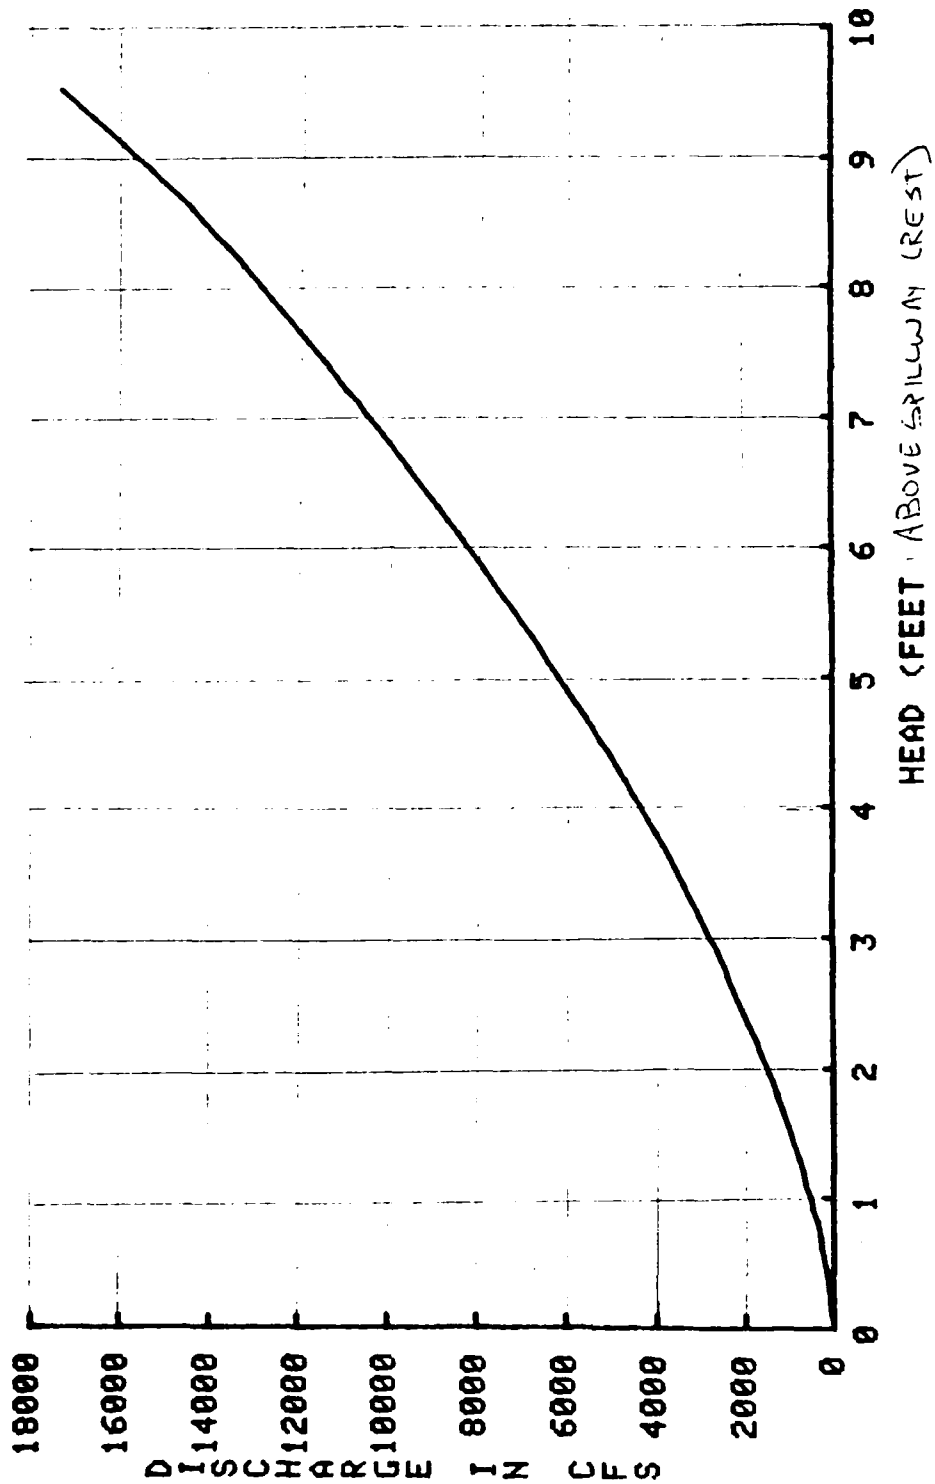
STAGE-DISCHARGE CURVE AT MERRIMACK VILLAGE DAM

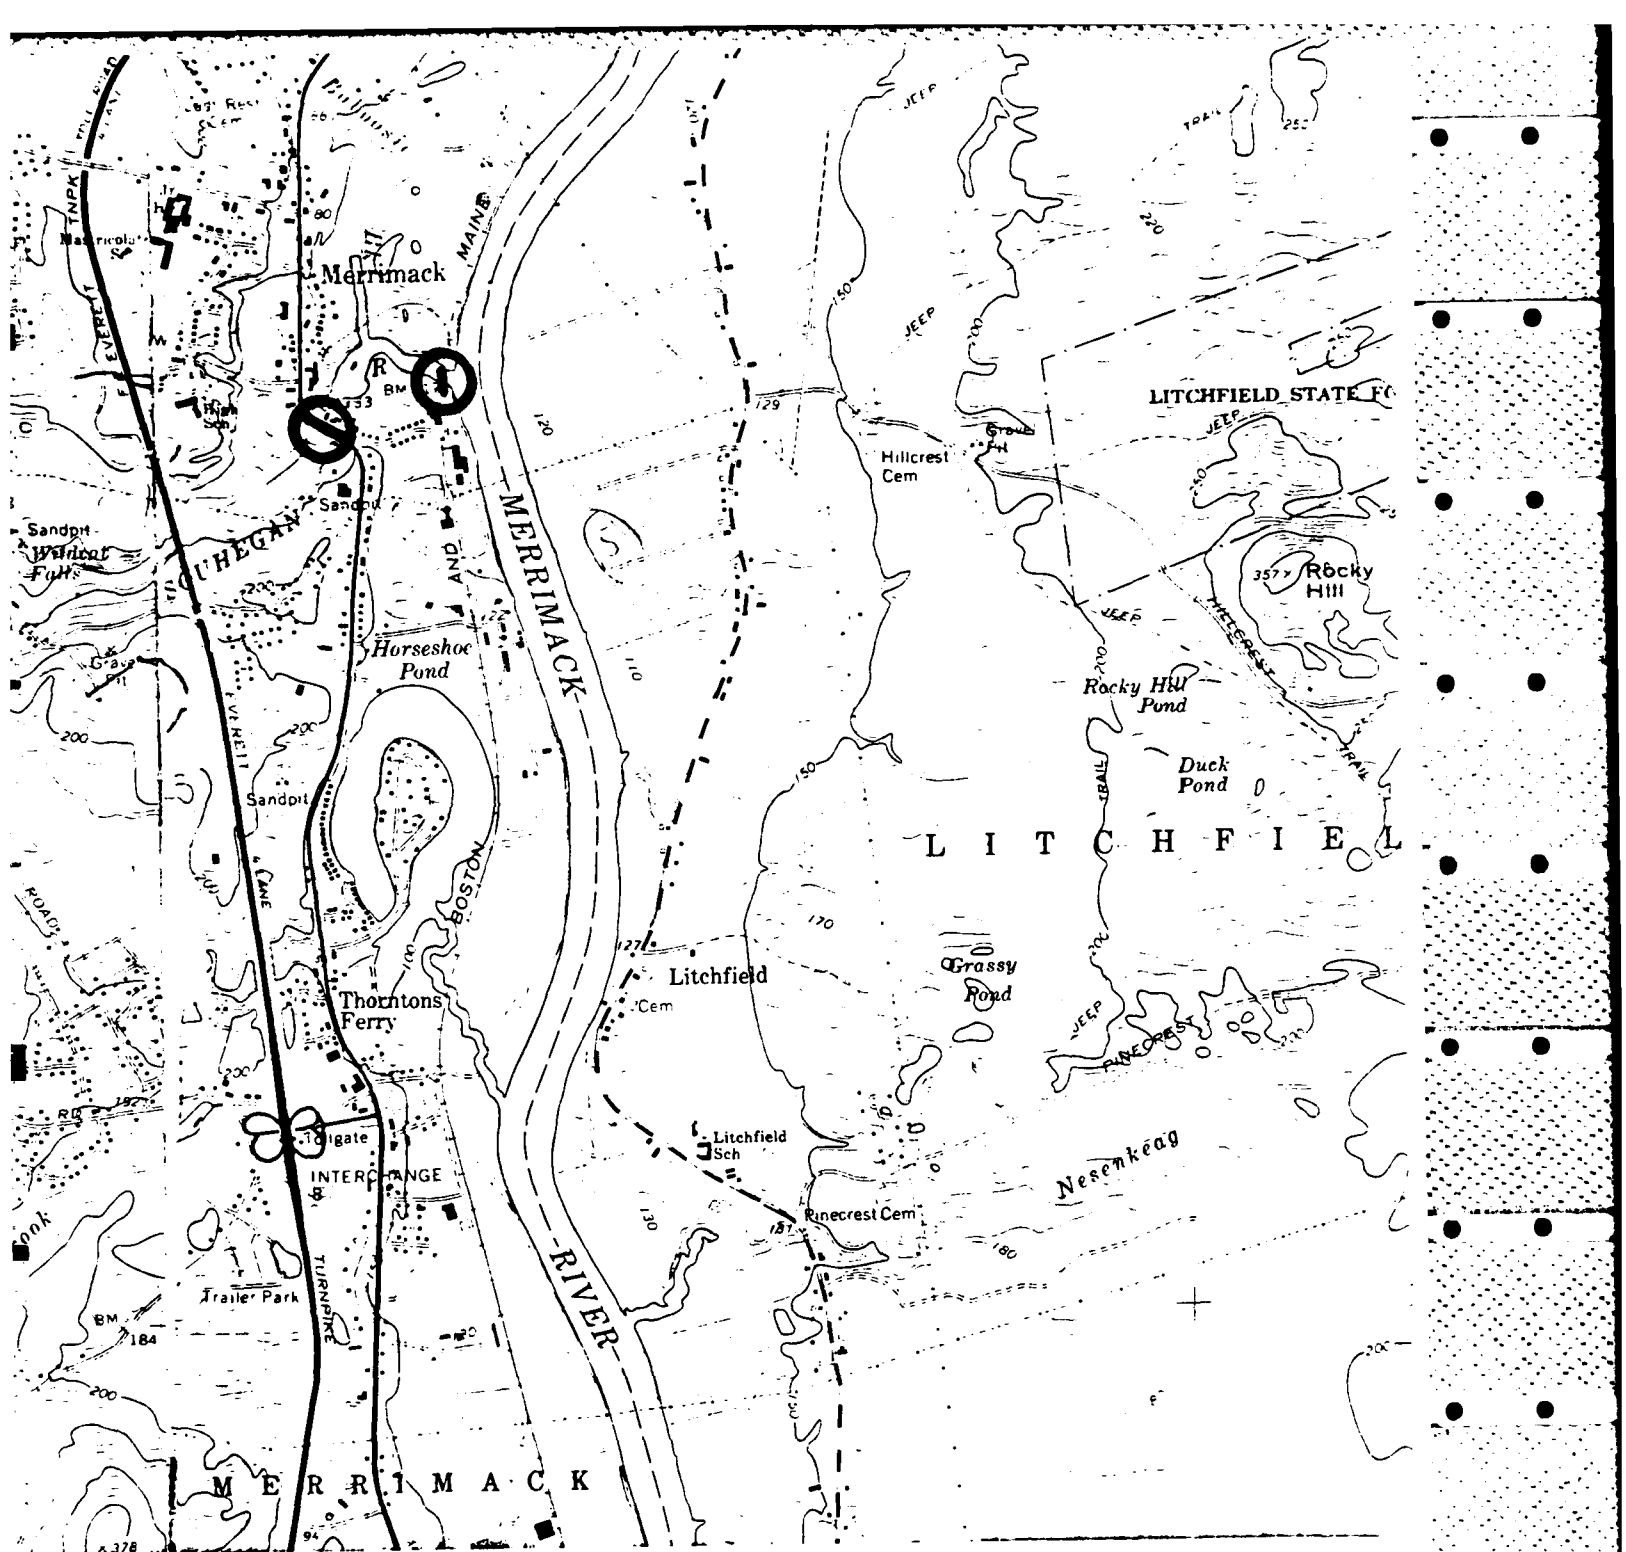
DOWNSTREAM FLOOD HAZARD AREAS

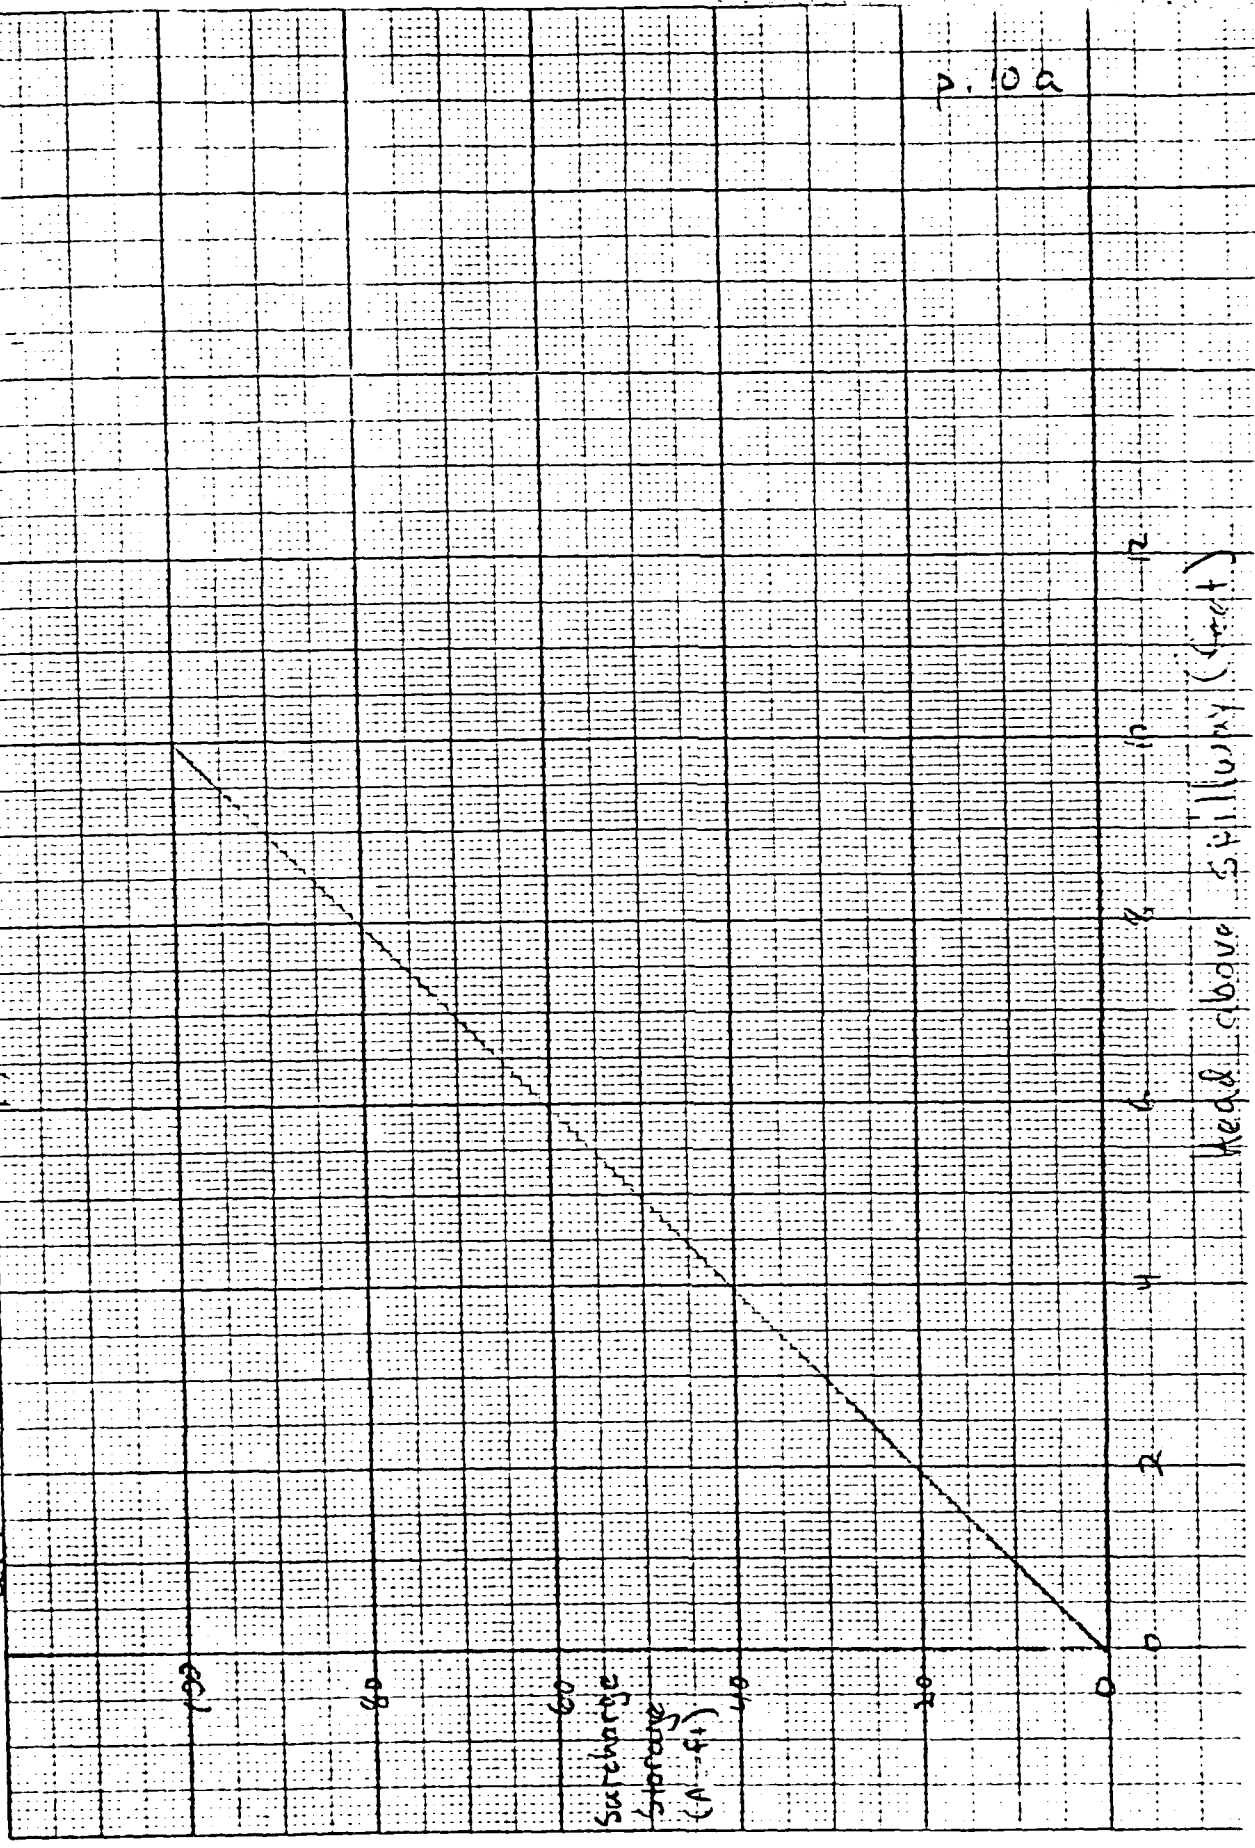
165 Dam Safety Merrimack Village Dam, # 4 TRB, 1-30-79, p. 1
