LOWER DAM  
NH 00129  
NHWRB 222.01

PHASE I INSPECTION REPORT  
NATIONAL DAM INSPECTION PROGRAM

DEPARTMENT OF THE ARMY  
NEW ENGLAND DIVISION, CORPS OF ENGINEERS  
WALTHAM, MASS. 02154

AUGUST 1980

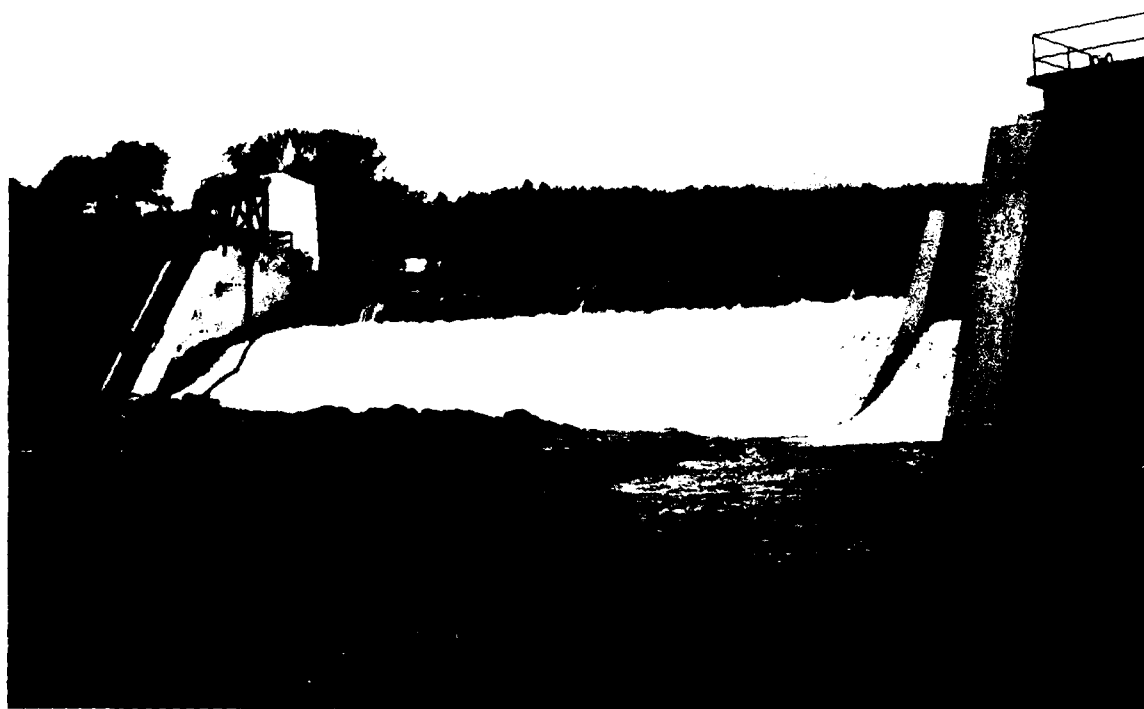
Overview of Dam

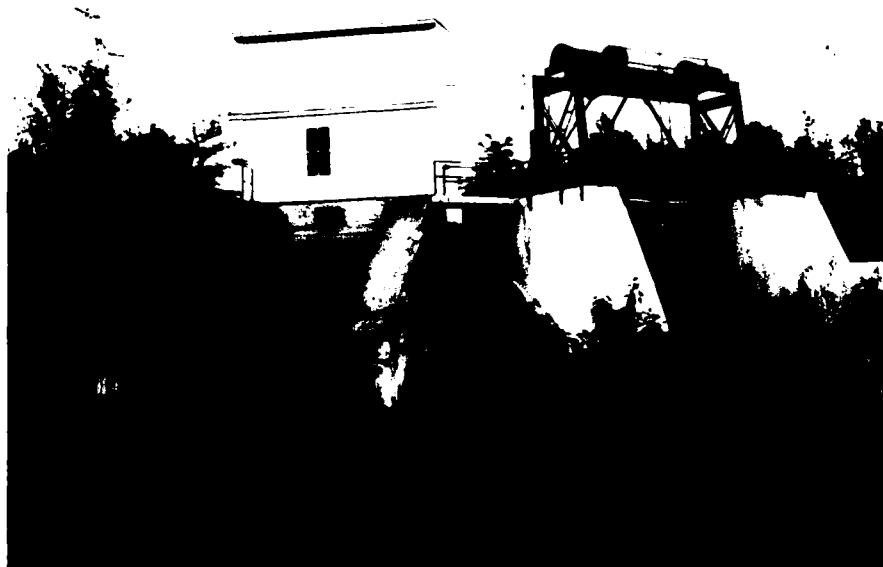
5. View of gate house from downstream side

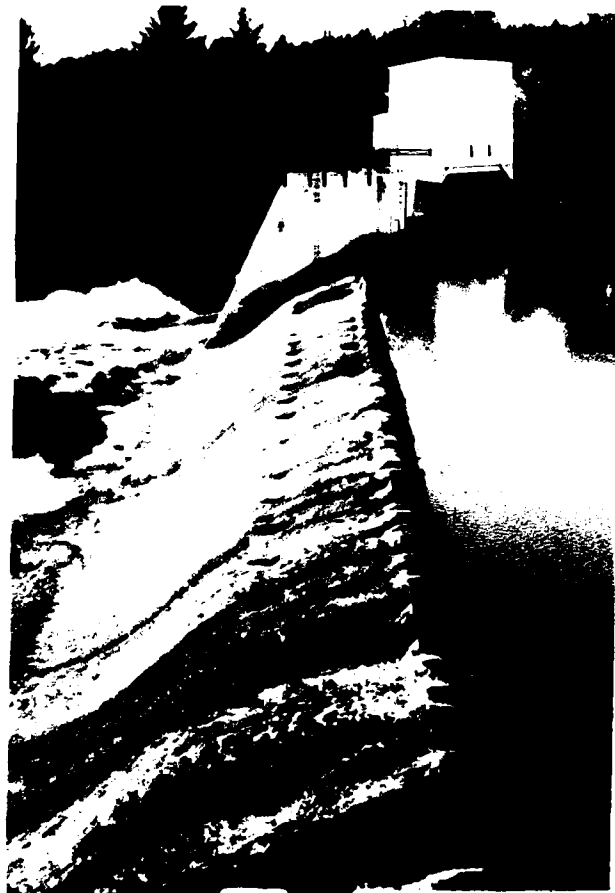
Observations of the downstream face of the spillway revealed that it is in good condition. Surface erosion on this face is periodically repaired with either a high strength Portland cement or epoxy mortar. The concrete apron is random in length either terminating at rock outcrops or terminated in a random configuration.

1. View of spillway from left side
