CONNECTICUT RIVER BASIN
HARRISVILLE, NEW HAMPSHIRE

SILVER LAKE DAM

NH 00062

PHASE I INSPECTION REPORT
NATIONAL DAM INSPECTION PROGRAM

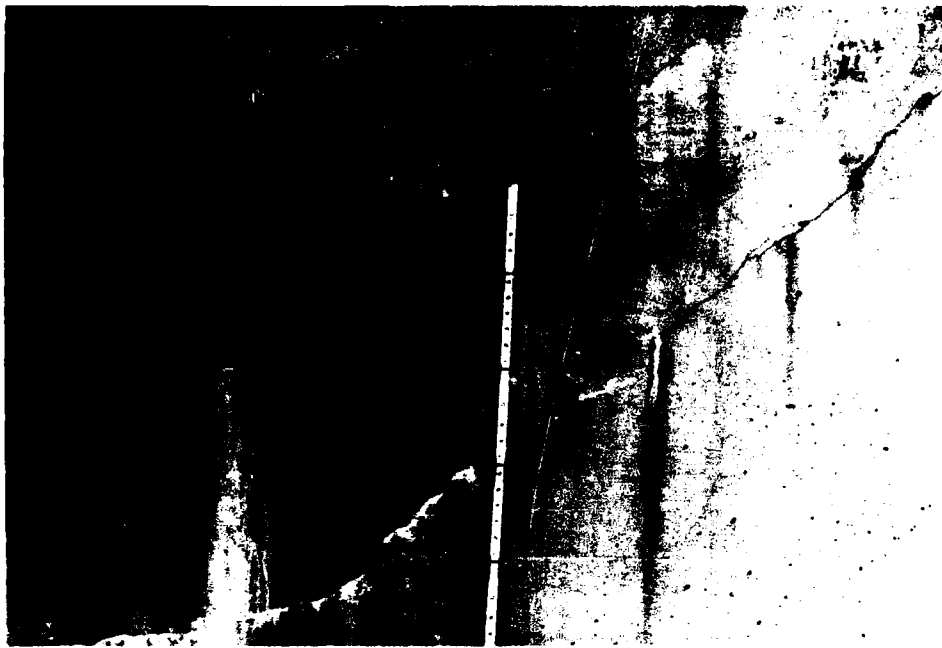
Photo No. 13 - Right wall of sluiceway structure.
Wall cracks at downstream area.

Visual inspection of the sluiceway section indicated that the right retaining wall has deteriorated since its construction. This right retaining wall has approximately 7 major horizontal and vertical cracks located in the vicinity of the service walkway decks. These cracks appear to be structural and were probably caused by excessive hydrostatic pressure induced by poor drainage in back of the wall. Also, the structural arrangement of this wall is such that earth pressures higher than active earth pressures could have been induced. The cantilever walls and the transverse decks rigidly connected could have prevented any wall movement and thus may have partially caused the observed cracking. This structural cracking was observed during the New Hampshire Water Resources Board inspection in 1975, and since that time additional drainage provisions have been made behind this wall, and at present it appears that the wall is in stable condition.

(b) The cracks in the right training wall of the sluiceway channel should be repaired.

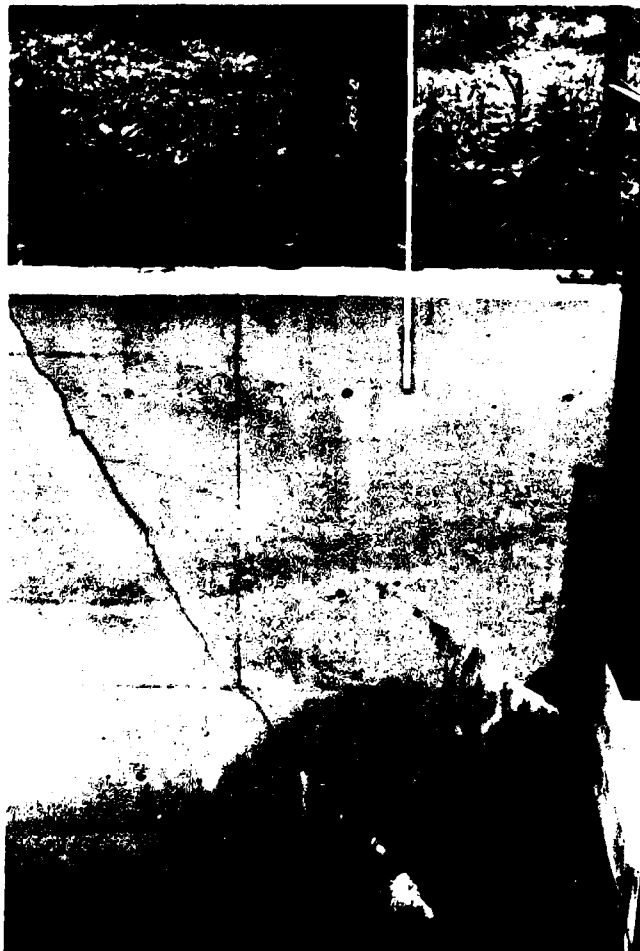
Photo No. 14 - Right wall
of sluiceway structure.
Wall cracks at high
water area.
