HIGHLAND LAKE SOUTH OUTLET

NH 00054

PHASE I INSPECTION REPORT  
NATIONAL DAM INSPECTION PROGRAM

Date of Inspection: 14 June 1978

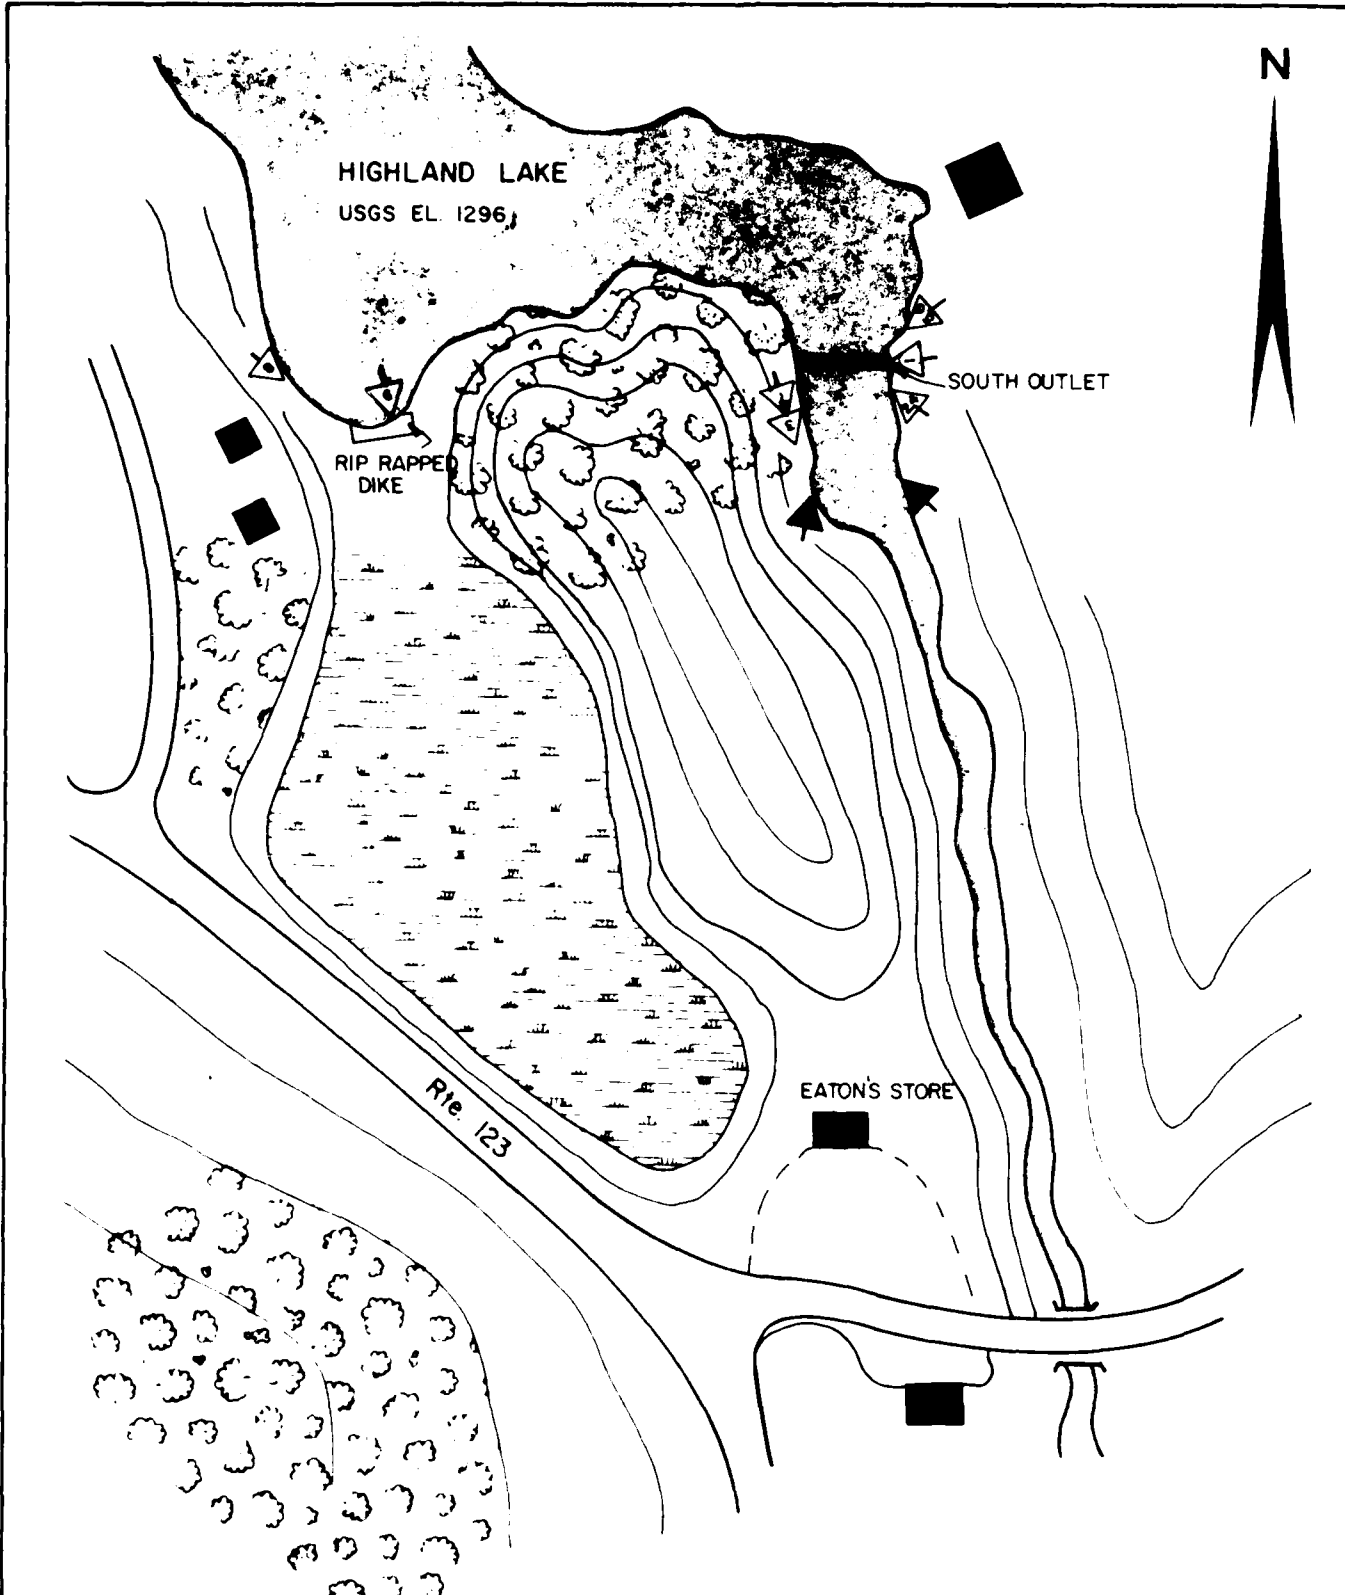
NATIONAL DAM INSPECTION PROGRAM  
 U.S. ARMY CORPS OF ENGINEERS, NEW ENGLAND DIVISION  
 HIGHLAND LAKE SOUTH OUTLET NH00054  
 NHWRB 223.01  
 SITE PLAN  
 JULY 1978 SCALE: 1" = 100' FIG. 1

The team observed no downstream conditions which adversely affect the operation of the dam or which pose a hazard to the safety of the dam. The downstream road bridge (Figure 1), however, could not pass the SDF without creating high tailwater levels at the dam.

Overtopping the South Dike would release a significant amount of water into the low area to the west of Eaton's store (Figure 1). The water would most likely cause some damage to Rte. 123 before rejoining the downstream channel of the main dam somewhere between Mill Village and Island Pond. Again, loss of life from this individual event is unlikely. Similar flooding would occur in the Dead Brook area.
