NATIONAL PROGRAM FOR INSPECTION OF NON-FEDERAL DAMS
LAKE KANASATKA DAM (N. (U) CORPS OF ENGINEERS WALTHAM
MA NEW ENGLAND DIV MAR 80

REPORT DOCUMENTATION PAGE		READ INSTRUCTIONS BEFORE COMPLETING FORM
1. REPORT NUMBER NH 00125	2. GOVT ACCESSION NO.	3. RECIPIENT'S CATALOG NUMBER
4. TITLE (and Subtitle) Lake Kanastka Dam NATIONAL PROGRAM FOR INSPECTION OF NON-FEDERAL DAMS		5. TYPE OF REPORT & PERIOD COVERED INSPECTION REPORT

Lake Kanasatka Dam
Moultonboro, NH

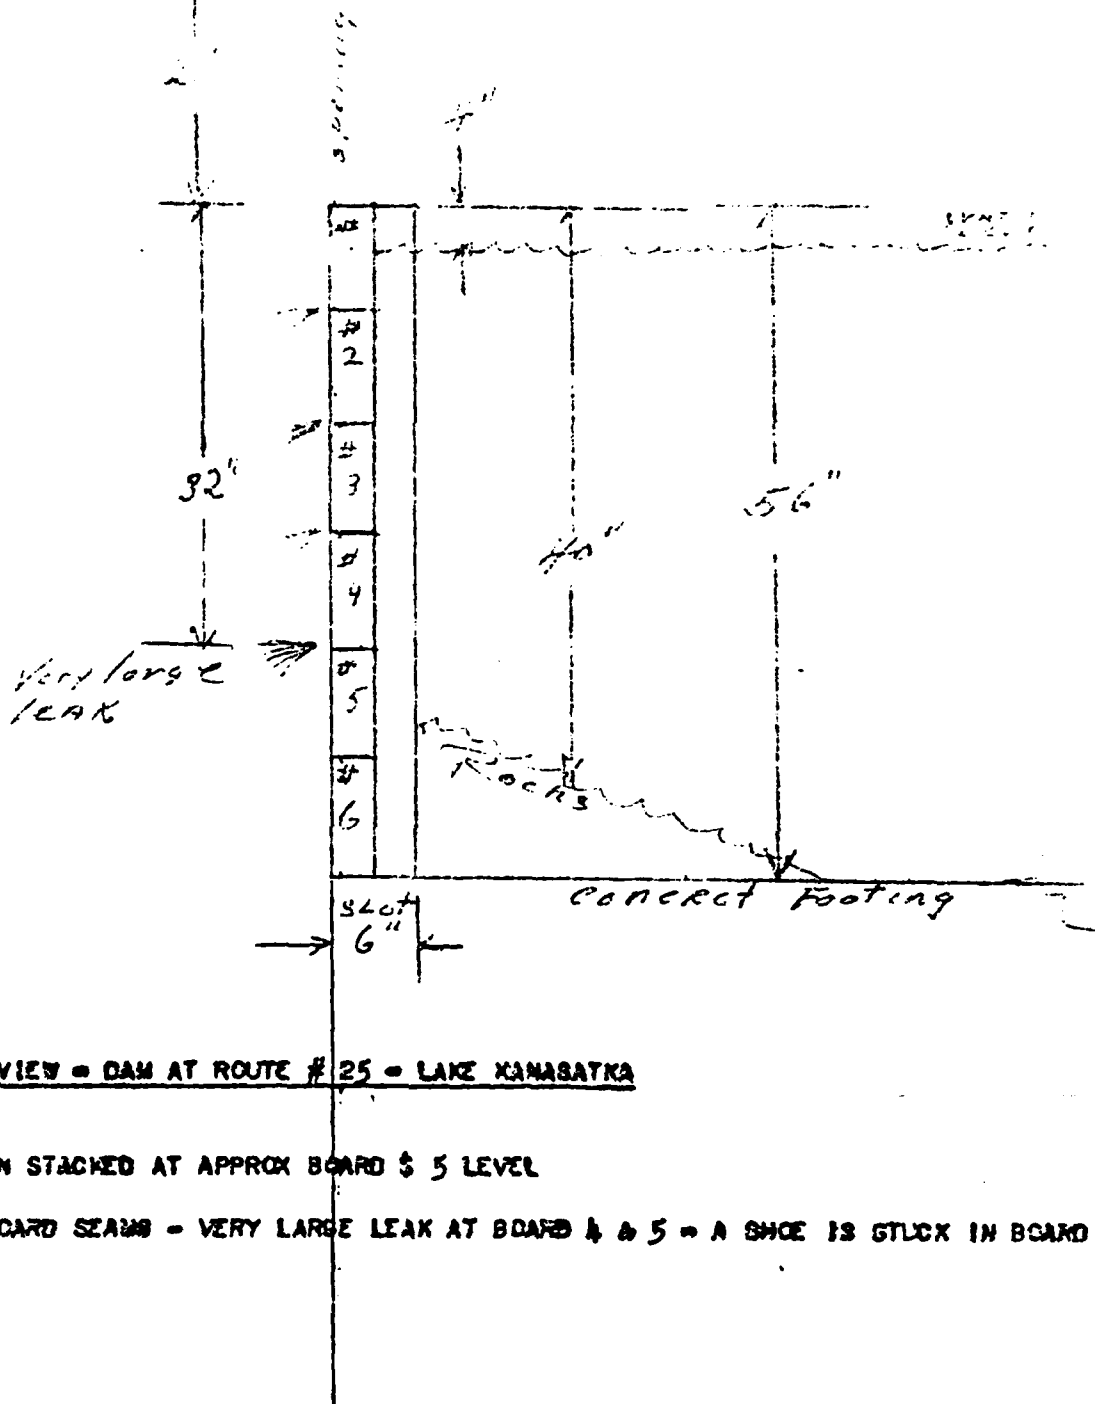
FIGURE # 2 : END VIEW - DAM AT ROUTE # 25 - LAKE KANASATKA

1. ROCKS HAVE BEEN STACKED AT APPROX BOARD 5 LEVEL
2. LEAKS AT ALL BOARD SEAMS - VERY LARGE LEAK AT BOARD 4 & 5 - A SHOE IS GLUCK IN BOARD

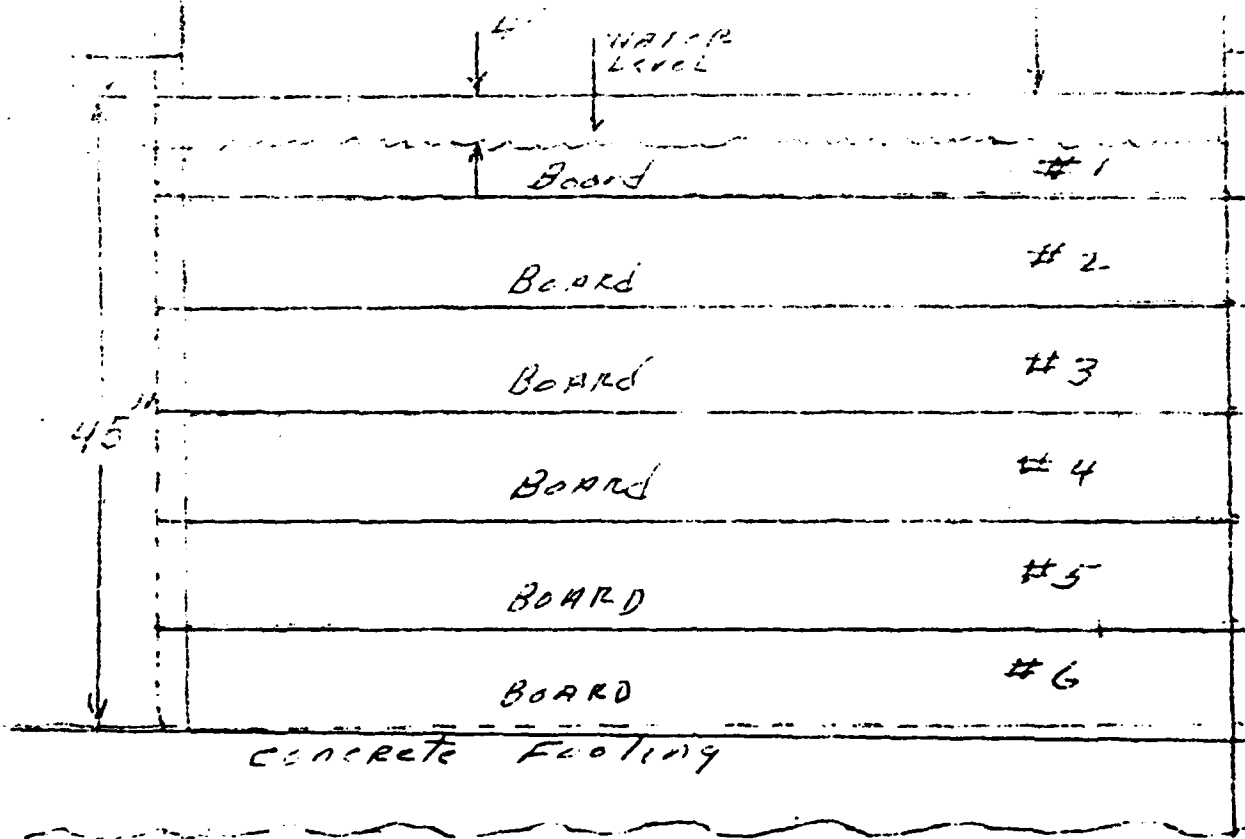
~~SECRET~~
FIGURE # 1 : LAKE SIDE VIEW - DAM AT ROUTE # 25 - LAKE KANASATKA.
