CONNECTICUT RIVER BASIN
LISBON NEW HAMPSHIRE

LOWER LISBON DAM
N.H. 00144

PHASE I INSPECTION REPORT
NATIONAL DAM INSPECTION PROGRAM

APRIL 1979

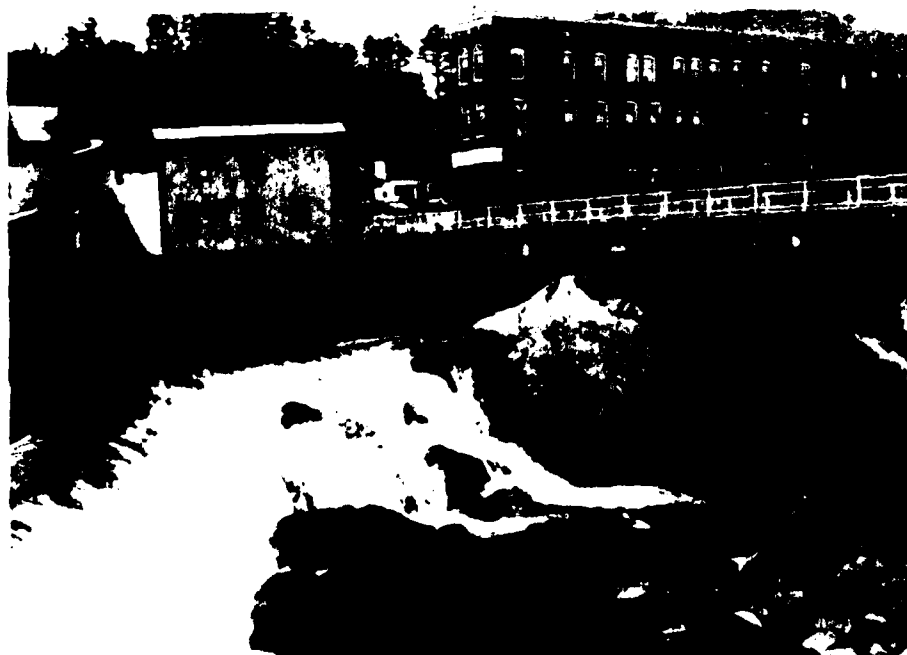
The maximum known flood on the pertinent section of the Ammonoosuc River occurred on March 18, 1936, recorded at the Bath gauge as 27,900 CFS. Transferring this flow to the dam using the six tenths ratio of their drainage areas gives a flood of 23,080 CFS at Lower Lisbon Dam. This flow would result in a flow depth of 8.3 feet over the spillway. Although this flood stage would not overtop the dam abutments it would cause considerable flooding along the left bank which is considerably lower than the dam abutment (see Photo 2).

#2. VIEW OF SPILLWAY

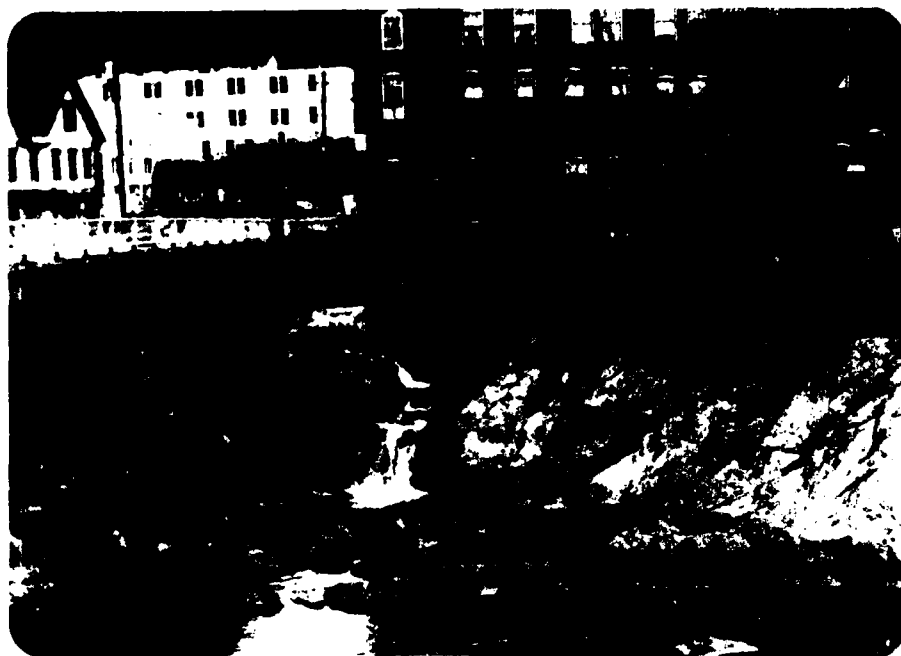
The next section of the dam connects the outcrop mentioned above to another outcrop adjacent to the waste gate. This is a raised berm section approximately 34 feet long with a 6-foot stop log spillway located 7 feet from the left outcrop (see Photo 3). This section is in good condition with some spalled areas.

#3. VIEW OF WASTE GATE AND FORMER HEADRACE CANAL
