NATIONAL PROGRAM FOR INSPECTION OF NON-FEDERAL DAMS  
LIMESTONE DAM (HE 004... (U) CORPS OF ENGINEERS WALTHAM  
MA NEW ENGLAND DIV SEP 81

REPORT DOCUMENTATION PAGE		READ INSTRUCTIONS BEFORE COMPLETING FORM
1. REPORT NUMBER ME 00492	2. GOVT ACCESSION NO.	3. RECIPIENT'S CATALOG NUMBER
4. TITLE (and Subtitle) Limestone Dam NATIONAL PROGRAM FOR INSPECTION OF NON-FEDERAL DAMS		5. TYPE OF REPORT & PERIOD COVERED INSPECTION REPORT

LIMESTONE COMMUNITY DAM

ME 00492

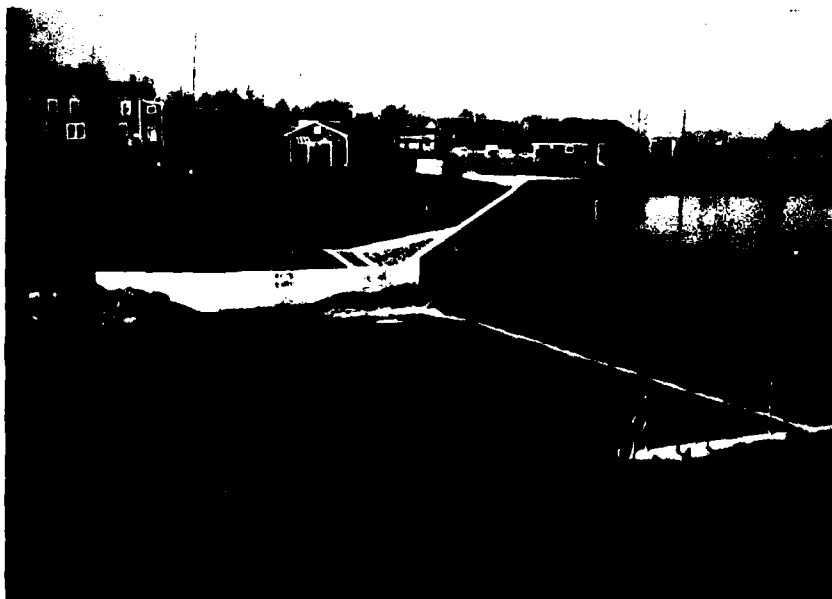
PHOTO #5  
SPILLWAY WITH FISH  
LADDER AND VALVE  
SHAFT

(3) Downstream slopes - The downstream slope rip-rap appeared in good condition. The slopes have well developed, tight grass covers. No significant gully action was observed on the slopes (Photos 5 and 6). No slides or sags were observed.

(1) Spillway - The broad crested weir spillway and chute were in good condition (Photo 5). The adjacent reinforced concrete training walls were also in good shape with no visible deterioration.
