CONNECTICUT RIVER BASIN  
CLAREMONT, NEW HAMPSHIRE

FITCH RESERVOIR DAM

PHASE I INSPECTION REPORT  
NATIONAL DAM INSPECTION PROGRAM

DECEMBER 1979

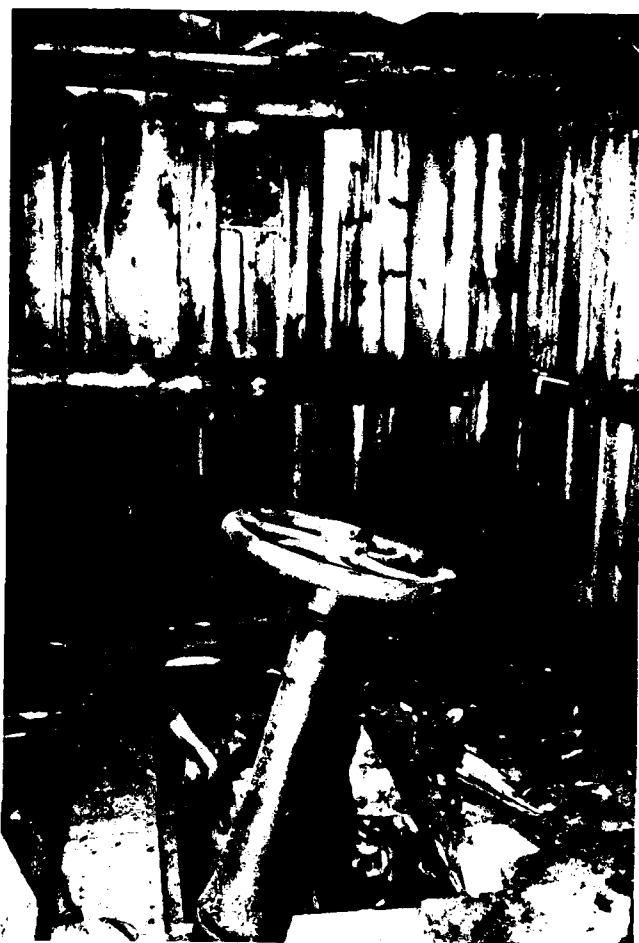
The wood framed gate house is in poor condition with an advanced degree of rot on the wood floor. The wood siding shows evidence of rot. The door of this structure is broken and the structure is prone to vandalism. The gearing system attached to the bench stand, for operating the 24-inch gate, is completely rusted. It is doubtful that this gate can be operated without complete rehabilitation. Discussions with personnel of the Claremont Water Works revealed that this gate has not been operated in the past five years and possibly once in the preceeding ten years. The 8-inch gate valve is operable and at the present time is partially opened. The rate of discharge at the time of inspection was 2 to 3 g.p.m.

9. Interior of gate house
