CONNECTICUT RIVER BASIN  
GRANTHAM, NEW HAMPSHIRE

EASTMAN LAKE DAM  
NH 00039

PHASE I INSPECTION REPORT  
NATIONAL DAM INSPECTION PROGRAM

MAY 1979

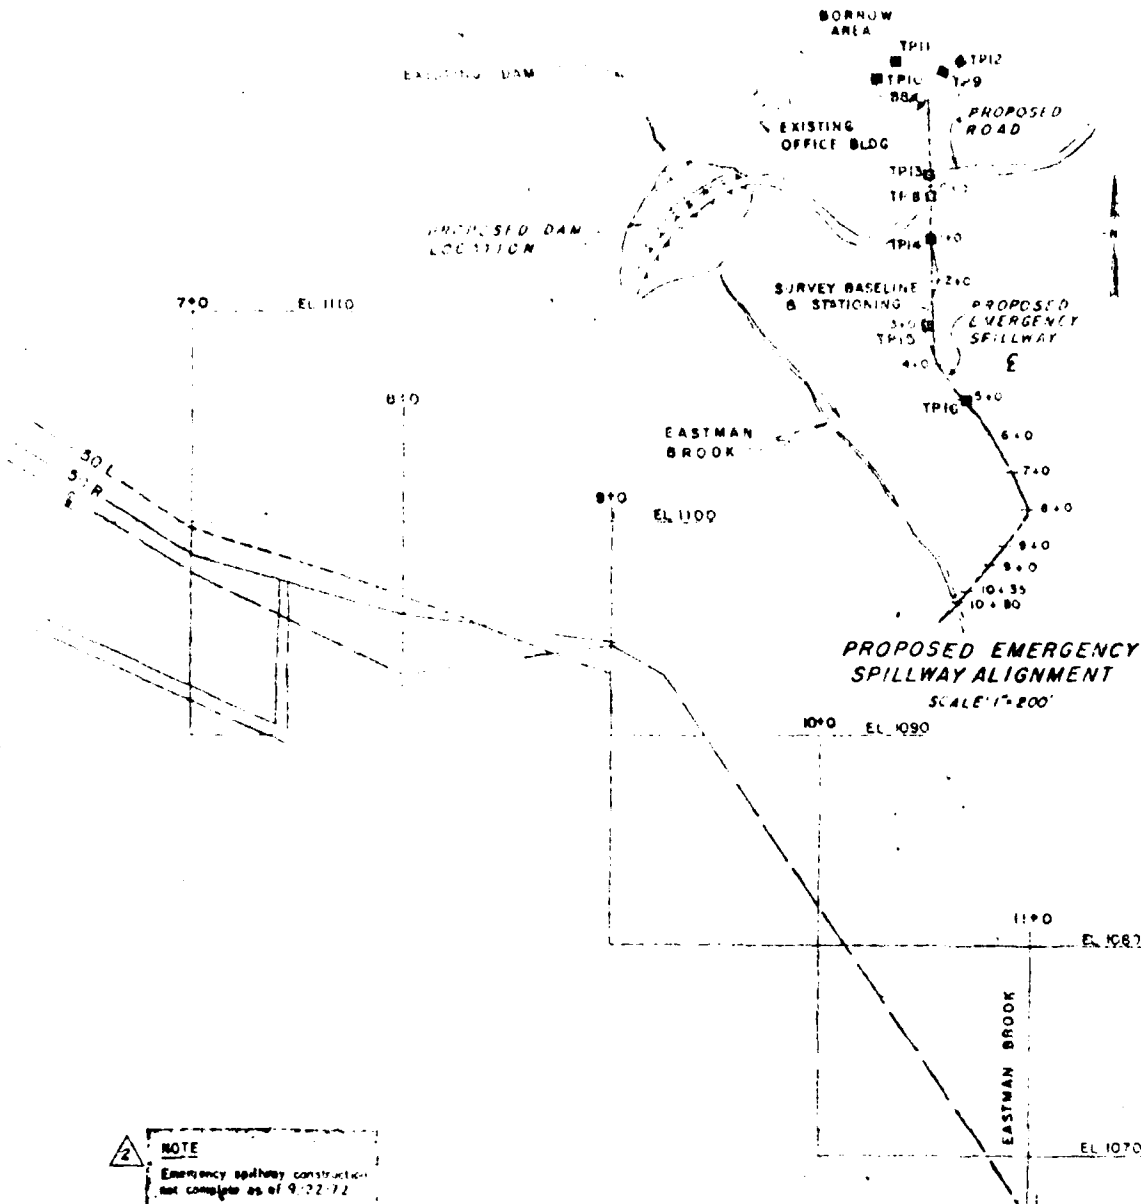
**NOTE**  
Emergency spillway construction not complete as of 9-22-72
