ORANGE RIVER BASIN
WHITING, MAINE

ROCKY LAKE DAMS
ME - 00399

PHASE I INSPECTION REPORT
NATIONAL DAM INSPECTION PROGRAM

MARCH 1979

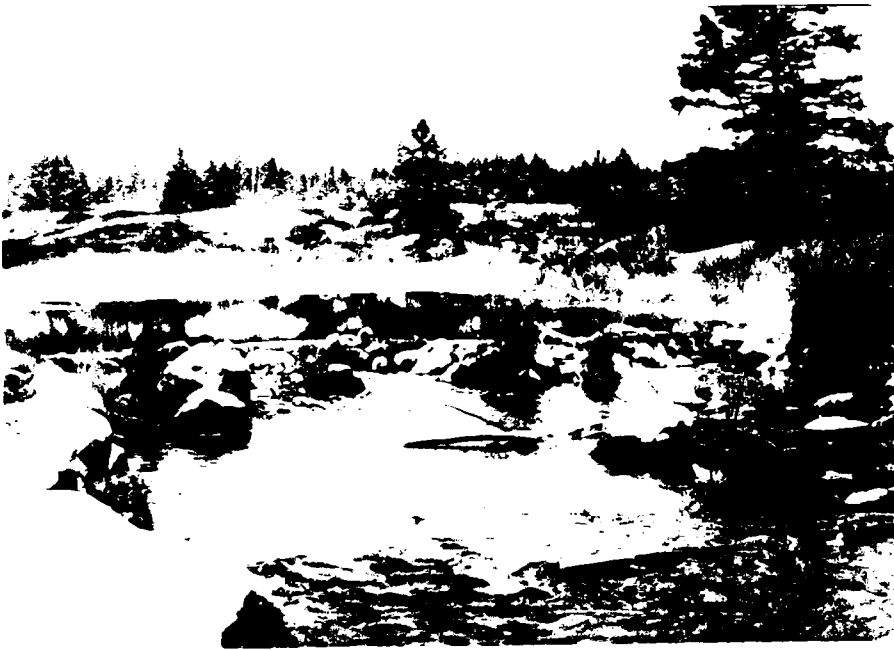
6

SOUTH DAM - UPSTREAM CONTROL
