KENNEBEC RIVER BASIN  
Waterville, Maine

# RESERVOIR DAM ME 00472

## PHASE I INSPECTION REPORT NATIONAL DAM INSPECTION PROGRAM

SEPTEMBER 1981

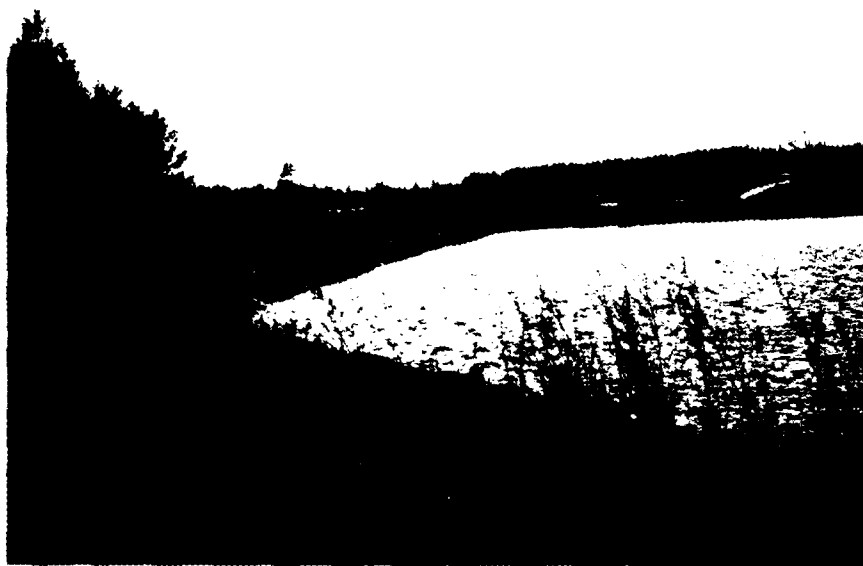
Photo 1

- b. Dam
  - (1) Crest - The embankment crest was true to line with no apparent dips, sags, cracks or other evidence of distress (Photo 1 & Overview). The crest has a well established grass cover with no signs of trespassing.

Upstream Face from  
Left Abutment

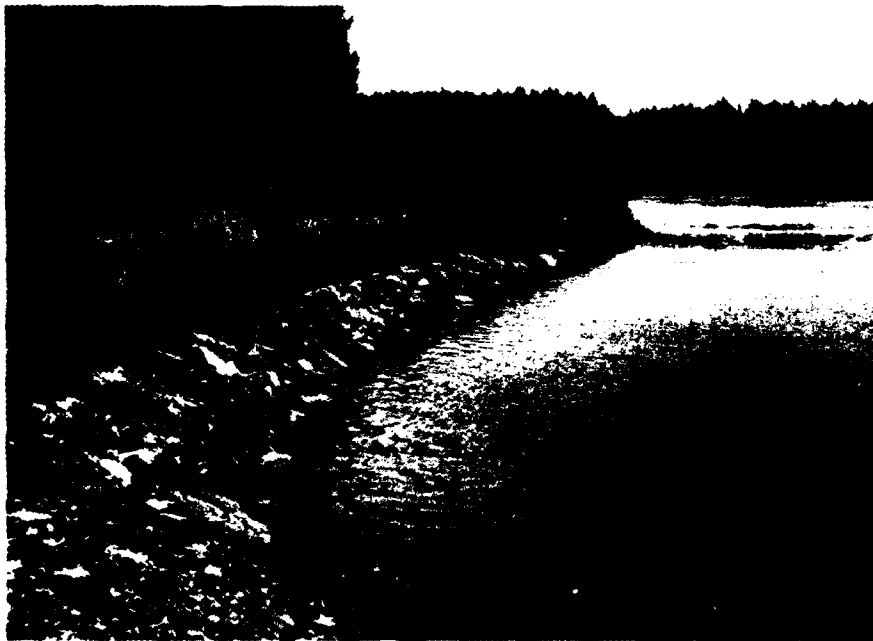
Photo 2

- (2) Upstream slopes - The upstream face was in very good condition with an undamaged rip-rap cover (Photos 1, 2 3 & Overview).
  - (3) Downstream slope - The downstream slope is dry with a heavy, well established grass cover (Photo 4). The slope showed no signs of lateral movement, erosion, sagging, or slides. No seepage was observed. The grass and weeds appeared overgrown and uncut but in general the slope was in good condition.

Upstream Right  
Abutment from  
Overflow Structure

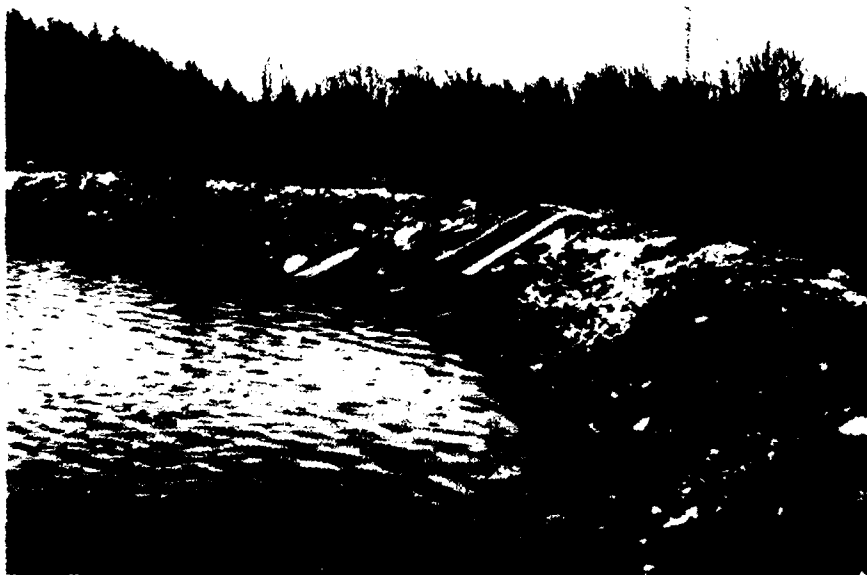
Photo 3

Upstream Right Face  
with Concrete Over-  
flow Structure

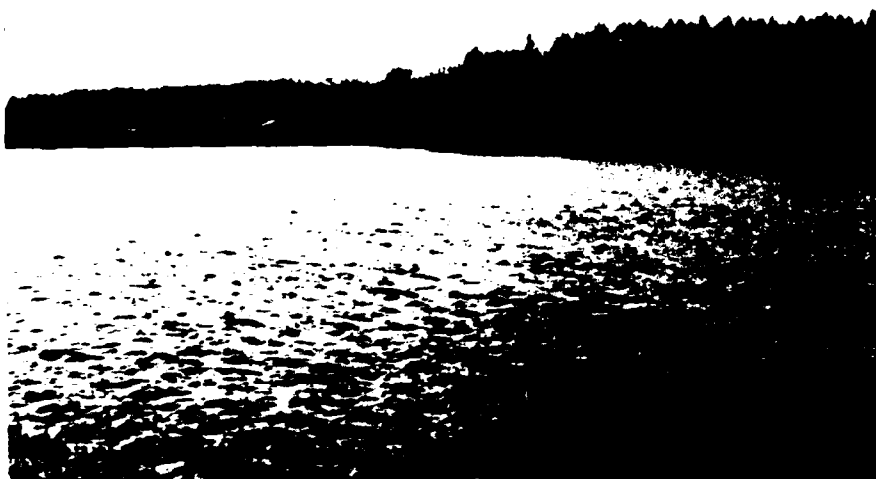
Photo 6  
View Across Reservoir  
from Left Side Looking  
Towards Dam.
