CONNECTICUT RIVER BASIN
KEENE, NEW HAMPSHIRE

ASHUELOT RIVER DAM
NH 00100
NHWRB 126.01

PHASE I INSPECTION REPORT
NATIONAL DAM INSPECTION PROGRAM

DECEMBER 1980

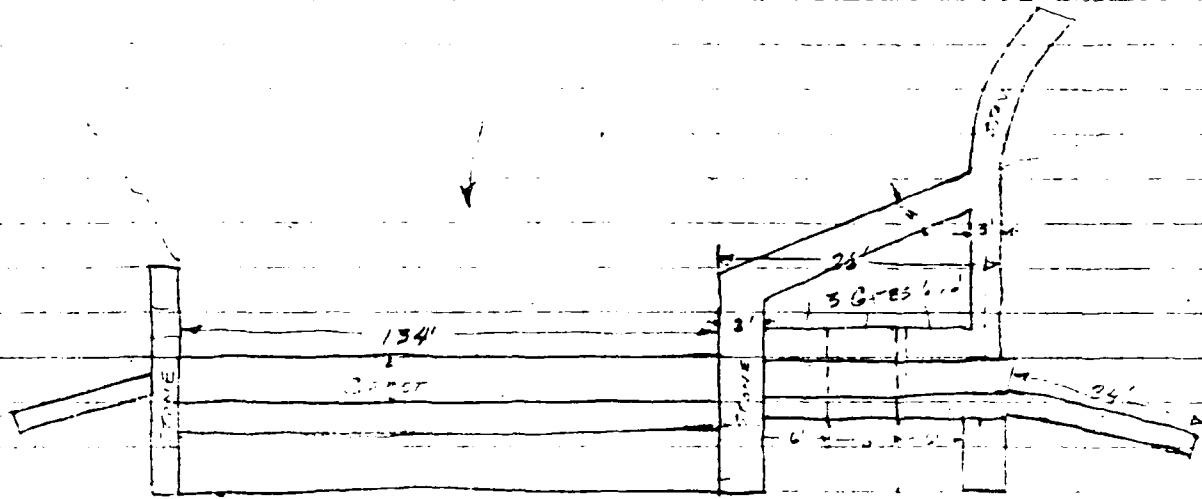
PLAN

2. Dike breached in 1936 flood where river lands repaired by wood piling 15000 by alternate layers soil & concrete

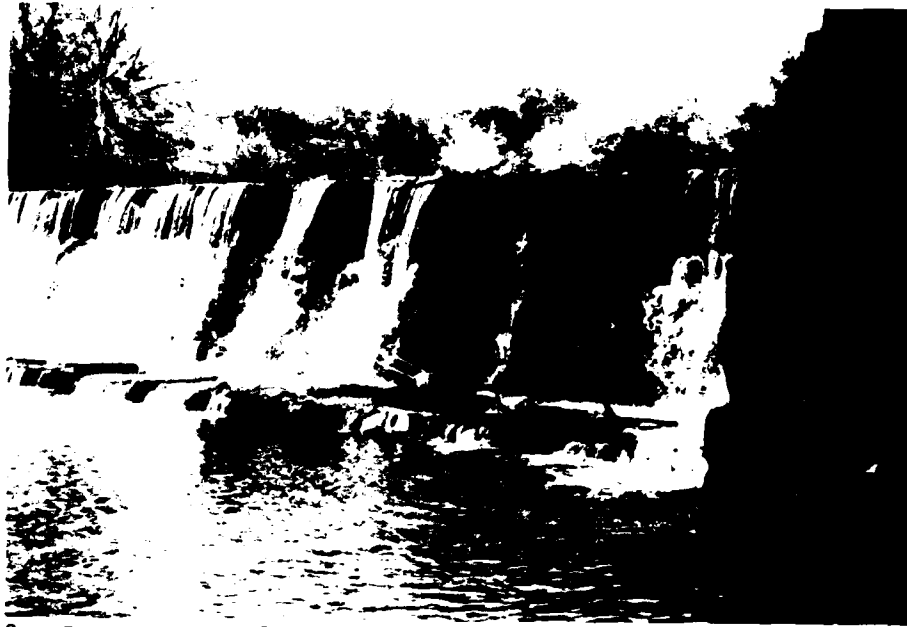
3. Downstream Left End of Spillway Showing Portion of Gate Structure at Left Abutment
