**BAKER FLOODWATER RESERVOIR
SITE 2**

NH 00231

**PHASE I INSPECTION REPORT
NATIONAL DAM INSPECTION PROGRAM**

JUNE 1979

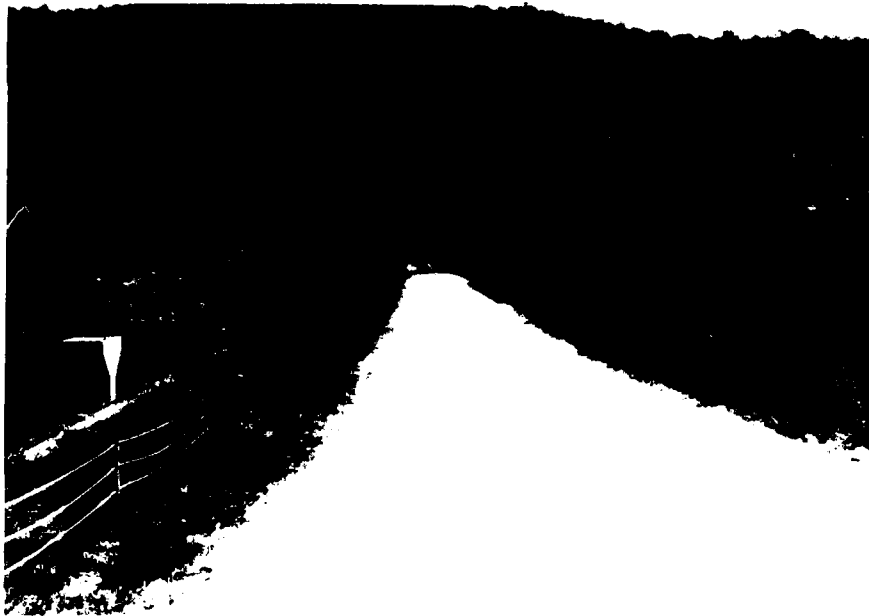
The crest of the dam is 20 feet wide and has a sand and gravel roadway, in good condition. Photo No. 5 shows the crest. No significant misalignment of the crest was observed.

PHOTO NO. 5 - View from right abutment of dam
crest and roadway.

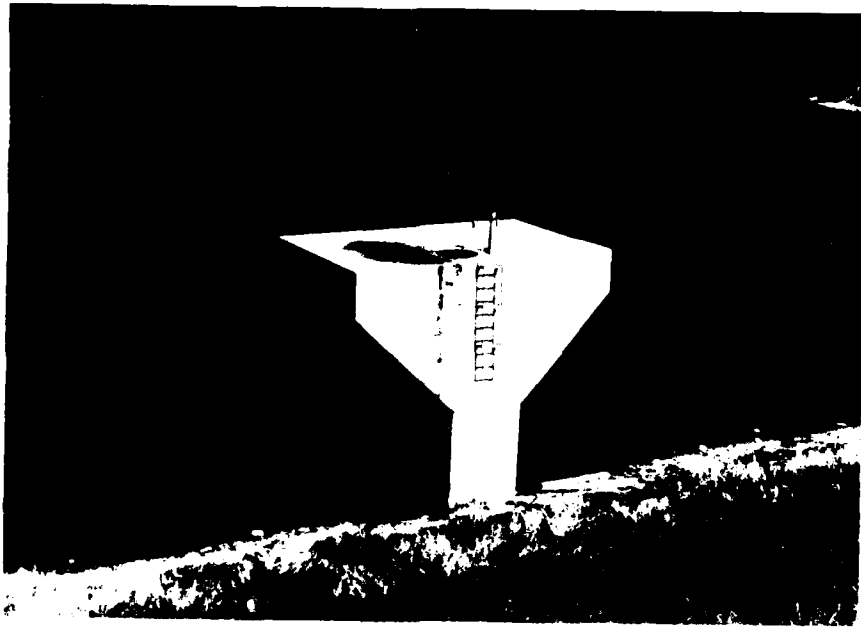
c. Appurtenant Structures. Visual inspection of the concrete riser (principal spillway) structure, emergency earth spillway outlet works structure did not reveal any evidence of stability problems. The riser structure generally appeared to be in good condition, except for rust staining, heavy scaling and loss of surface mortar in some locations on the shaft walls.

The concrete riser (principal spillway) structure consists of three elements; an overflow control with low stage inlet and high stage, covered top crest spillway, a vertical transition and a closed discharge conduit with an impact type stilling basin. The riser structure is placed in the embankment. Visual inspection revealed that the riser structure appeared to be in good condition, except for rust staining, extensive surface scaling, cracks and loss of surface mortar in some locations. Loss of coarse aggregate particales were noted, Photos No. 8,9,10,11 & 12.

PHOTO NO. 8 - View of riser and covered high stage inlet
from dam.

- (a) Repair the concrete surface of the riser structure.
- (b) Repair the concrete spalling at the end of the 4 foot diameter discharge pipe.
- (c) Observe and record the condition of the spring on the right abutment with changing reservoir level. It is particularly important that these observations be made during the next filling of the reservoir.

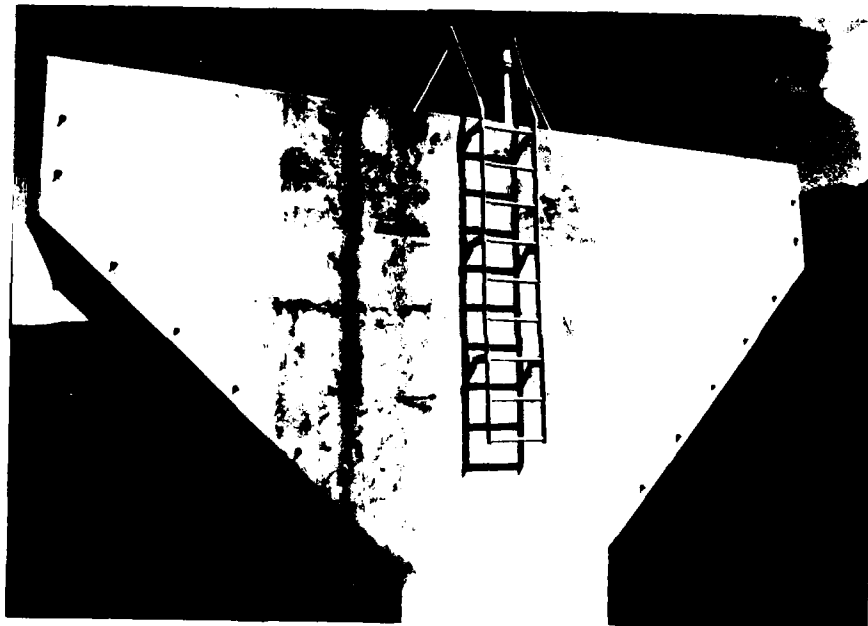
PHOTO NO. 9 - View covered high stage inlet.

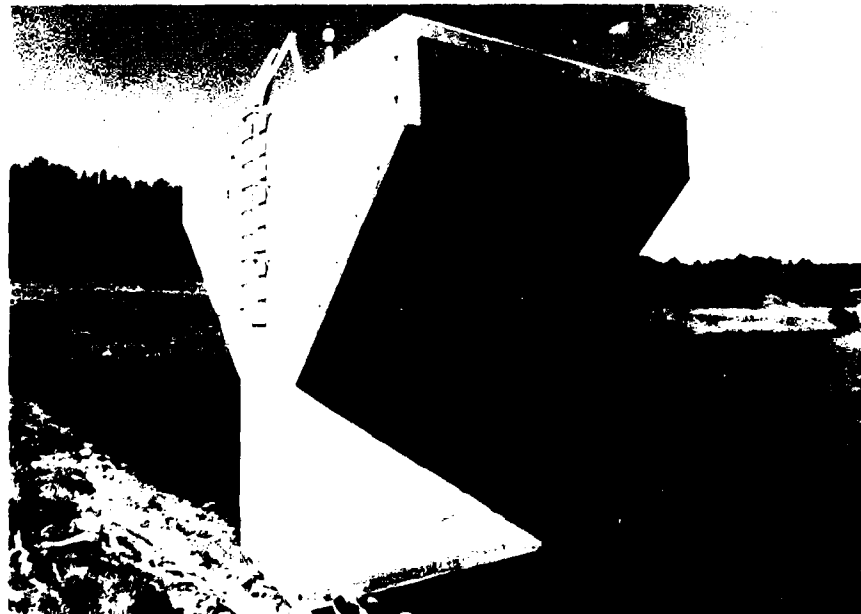
PHOTO NO. 11 - View of left side of riser and high stage trash rack.

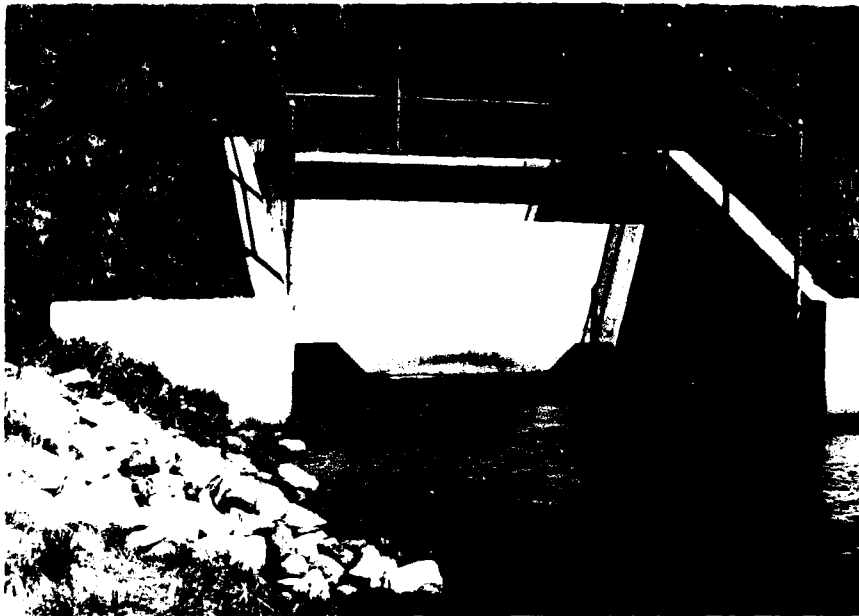
The outlet works structure at the toe of the dam consisting of 48 inch reinforced concrete pipe and stilling basin structure is located at the original stream channel, Photos No. 13 & 14. The apron slab and training walls of the stilling basin structure appear to be in sound condition. Some water staining and concrete spalling were noted at the discharge pipe area.

PHOTO NO. 14 - View of impact type stilling basin.

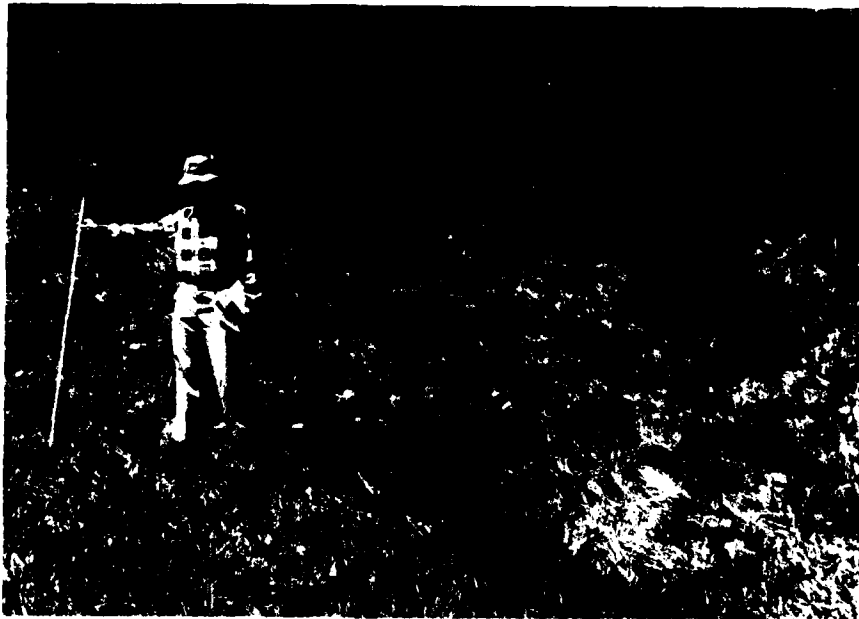
There is a wet area at the toe of the slope which appears to be due to runoff from a spring on the right abutment about 10 feet from the toe of the embankment at about El 832. The area of this spring is shown in Photo No. 17. The pool elevation at the time of inspection was about 834.5. Since the dam is about 160 feet wide at El 834, it does not seem likely that the spring is a result of seepage through the embankment. This spring and the wet area at the toe of the slope should be closely observed at various reservoir elevations to establish if flow from the spring is related to the reservoir elevation.

PHOTO NO. 17 - Seep area at approximately elevation 832 on downstream side of right abutment.
