DAN HOLE POND DAM

NH 00376

PHASE I INSPECTION REPORT
NATIONAL DAM INSPECTION PROGRAM

NOVEMBER 1978

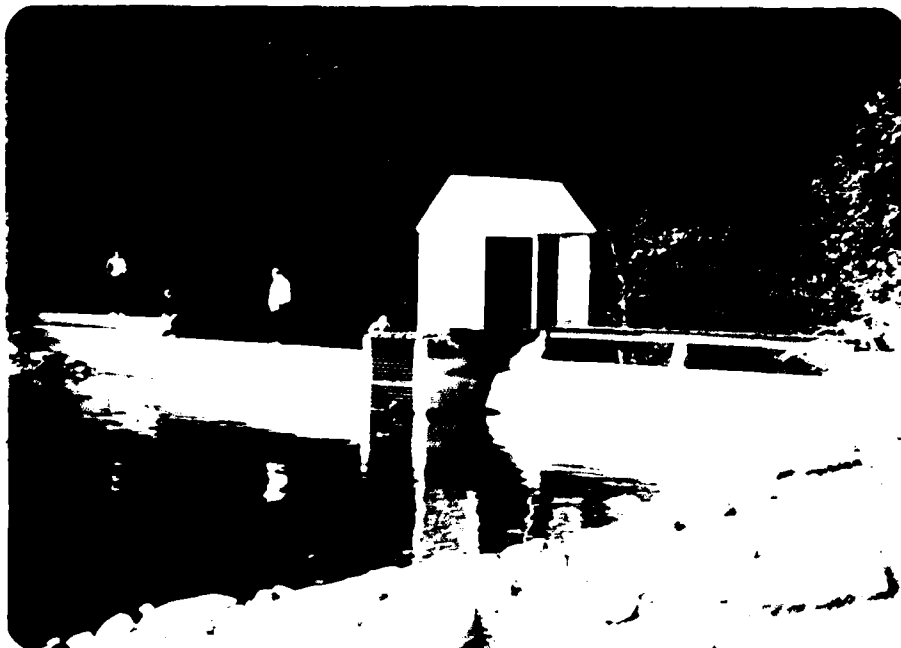
Overview from right side upstream

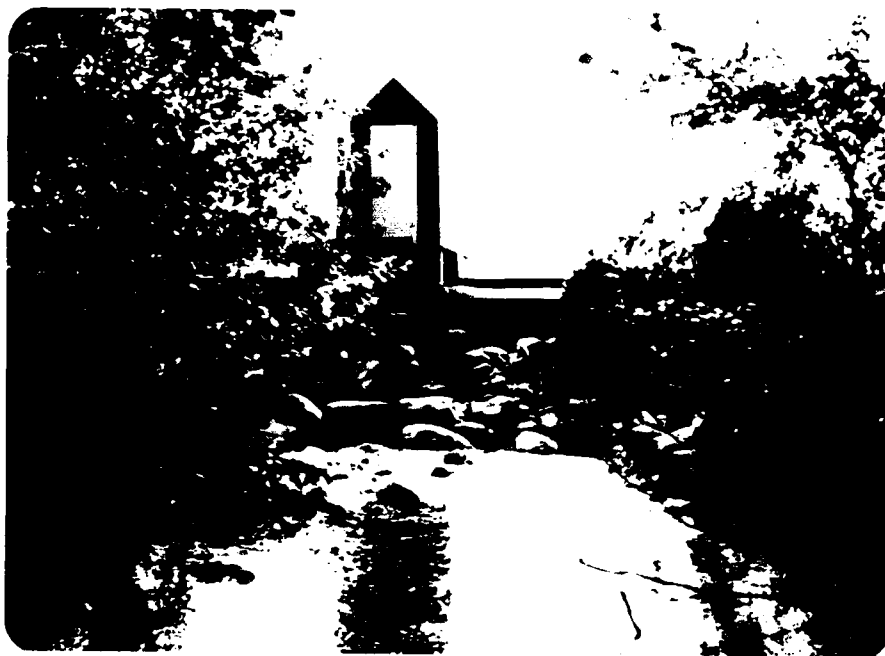
Overview from left side downstream

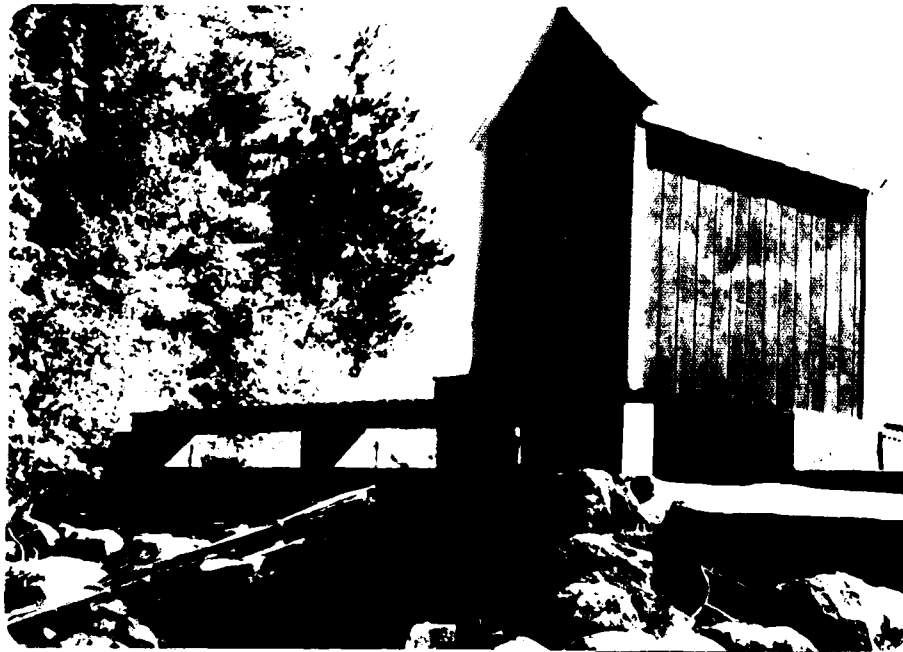
Overview of right side of dam and
gatehouse from downstream
