NATIONAL PROGRAM FOR INSPECTION OF NON-FEDERAL DAMS  
MASCOMA DAM (NH 00155) (U) CORPS OF ENGINEERS WALTHAM  
MA NEW ENGLAND DIV JUL 80

CONNECTICUT RIVER BASIN  
LEBANON, NEW HAMPSHIRE

MASCOMA DAM  
NH 00155  
NHWRB 134.09

PHASE I INSPECTION REPORT  
NATIONAL DAM INSPECTION PROGRAM

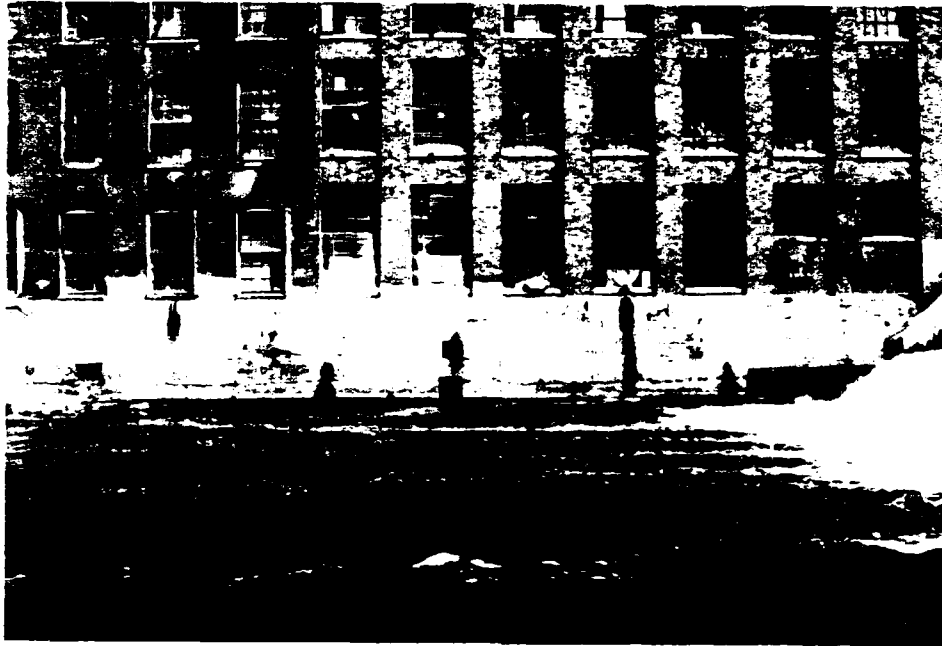
3. Downstream Outlets and Mill Building

The sluiceway outlets are 6 feet wide and 4 feet high. Saplings and other vegetative growth flourishes between the walls and the sluiceway outlets. The concrete invert of this sluiceway outlets has completely eroded exposing reinforcing steel and timber supports. The remains of the invert slab is also undermined. The bases of the end walls and dividing walls of the outlet structure are eroded up to 4 inches in height and up to 6 feet in length. The downstream side of the gate structure exhibits a high degree of spalls, open horizontal construction joints and a high degree of efflorescence. The spalling can be attributed to moisture intrusion subjected to alternate freeze and thaw cycles. Seepage is in evidence between the concrete end walls of the outlet structure and the dry stone masonry walls.

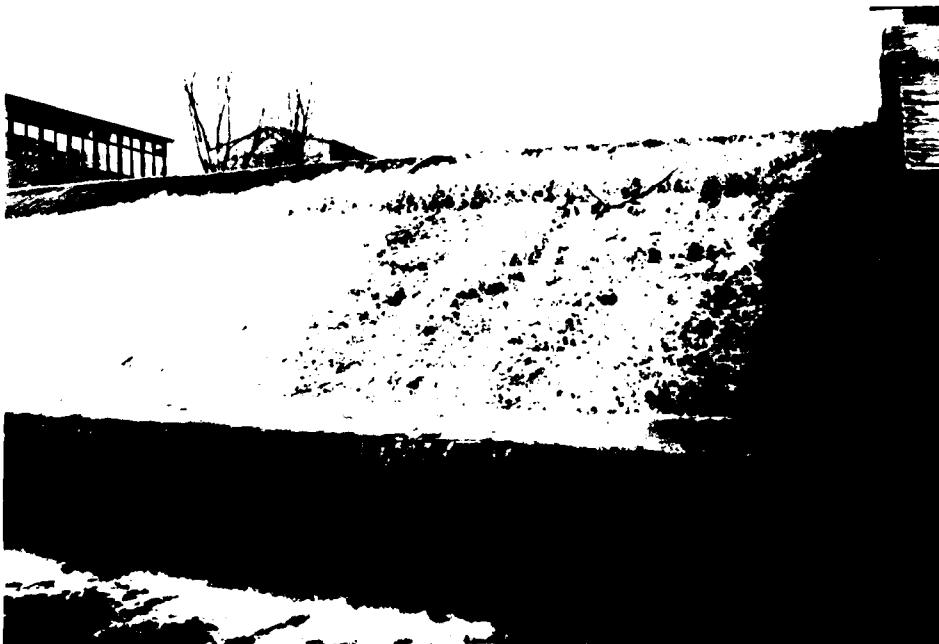
4. Right Spillway Section

This structure is in deplorable condition as evidenced by severe erosion, exposure of formerly concrete faced timber cribbing and settlement. There is a large horizontal crack and settlement over the entire downstream face of the spillway 2 to 3 feet below the crest. In addition to the foregoing there are numerous horizontal cracks and holes resulting from cavitation.

Approximately 20 feet of the left end of this structure has been subject to such a high degree of cavitation and ice damage that large rubble stones have been exposed. The entire downstream sloping surface has settled in excess of 6 inches and possibly in excess of 12 inches. The actual degree of settlement could not be determined due to the overflows. A 5 foot wide concrete faced platform supported on a timber crib is located on the downstream end of this structure. The top of this platform is approximately 4 feet above the tailrace channel. The concrete surface has been subjected to considerable erosion which can be attributed to ice damage. The downstream end of this concrete platform has been shattered exposing the timber crib. Observations have revealed that the crest is not level; the left portion being lower than the right. It was also observed that the right end of the downstream platform is lower than the left.

(b) Severe erosion and general poor condition of the right timber crib spillway section.

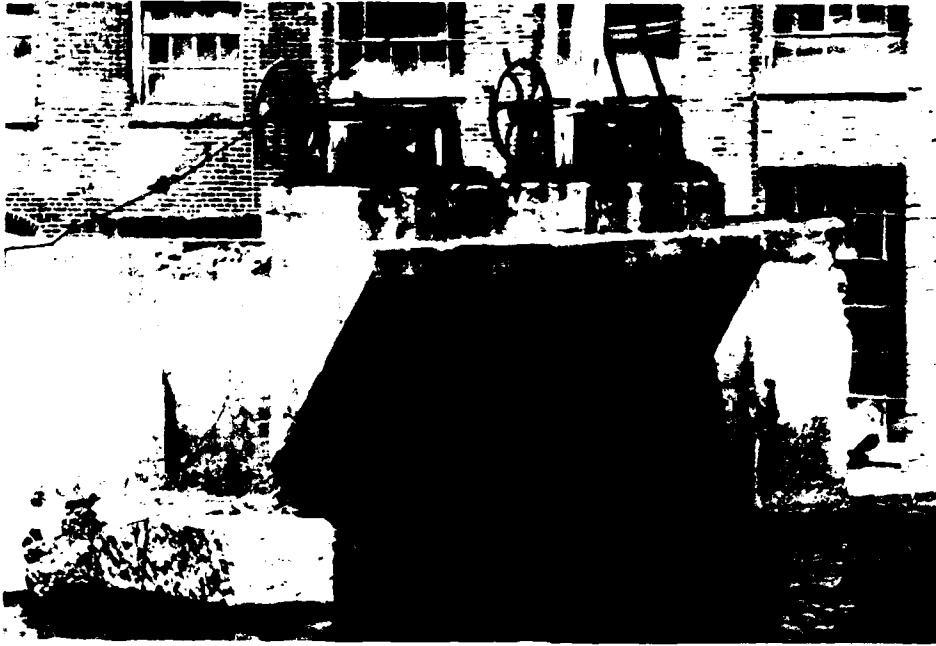
7. Upstream View of Waste Gate Structure

The top upstream right and left corners have been subjected to a high degree of spalling. This spalling is in excess of 6 inches in depth. The concrete platform which supports the gate bench stands is cantilevered over the impoundment pool by approximately 3 feet by means of 4 concrete brackets. The platform itself is in good condition.

The manually operated gate mechanisms consist of hand wheels and worm gears which actuate the rack gears on the timber stems. The operating mechanisms are severely rusted. In 1978 they were raised for a height of 3 inches with considerable effort. The timber sluice gates are in good condition and well seated with minor seepage flowing around the gates.
