PISCATAQUA RIVER BASIN
WAKEFIELD, NEW HAMPSHIRE

UNION MEADOWS DAM
N.H. 00222

PHASE I INSPECTION REPORT
NATIONAL DAM INSPECTION PROGRAM

NOVEMBER 1979

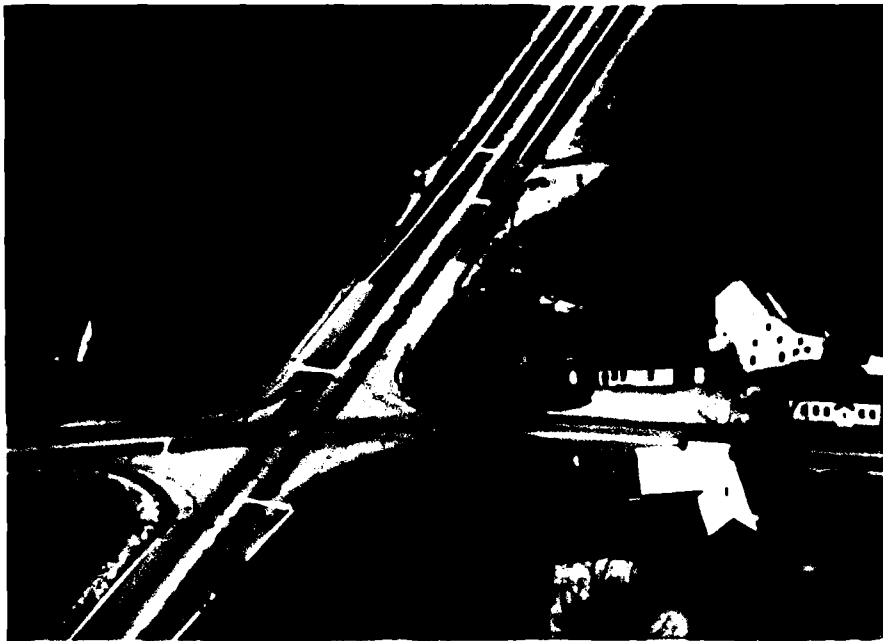
September 1979
Figure 1 - Overview of Union Meadows Dam. Note
State Route 16 bridge just downstream.

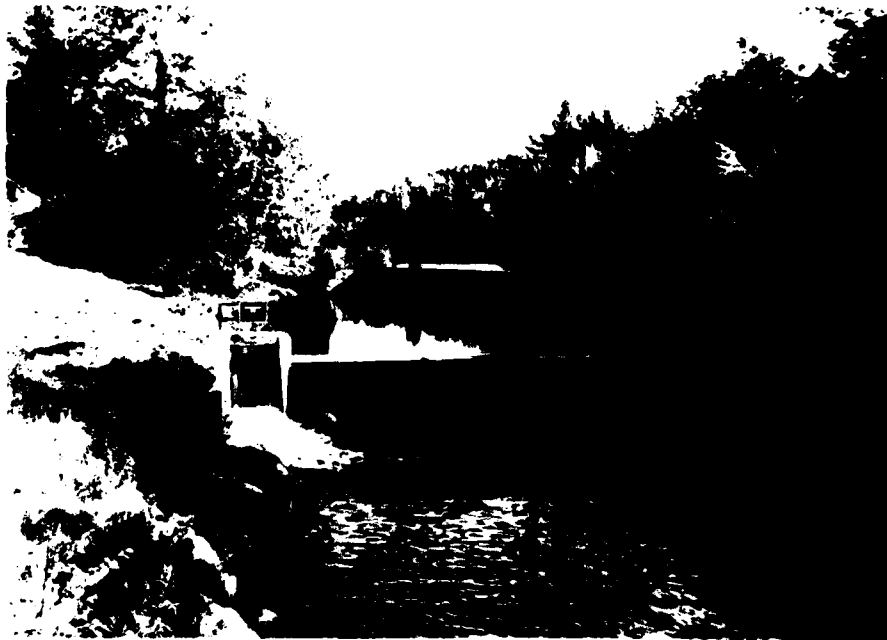
September 19, 1979
Figure 2 - Close-up view of Union Meadows Dam from
the State Route 16 bridge.

b. Dam. Union Meadows Dam is a concrete-capped dry stone-masonry dam, 10 feet high, 67 feet long, and 8 feet wide at the crest. (See Appendix C - Figure 2.) The concrete cap and dry stone-masonry appear to be in good condition. (See Appendix C - Figure 3.) Soil covered bedrock is exposed at the east abutment. (See Appendix C - Figure 4.) No evidence of seepage through the abutment or deterioration of the abutment rock was observed.

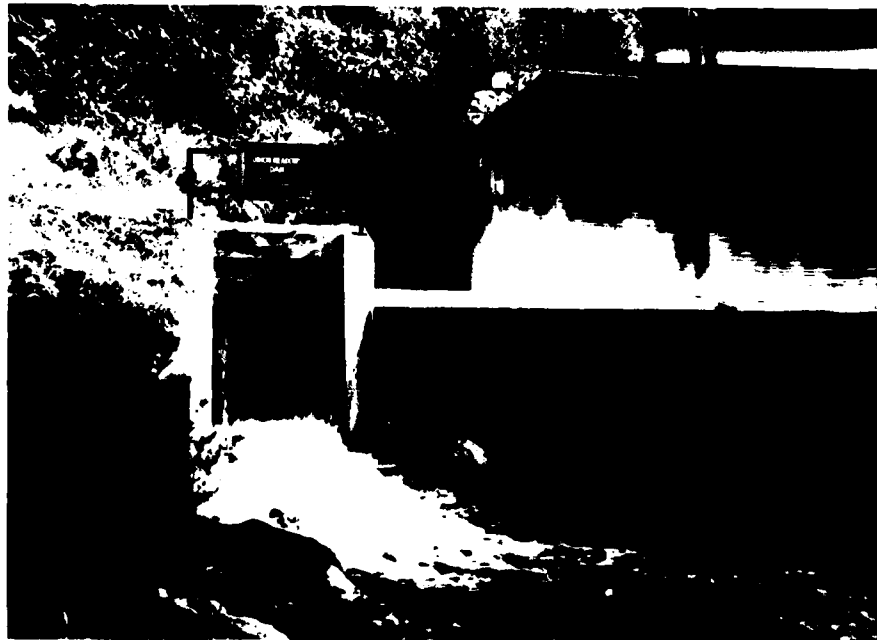
September 19, 1979
Figure 6 - Looking north at downstream face of stoplog structure.

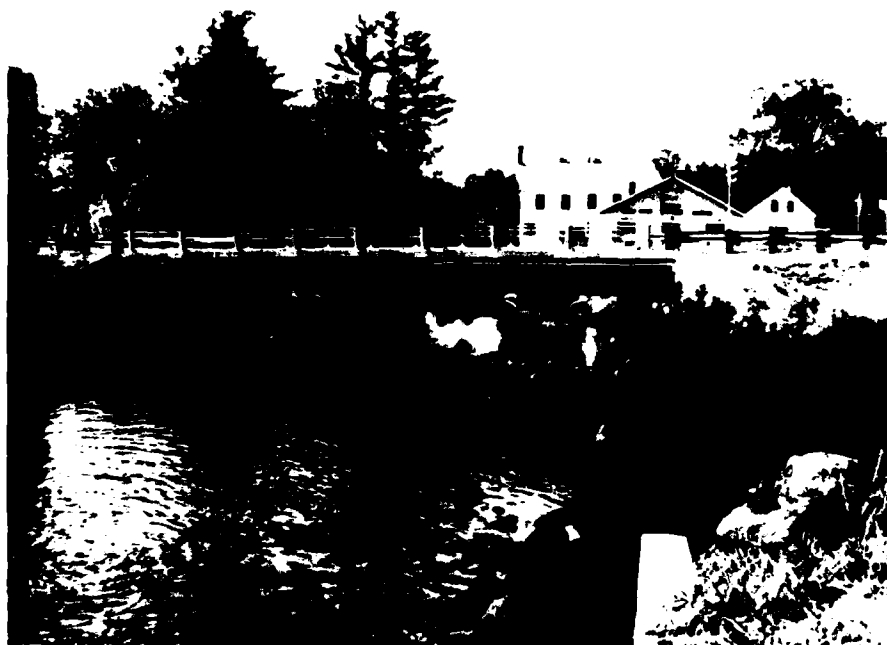
condition. Trees growing on the east bank of the discharge channel between the dam and State Route 16 would obstruct the channel and the culvert downstream if they should fall over during floodflow conditions.

September 19, 1979
Figure 8 - Looking south at State Route 16 bridge
from top of stoplog structure.

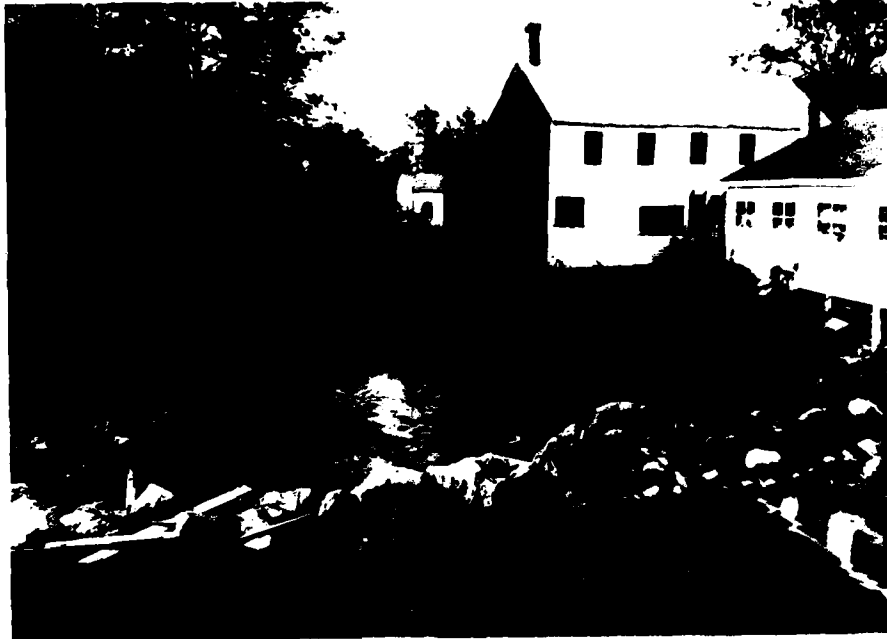
September 19, 1979
Figure 9 - Looking south at Reach 2 from Route 16
bridge.

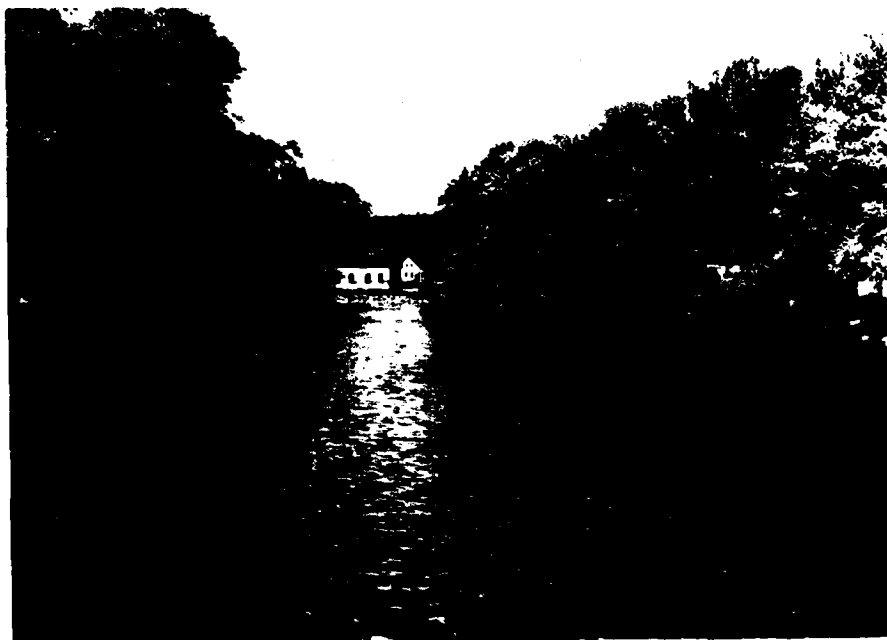
September 19, 1979
Figure 10 - Looking northwest at Reach 2 just
upstream of Dam "A".

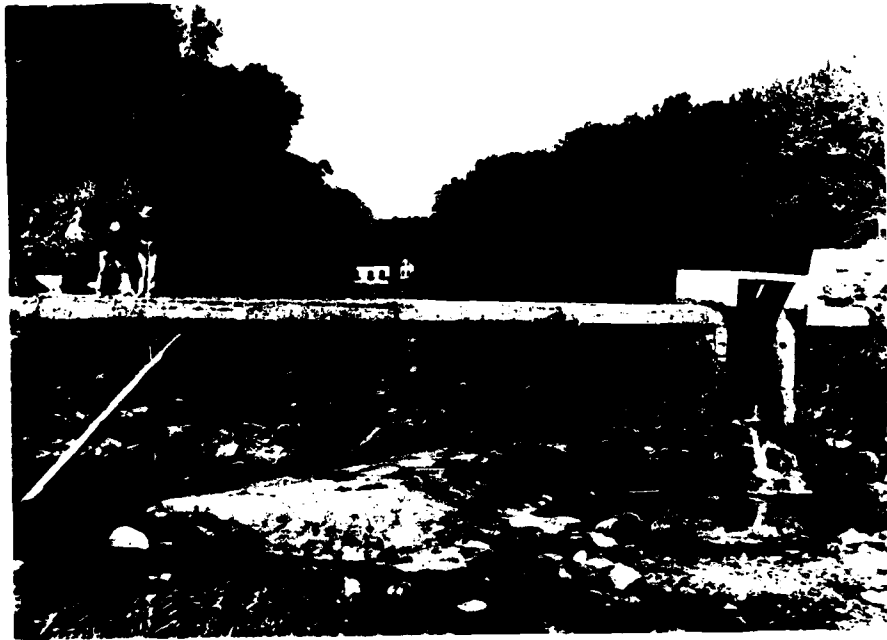
September 19, 1979
Figure 11 - Looking northwest at downstream face of
Dam "A".

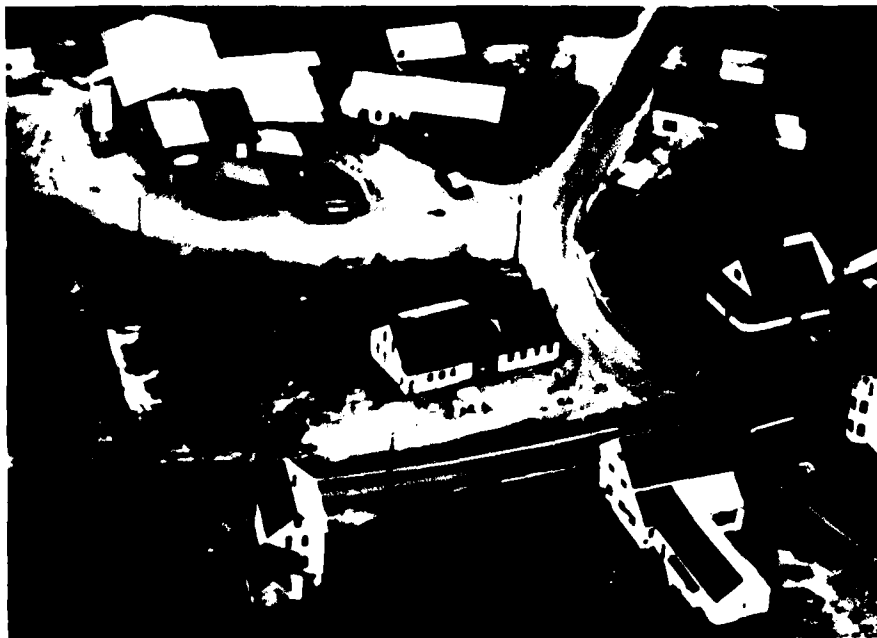
September 19, 1979
Figure 12 - Overview looking east at Dam "A". Note
Maple Street bridge just downstream.

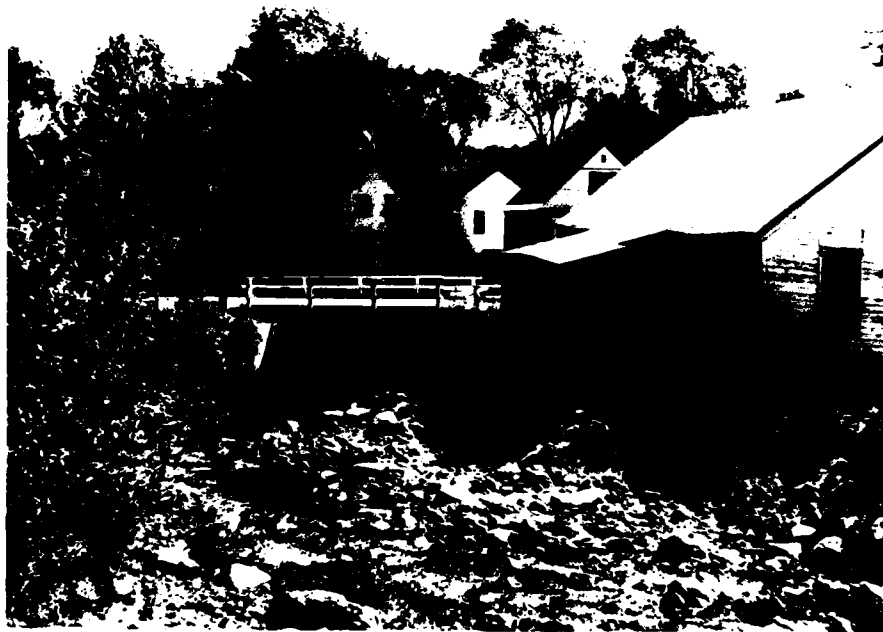
September 19, 1979
Figure 13 - Looking south at Reach 3 downstream of
Dam "A".

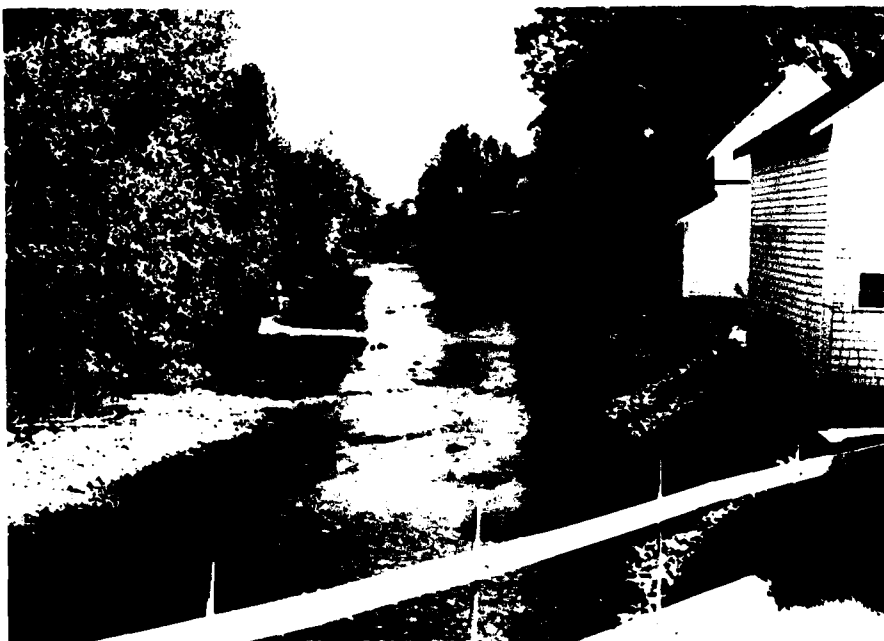
September 19, 1979
Figure 14 - Looking southeast at Reach 4 downstream
of Maple Street.

Two inhabited structures located along Reach 4 would be subject to up to 3 feet of water. Appreciable property damage would result but loss of life would probably not occur.
