MEGUNTICOOK RIVER BASIN
CAMDEN, MAINE

MEGUNTICOOK LAKE DAMS
EAST ME - 00278
WEST ME - 00279

**PHASE I INSPECTION REPORT
NATIONAL DAM INSPECTION PROGRAM**

AUGUST 1978

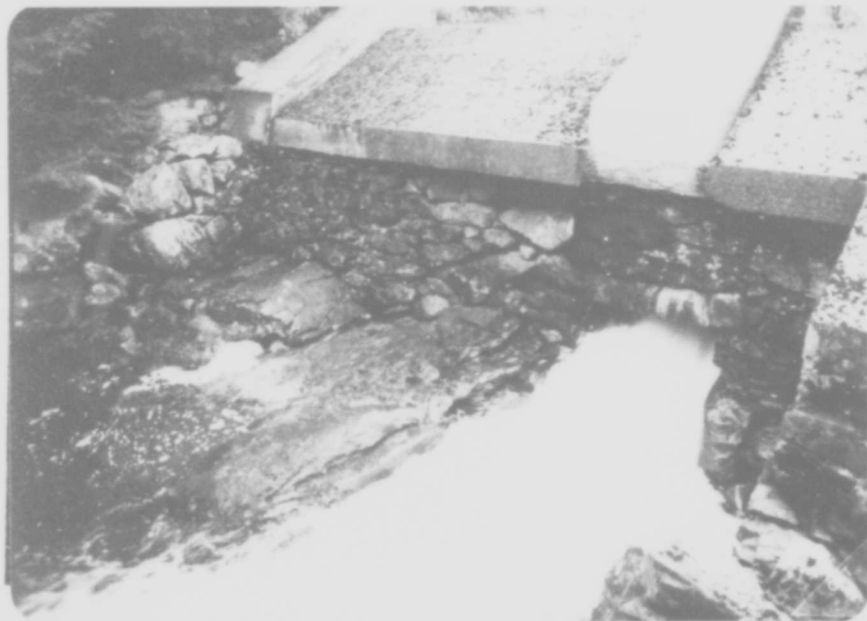
E-1
GATE OPENING AND DOWNSTREAM FACE OF DAM

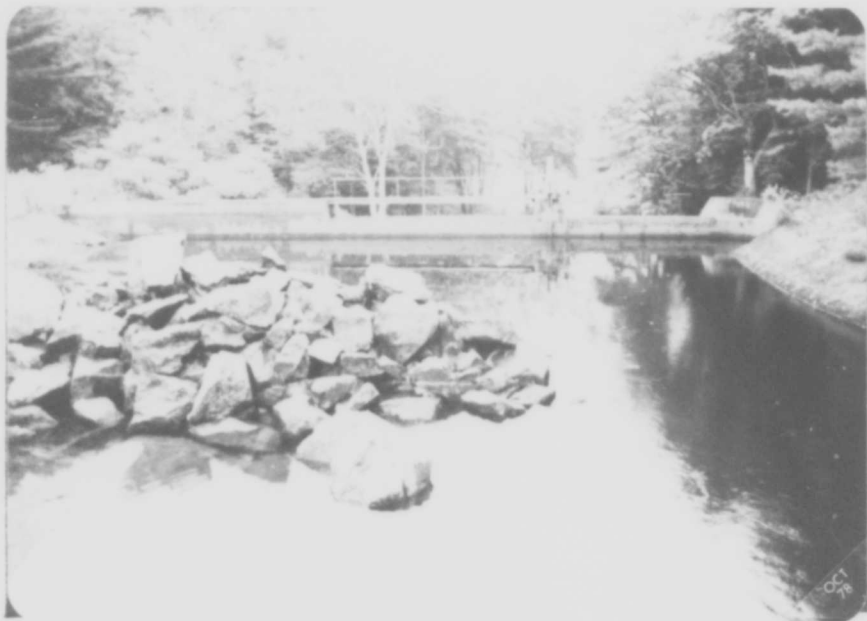
E-2
UPSTREAM FACE OF DAM AND ABANDONED COFFER DAM

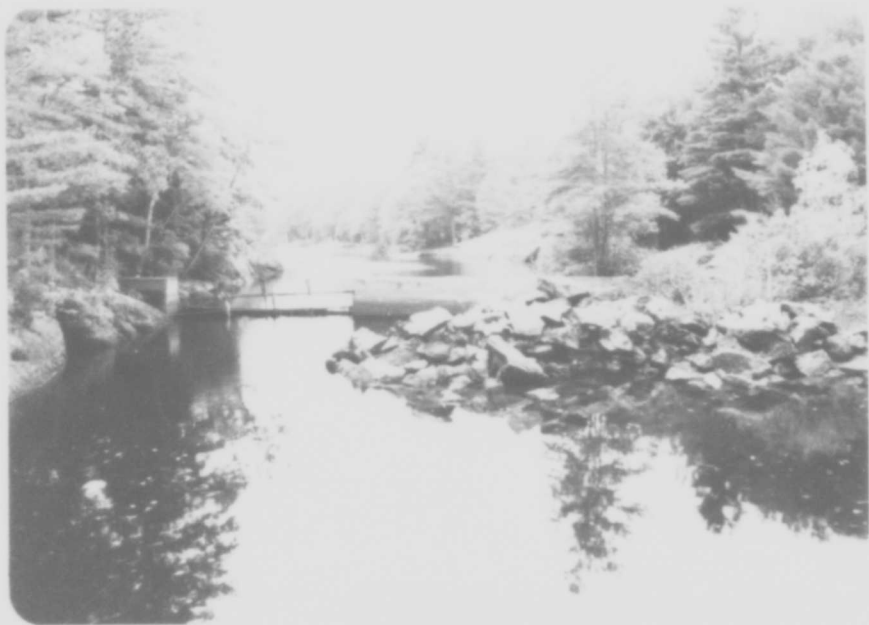
E-3
FISH SCREEN

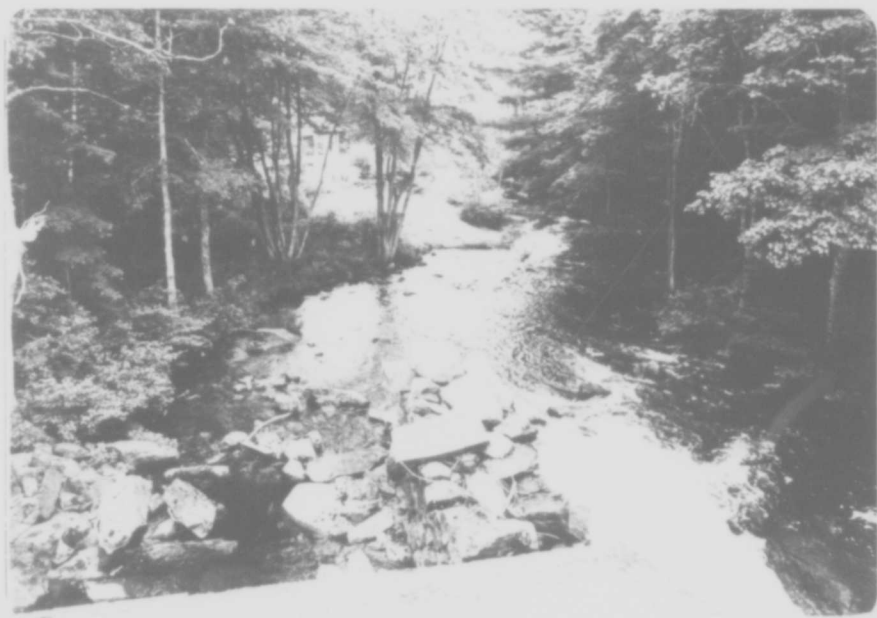
E-4
DOWNSTREAM CHANNEL

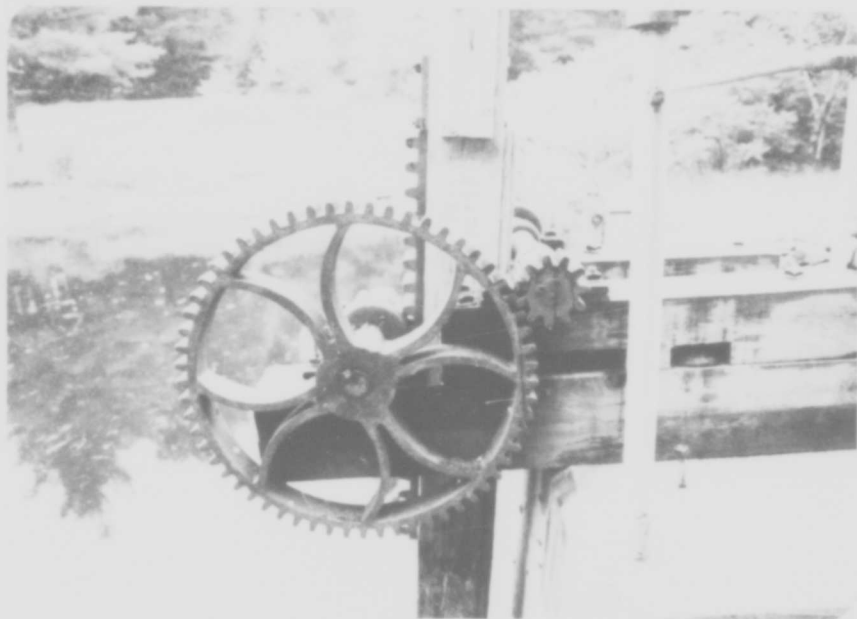
E-7
GATE OPERATING MECHANISM

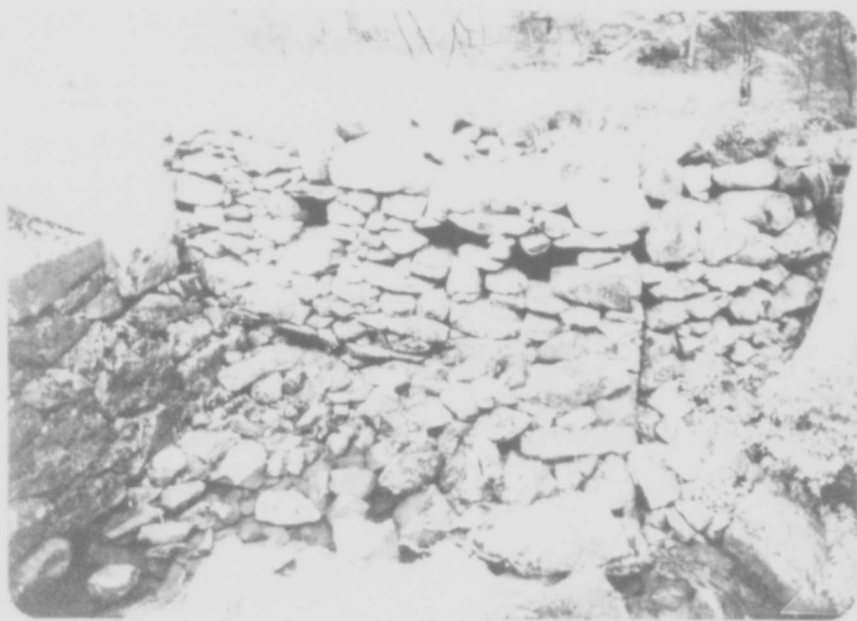
E-8
EMBANKMENT STRUCTURE

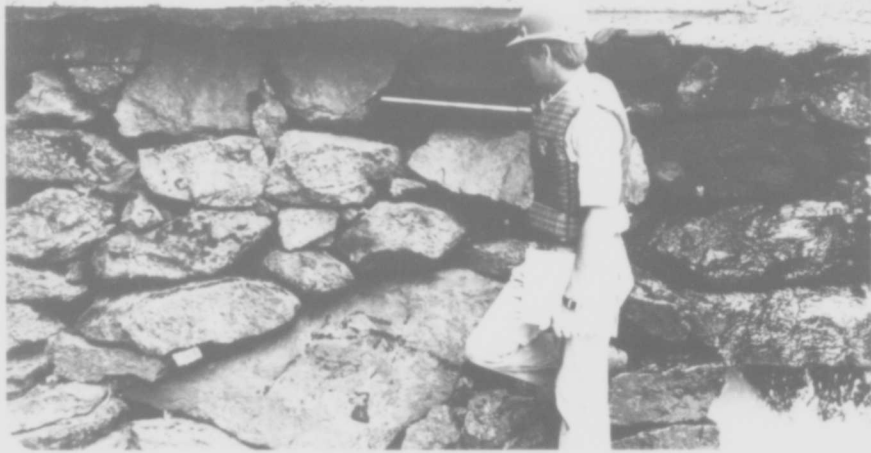
A major concern at both structures is the potential loosening and loss of the downstream stone masonry which could result in a progressive failure of the spillway sections of the structures. Under high flows the downstream faces may be subjected to negative pressures and vibrations which could cause loosening of the unbound dry laid stone masonry. At the East Dam the concrete spillway is a gravity section lying on top of the stone masonry and under high flows when tailwater approaches the height of the bottom of the spillway, negative pressures could develop which would lift the spillway section. At the West Dam, the timber spillway and service bridge would likely not survive the test flood. The loss of this section would result in progressive loss of the unbound stone masonry portion of the dam.

Stone Masonry Surfaces - the downstream portion of the dam including the downstream face is constructed of dry laid stone masonry. The face of this unbound masonry is generally tight but some stones are missing. See Photograph E-9.

E-9
DOWNSTREAM FACE OF DAM

1. Construction of a concrete downstream face to secure the stone masonry at the East Dam. Such a concrete section would have to provide adequate drainage and should be doweled to the spillway concrete. Construction of a concrete downstream face would provide resistance to loss of the masonry and spillway apron during flood flows.
2. Replacement of the timber spillway at the West Dam with one constructed of reinforced concrete. The existing timber spillway is inadequate during flood flows, and would likely be torn loose from the structure during a high overtopping flood. The construction of a concrete downstream face as discussed for the East Dam above should also be investigated for the West Dam.
3. Reconstruction of the timber sluiceway through the West Dam using reinforced concrete.
4. Enlargement or alteration of the spillways to improve the discharge capacity at each dam.

2. Repair all spalled surfaces of concrete and fill all joints and cracks.
 3. Replace all stones missing from the downstream masonry portions of the dams. Chink voids with small stones to assure a tight masonry face.

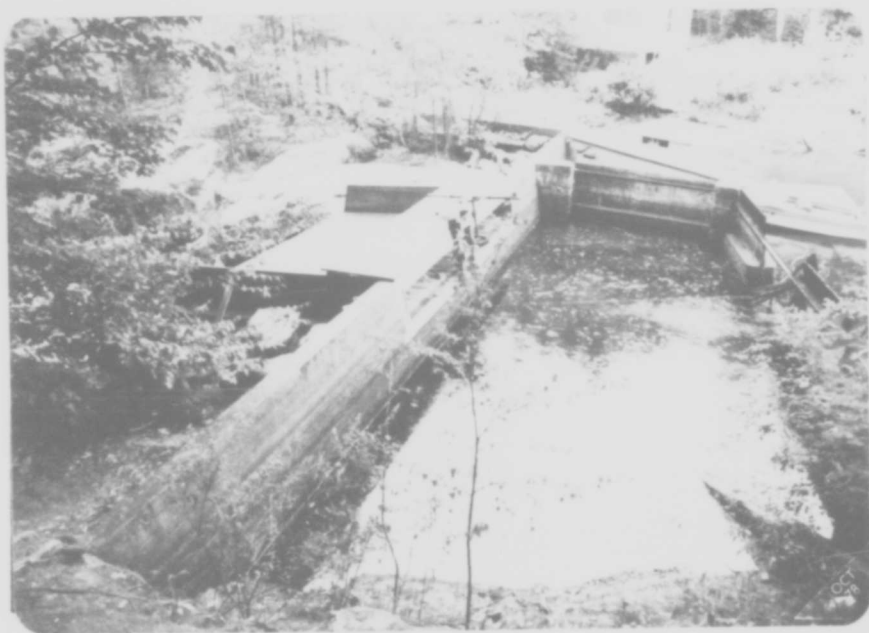
W-1
UPSTREAM FACE OF DAM

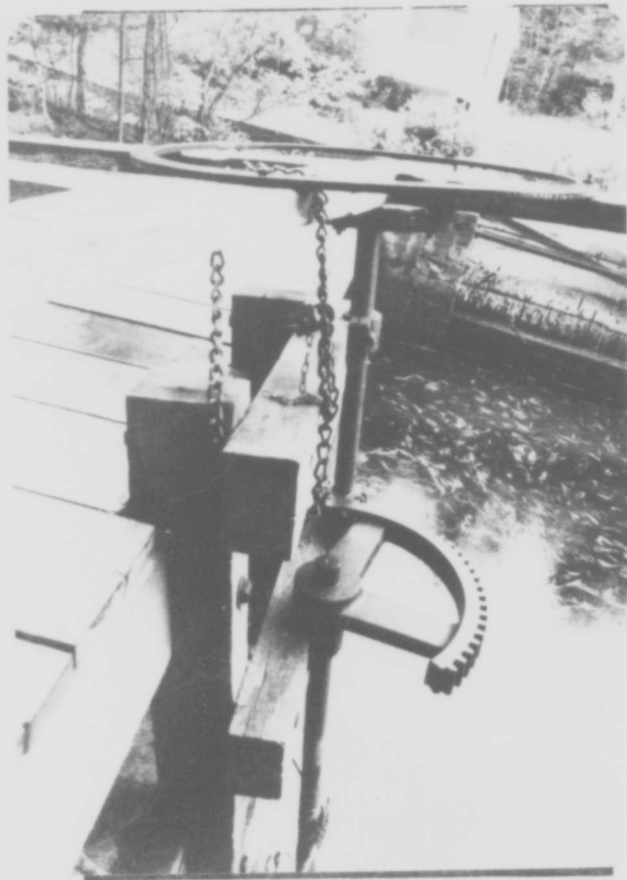
The gate works at the West Dam consist of a butterfly gate manually operated by a vertical stem and horizontal rack and gear. The gate is in good mechanical order and is locked by a chain and padlock. The operating stem shows substantial corrosion. See Photographs W-2 and 3.

- b. Structural Cracking - several fine cracks were observed in the wing walls and in the upstream face of the spillway section. All cracking appeared to be related to shrinkage and temperature. See Photograph W-2.

W-2
GATE OPERATING MECHANISM

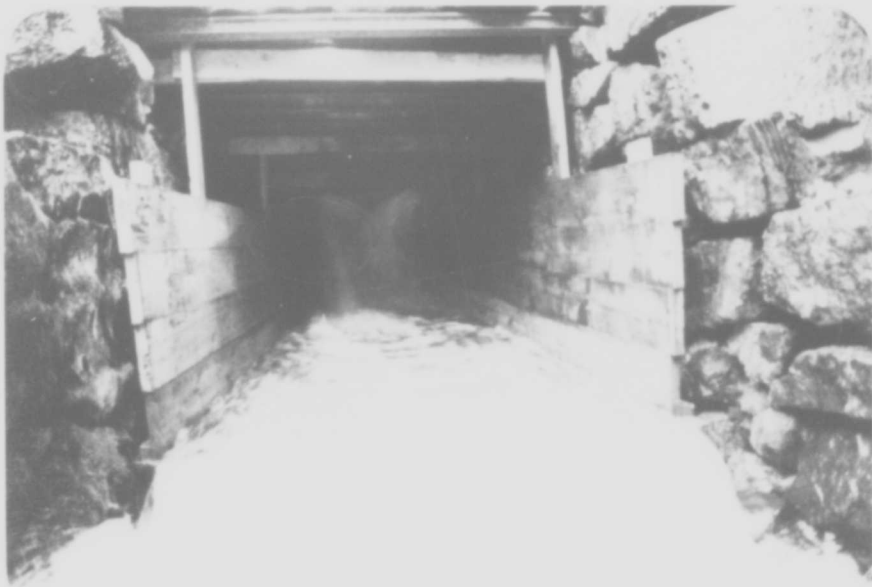
W-4
SLUICWAY OUTLET

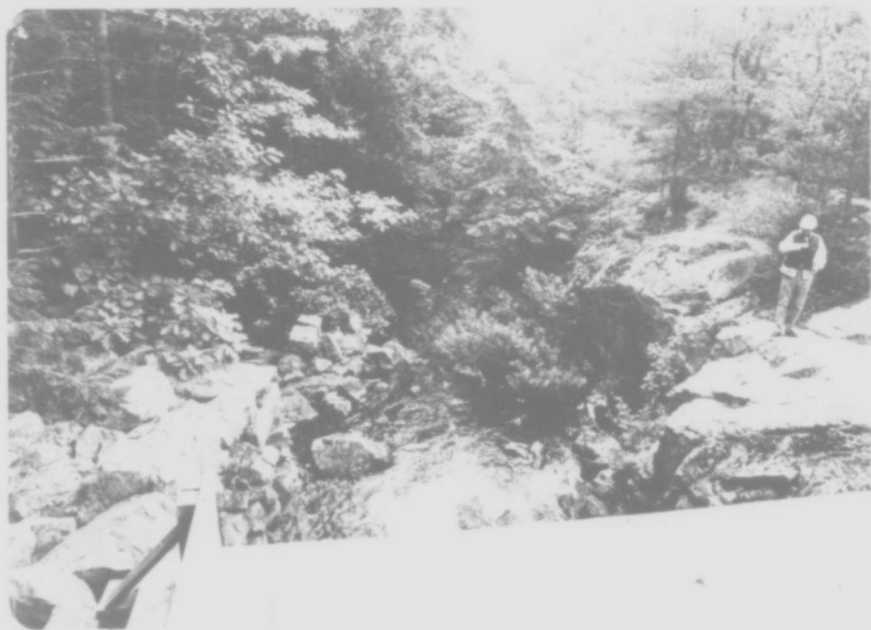
W-5
DOWNSTREAM CHANNEL

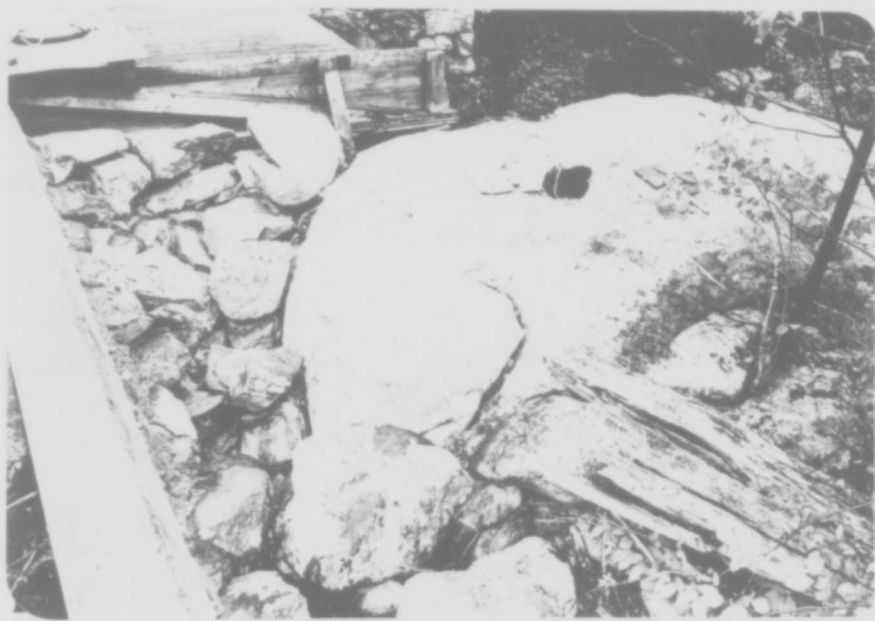
- a. Settlement - no settlement observed.
- b. Slope Stability - the embankment east of the spillway is retained by stone masonry walls which are in good condition and show no signs of movement. See overview Photograph.
- c. Seepage - Seepage, several gpm was observed coming from the toe of the retaining wall at the edge of the stream just east of the spillway. This seepage appears to be coming from leakage around the control gate and timber sluiceway at the regulated outlet.
- d. Drainage Systems - not applicable. The stone masonry walls have inherent drainage capacity.
- e. Slope Protection - the east embankment is retained by stone masonry walls which provide erosion protection at the downstream face. The surface of the embankment is stone covered and in good condition. See Photograph W-5. The west embankment has eroded leaving only large stones. See Photograph W-6.

W-6
WEST EMBANKMENT

1. A system to prevent erosion of the embankment materials downstream of the wing walls at both dams should be provided since the spillway is inadequate for flows larger than a 10-year flood event.
