CONNECTICUT RIVER BASIN  
LEBANON, NEW HAMPSHIRE

MASCOMA DAM NO. 2

PHASE I INSPECTION REPORT  
NATIONAL DAM INSPECTION PROGRAM

JULY 1980

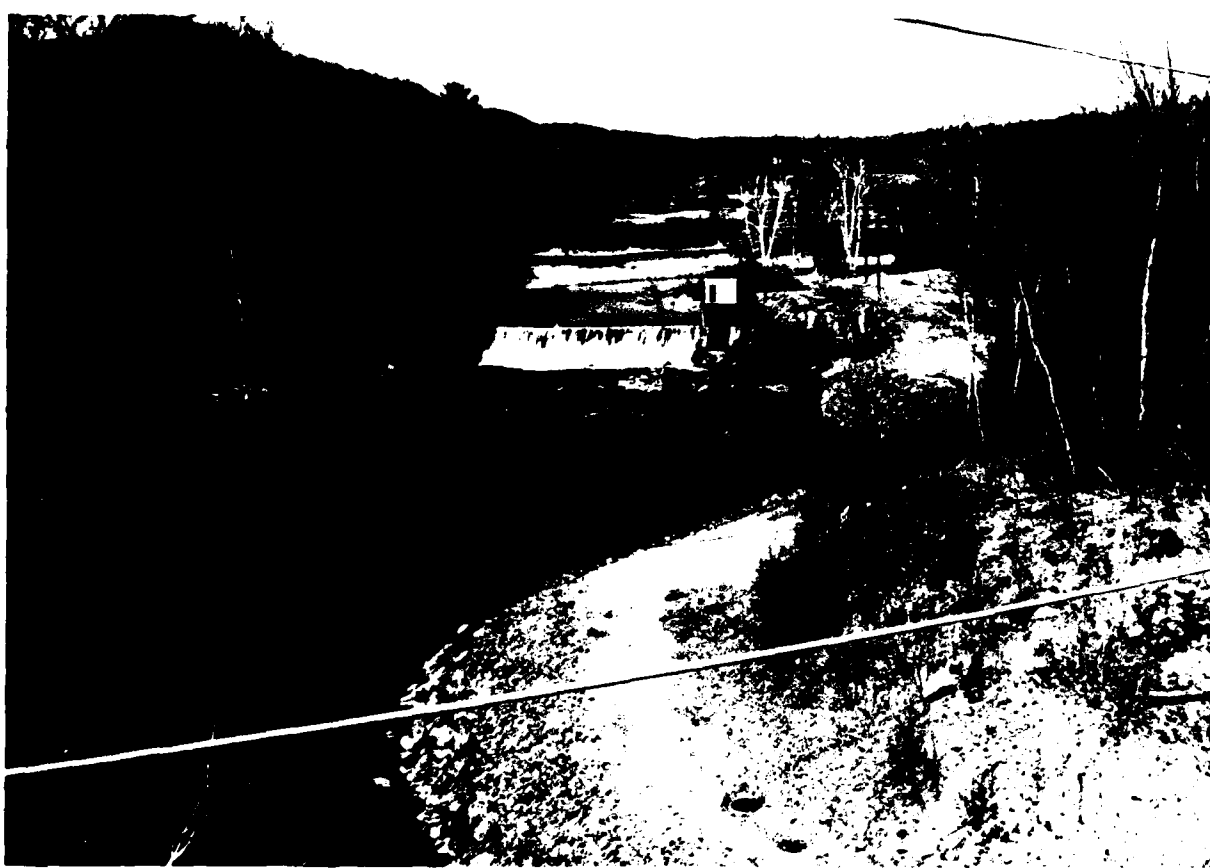
Overview of Dam

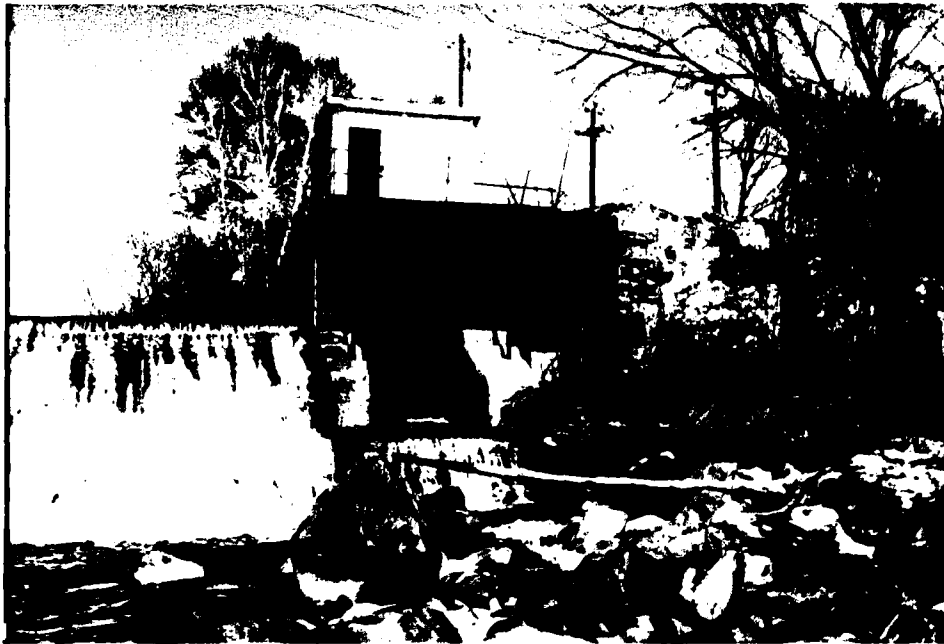
The wood framed gate house is in good condition.

1. Gate House Structure from Downstream Side

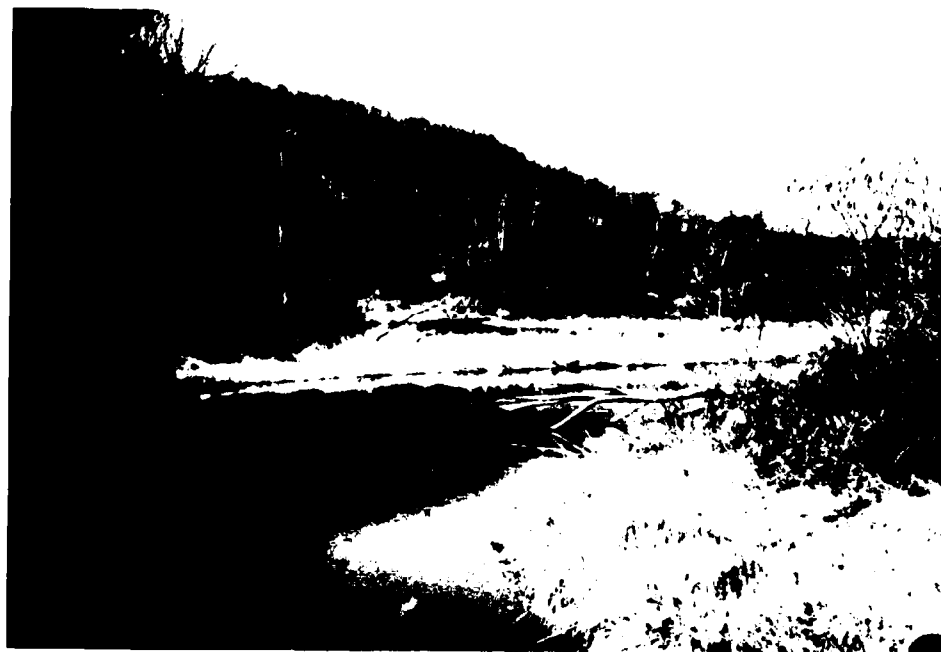
The reservoir area is the Mascoma River channel. It appears to be stable and in good condition.

8. Upstream Reservoir Area

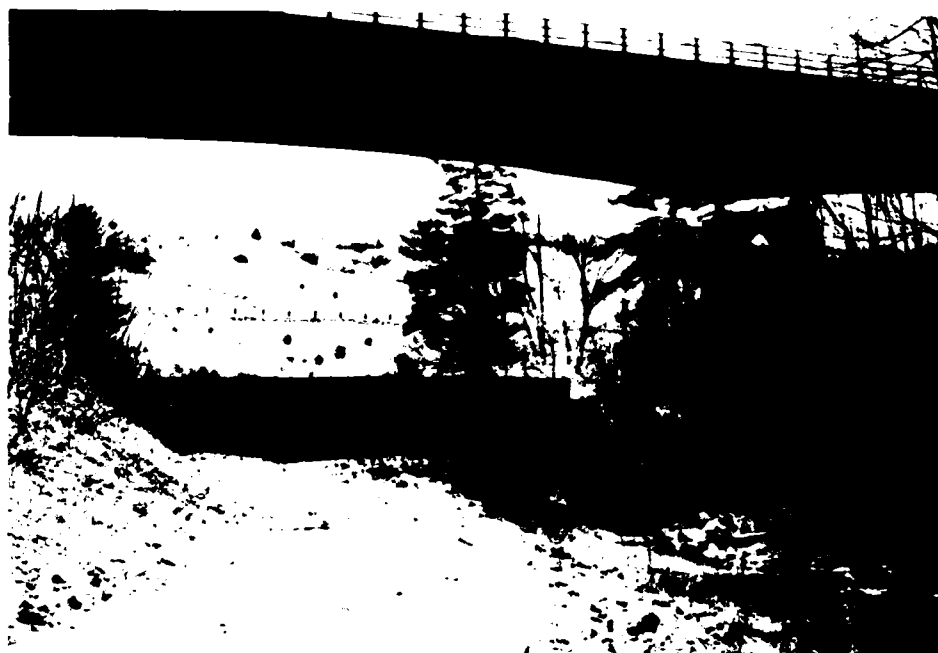
10. View Showing Relative Positions of Highway  
and Railroad Bridges

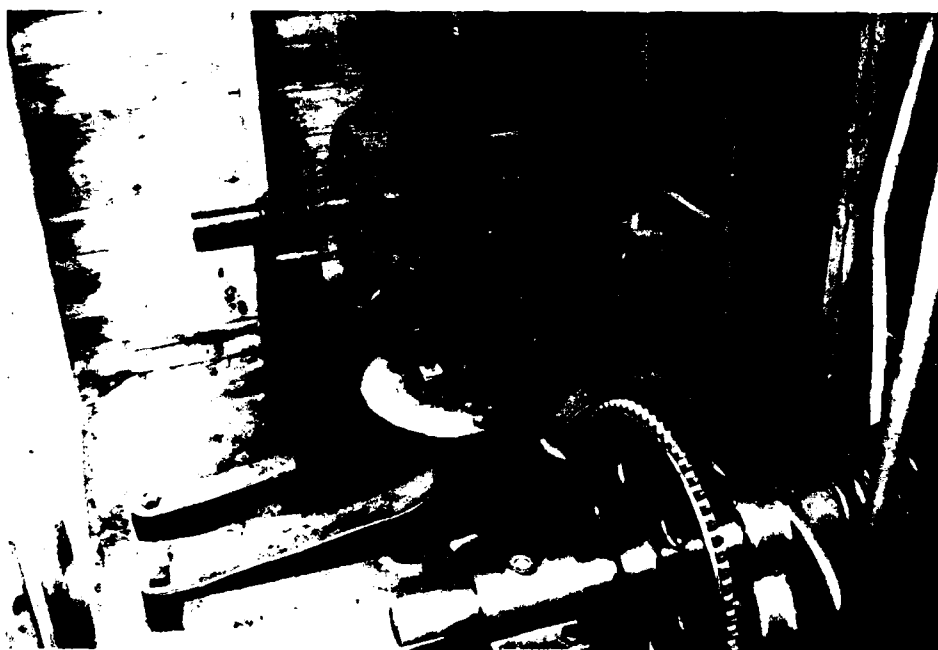
13. Waste Gate Operating Mechanism
