MEREDITH RESERVOIR DAM  
N.H.00308

PHASE I INSPECTION REPORT  
NATIONAL DAM INSPECTION PROGRAM

APRIL 1979

Identification No: NH 00308  
Name of Dam: Meredith Reservoir Dam  
Town: Meredith  
County and State: Belknap County, New Hampshire  
Stream: Unnamed  
Date of Inspection: November 13, 1978

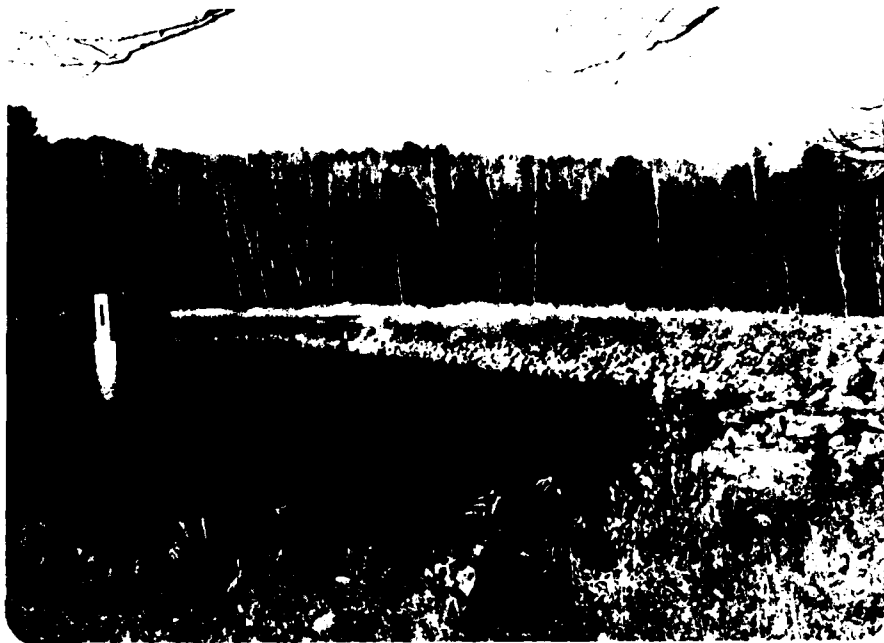
#1. VIEW OF EARTH DAM AND CONTROL TOWER

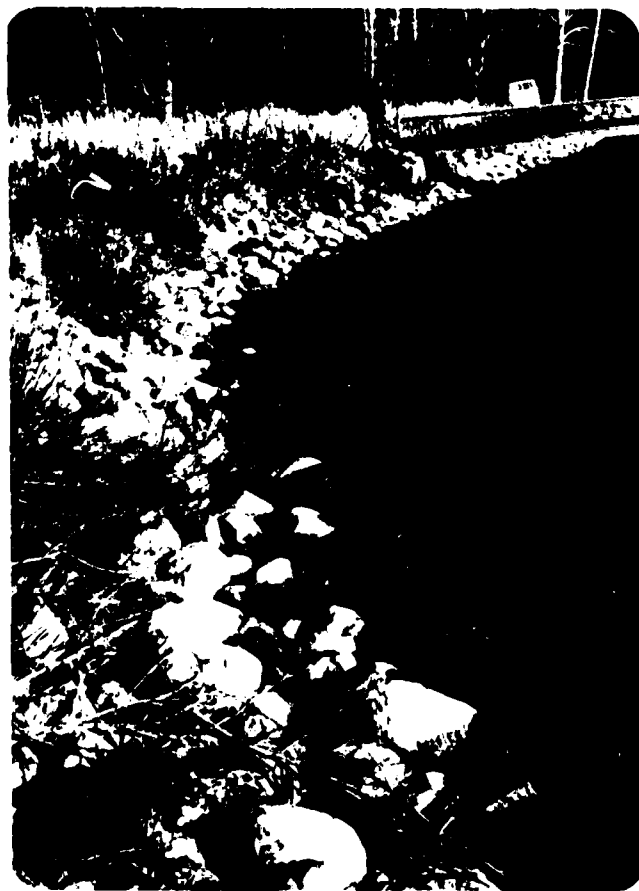
The downstream slope is approximately 1.5H:1V, while the upstream slope is somewhat steeper at 1H:1V. The water level at the time of inspection was approximately 1.3 feet below the spillway crest and therefore a complete visual inspection of the upstream slope could not be performed. The upper portion which could be viewed indicated a uniform riprap facing which was in good condition.

#2. VIEW OF UP-  
STREAM DAM  
EMBANKMENT

1. Repair the spalled and cracked concrete on the spillway walls and floor.
2. Repair the operating valves in the control tower.
3. Perform an inspection of the upstream dam embankment at low water conditions.

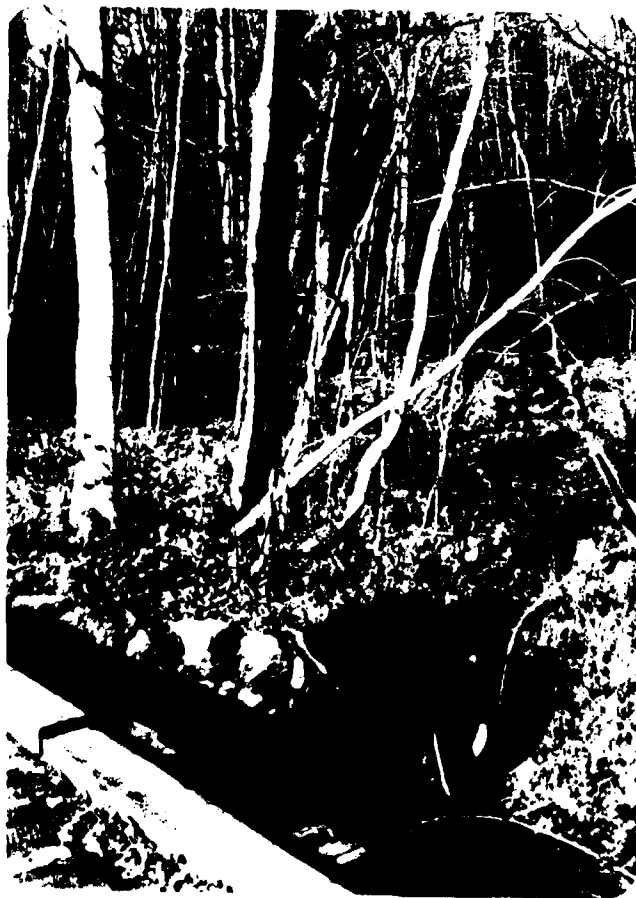
The concrete sections of the spillway structures are in poor condition. Most of the concrete is either cracked or spalled with major spalling occurring on the left training wall facing. There were no signs of significant leakage through the spillway structure during inspection, but leakage may be present during higher water levels.

#6. VIEW OF LEFT  
SPILLWAY TRAINING  
WALL AND TREES ON  
EMBANKMENT

2. The trees and bushes growing on the dam should be removed yearly.
3. The existing tree stumps on the downstream slope should be inspected yearly for indications of seepage in their vicinity.
4. The wet area downstream of the dam should be observed periodically to detect any possible seepage flows.
5. The spillway should be subject to maintenance every two years. This would include repairs to the stone training walls, and patching of any cracked and spalled concrete. The first maintenance should be performed within one year.
6. Establish a formal warning system.
7. Maintain all gates in operational condition.
