REPORT DOCUMENTATION PAGE		READ INSTRUCTIONS BEFORE COMPLETING FORM
1. REPORT NUMBER NH 00187	2. GOVT ACCESSION NO.	3. RECIPIENT'S CATALOG NUMBER
4. TITLE (and Subtitle) Second Connecticut Lake Dam NATIONAL PROGRAM FOR INSPECTION OF NON-FEDERAL DAMS		5. TYPE OF REPORT & PERIOD COVERED INSPECTION REPORT

SECOND CONNECTICUT LAKE DAM

NH 00187

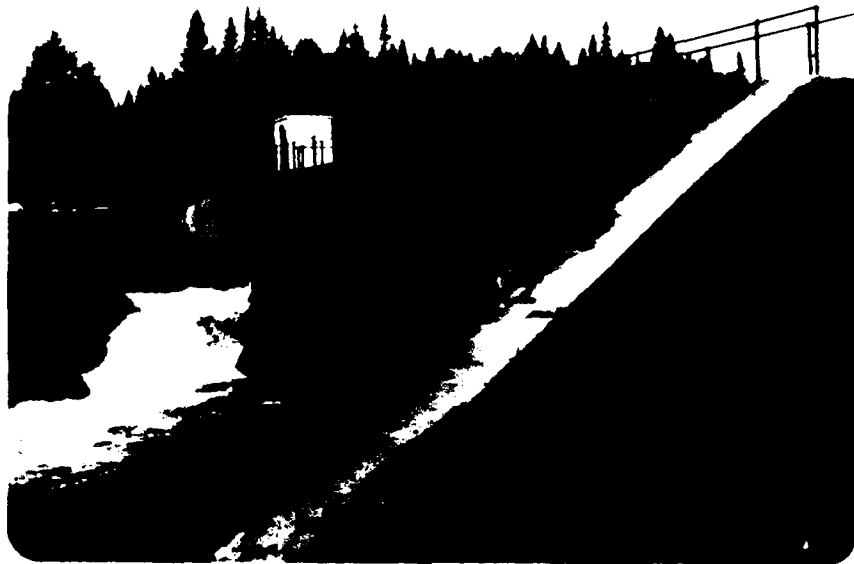
1. South abutment and downstream side of dam, looking north.

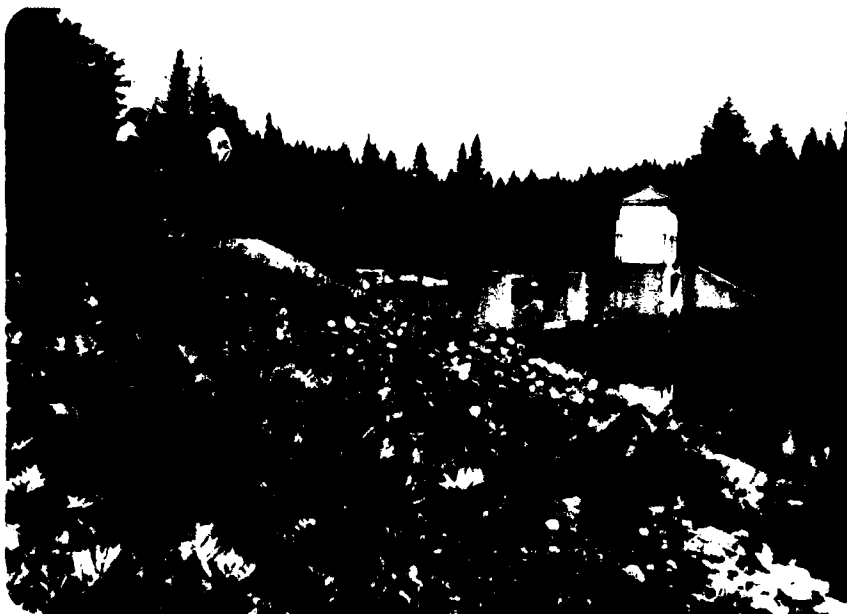
2. Upstream side of dam, looking north.

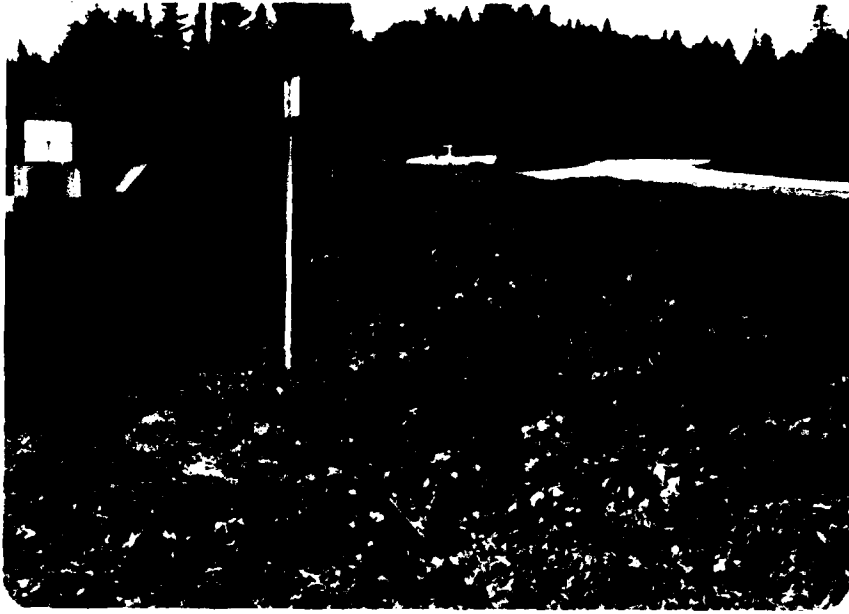
3. Upstream slope of north dike by Route 3 highway.

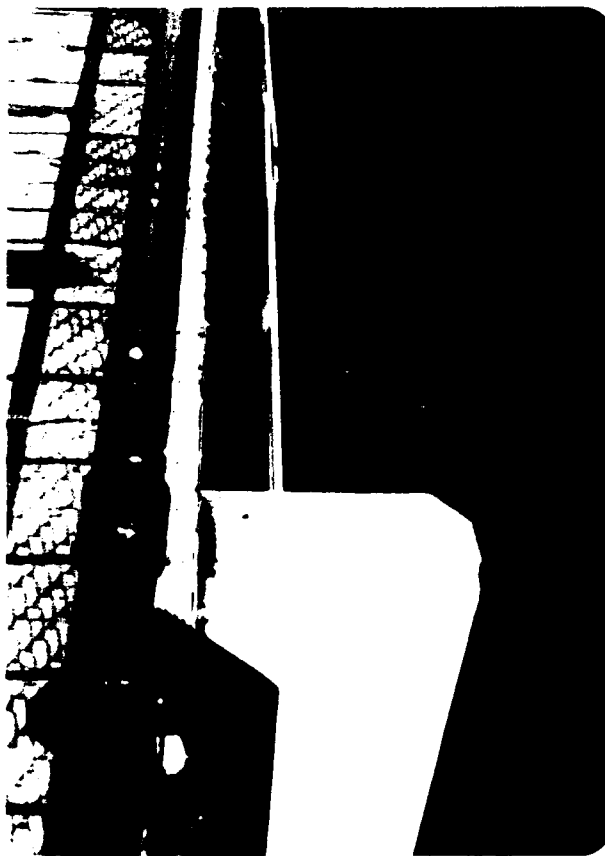
7. Spillway flashboards, pins
and upstream concrete pier,
looking north.

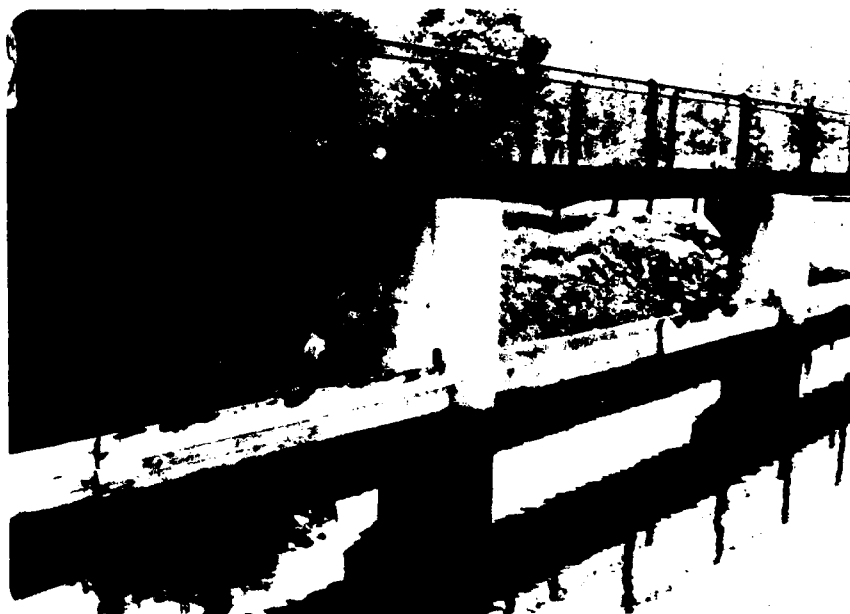
8. Spillway flashboards and footbridge, looking northwest.

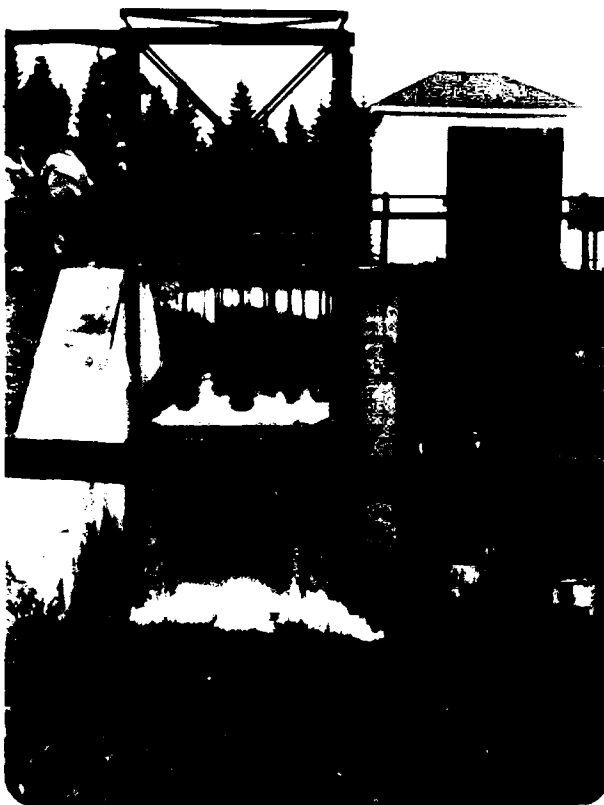
9. North abutment, stop log sluice and gate structure.

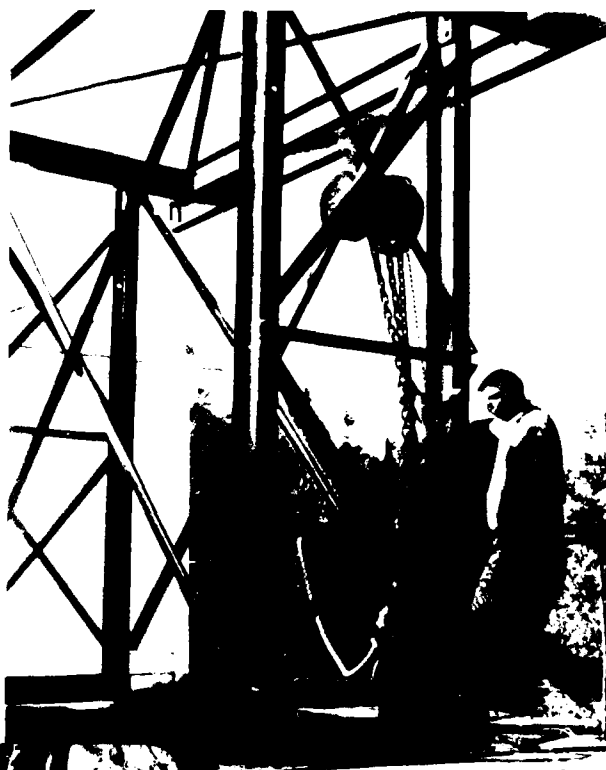
11. Chain hoist for
stop logs, looking
north.
