SOUHEGAN RIVER WATERSHED  
DAM NO. 28

NH 00429  
NHWRB 147.26

PHASE I INSPECTION REPORT  
NATIONAL DAM INSPECTION PROGRAM

AUGUST 1979

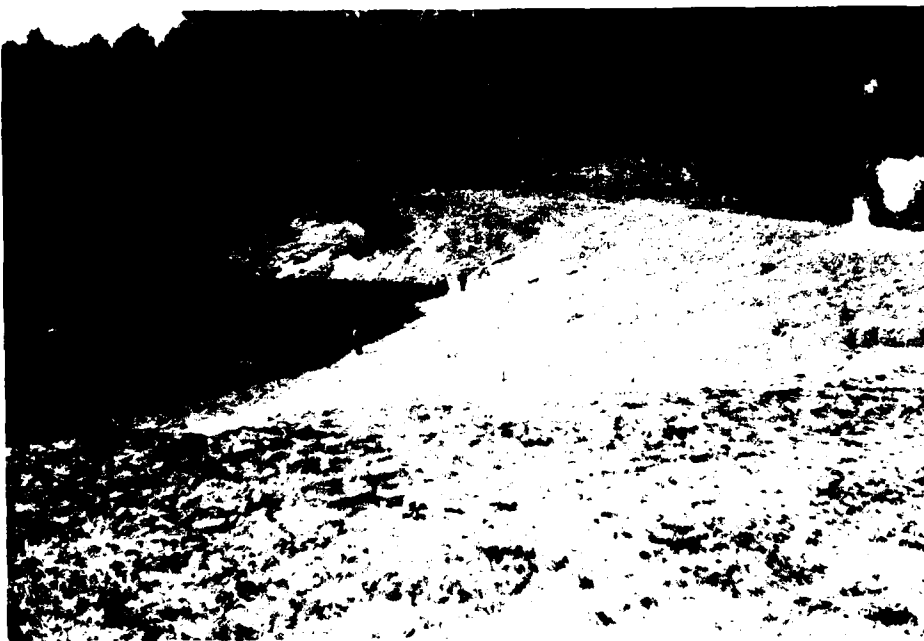
Overview of upstream slope

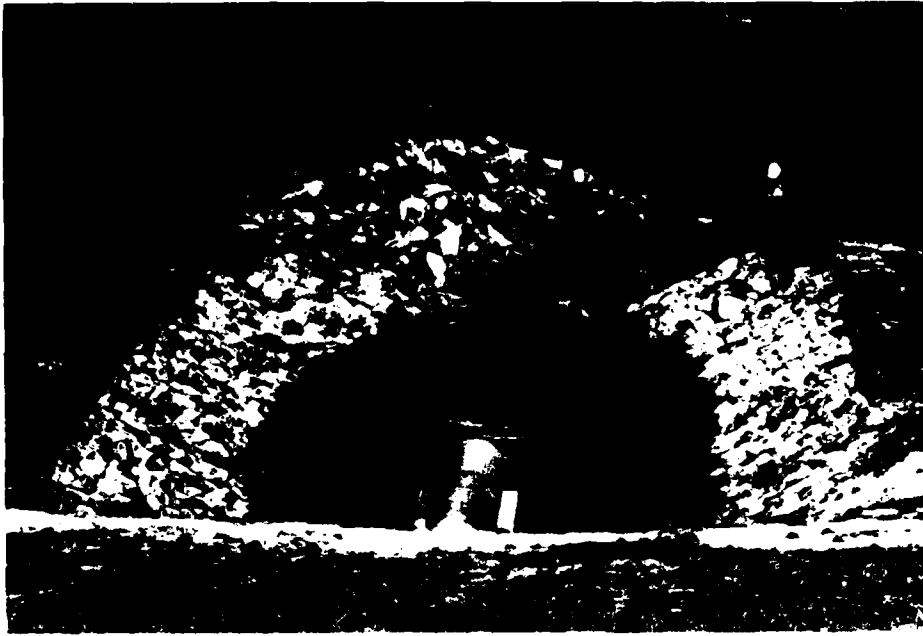
The plunge pool is protected by hand placed rip rap and is stable and in good condition.

5. View of downstream channel showing plunge pool and riprap protection

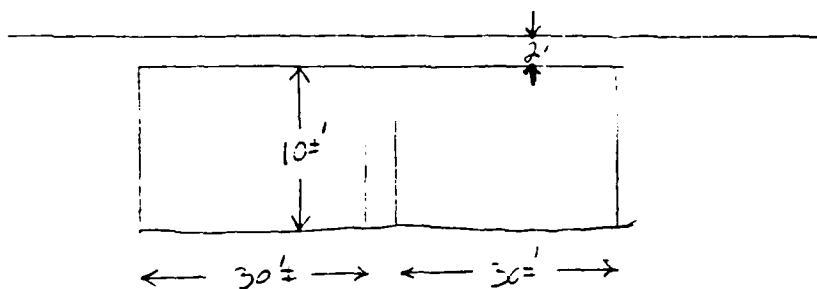
Railroad bridge 200' a/s of confluence

The estimated peak dam failure flow depth of 14' would probably damage the railroad bridge and roadbed.
