NOONE MILLS DAM

NH 00427

PHASE I INSPECTION REPORT  
NATIONAL DAM INSPECTION PROGRAM

MARCH 1980

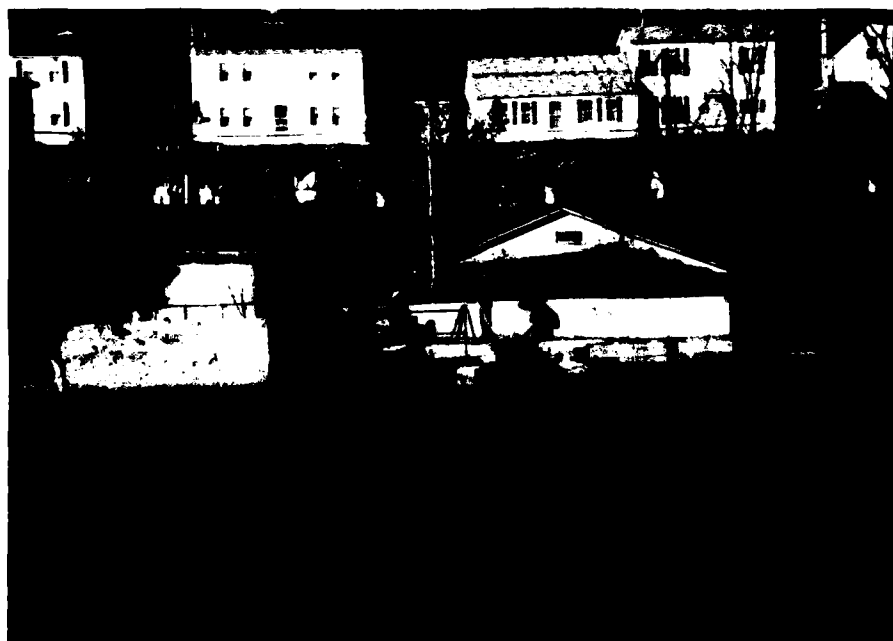
The penstock is located through this concrete embankment wall and consists of a concrete intake structure with gate lifting mechanism and bar screening. (See Photo No. 4.) A 5.5 feet diameter riveted steel plate penstock extends from the intake structure through the concrete embankment wall and continues downstream for about 100 feet where it terminates. The penstock has been abandoned since 1961 and many sections have been removed. The penstock gate is closed and inoperable, the lifting mechanism is severely rusted, and wood members of the gate mechanism have rotted. There is some minor leakage through the gate which eventually discharges into the river through large holes in the bottom of the penstock. The concrete intake structure for the penstock is spalled considerably and the bar screening is covered with rust.

A leak in the penstock gate, the inoperability of the gate lifting mechanism, and considerable spalling of the concrete intake structure are signs of considerable deterioration of the gate. If the leakage is not corrected, it could lead to further deterioration and eventual failure of the gate.

Photo No. 4 - View of penstock intake structure from upstream channel.
