TRICKLING FALLS DAM

NH 00440

PHASE I INSPECTION REPORT  
NATIONAL DAM INSPECTION PROGRAM

NOVEMBER 1978

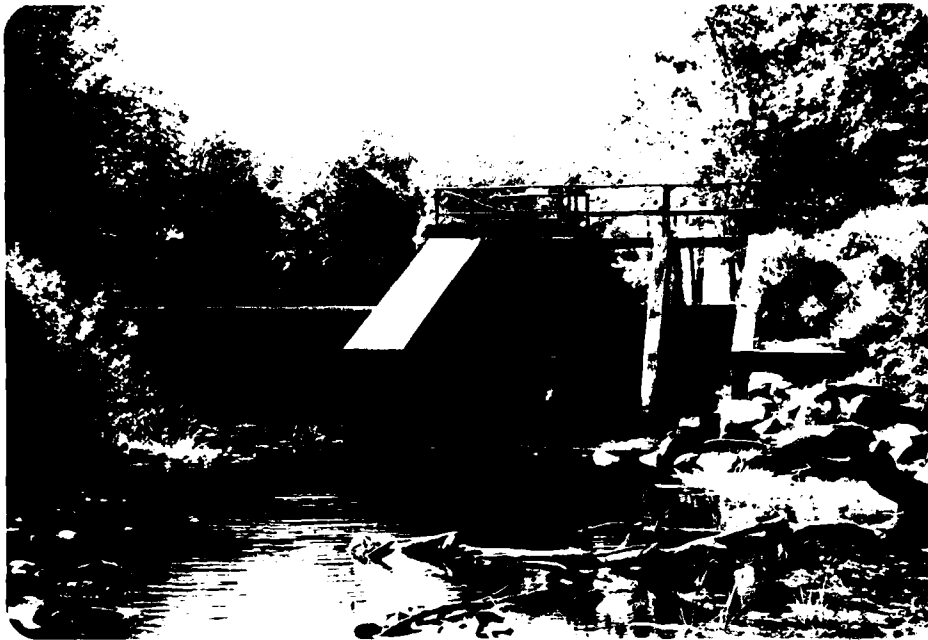
Overview of dam from left side  
downstream (Sept. 21, 1978)

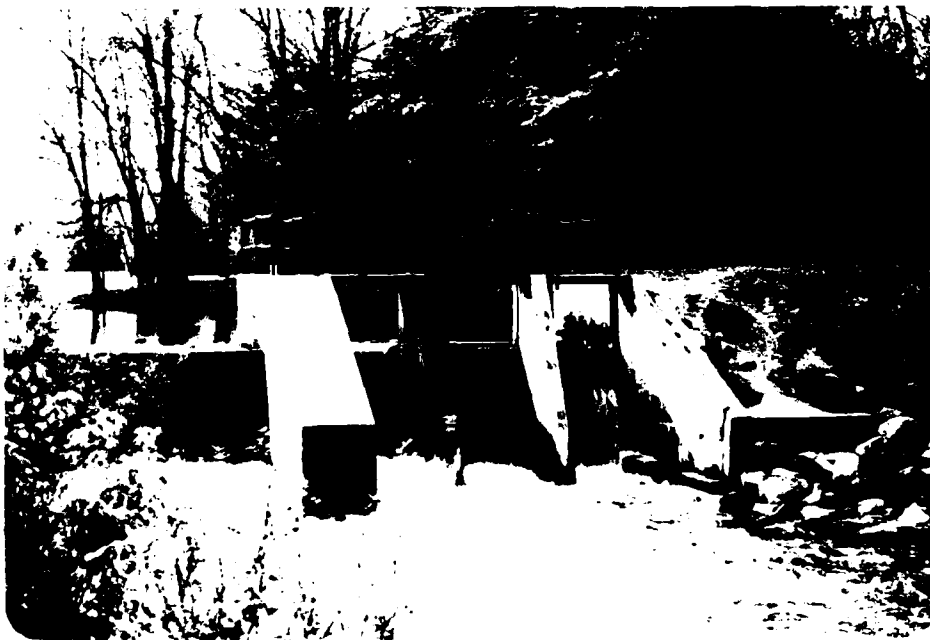
Overview of dam from right side  
downstream (May 25, 1978)

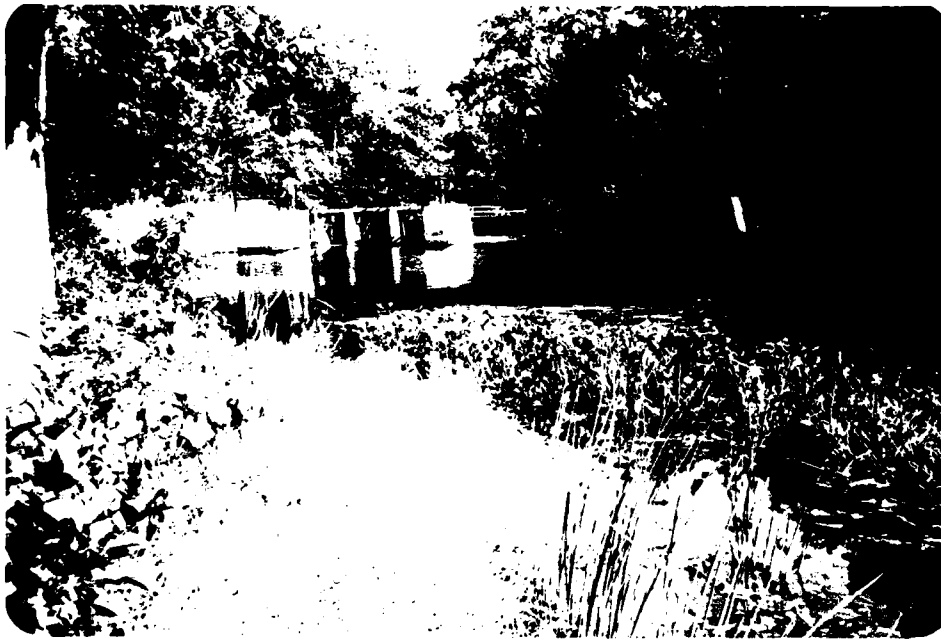
Overview of dam from left side upstream  
(Sept. 21, 1978)
