BUCK STREET WEST DAM

NH 00444

PHASE I INSPECTION REPORT NATIONAL DAM INSPECTION PROGRAM

FEBRUARY 1979

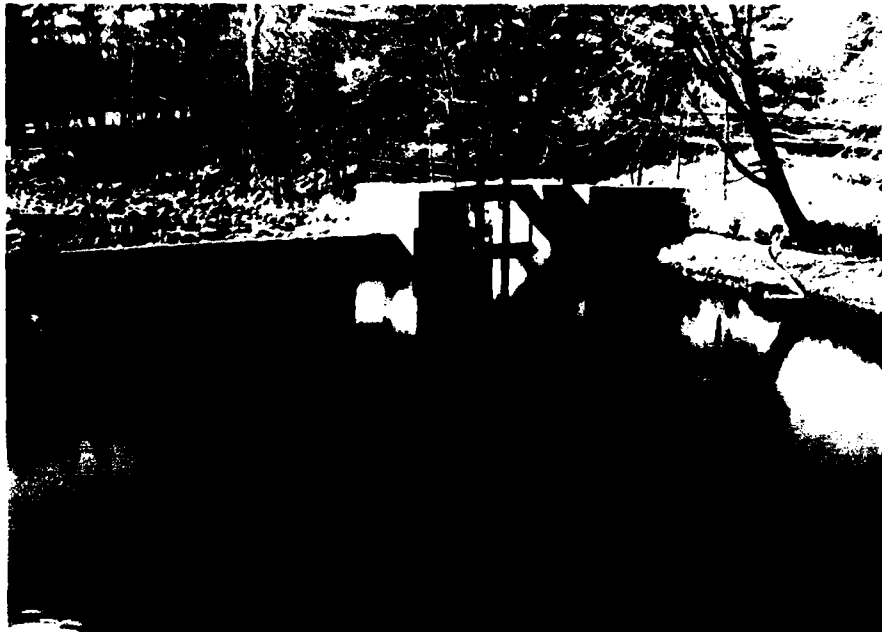
PHOTO NO. 2 - Sluiceway structure and right abutment.

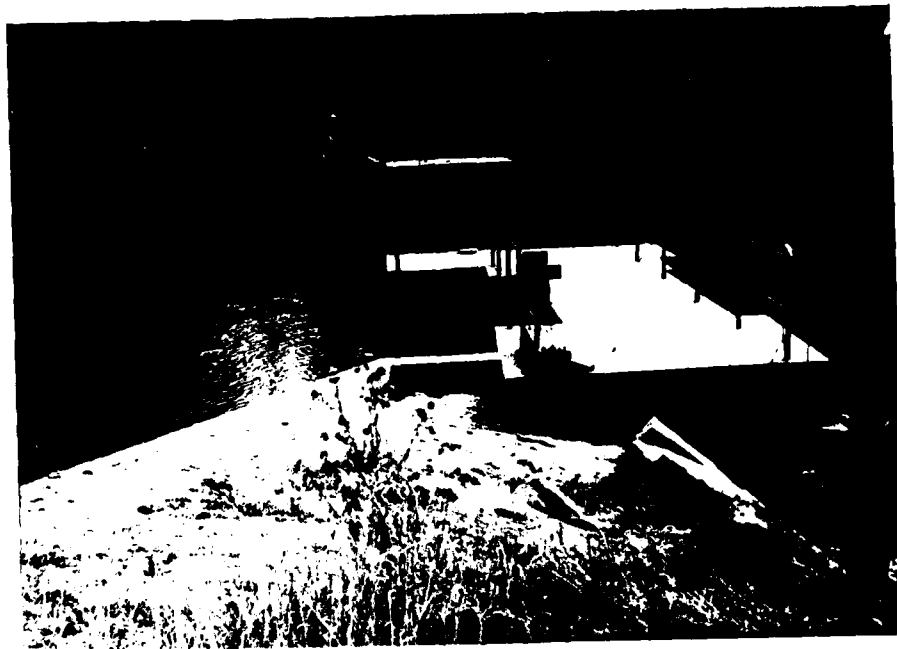
PHOTO NO. 4 - View of dam from right abutment.

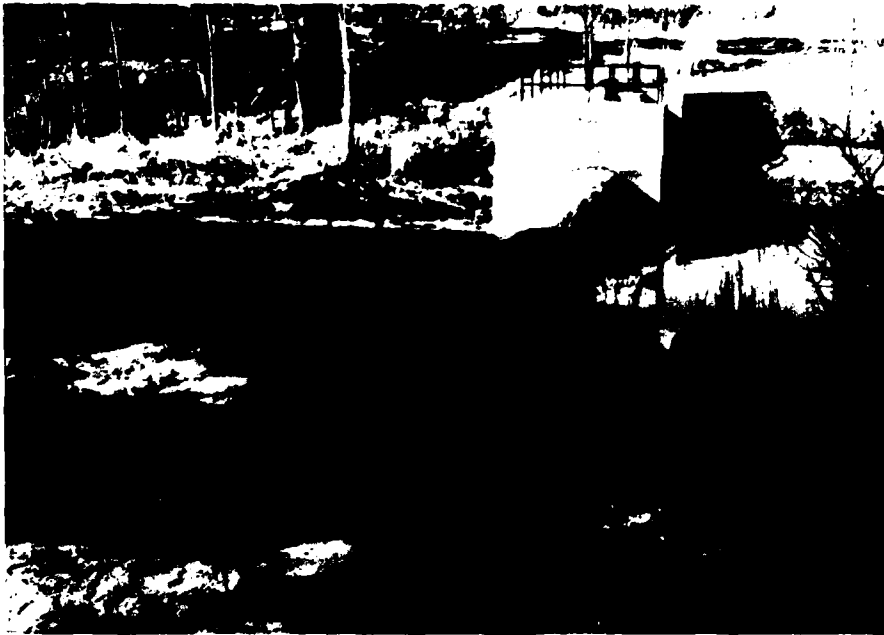
PHOTO NO. 5 - View of dam from left abutment.

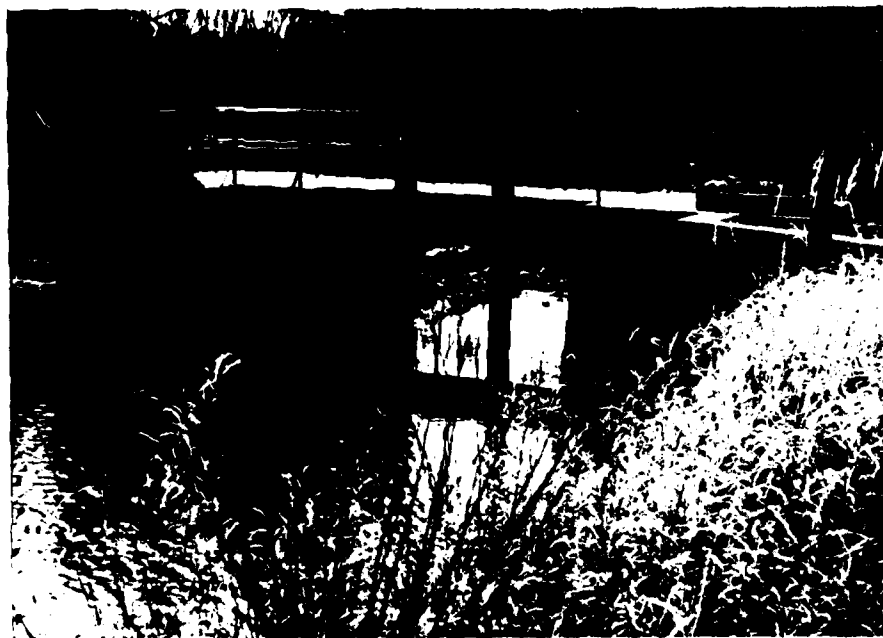
PHOTO NO. 8 - Upstream face of sluiceway structure.

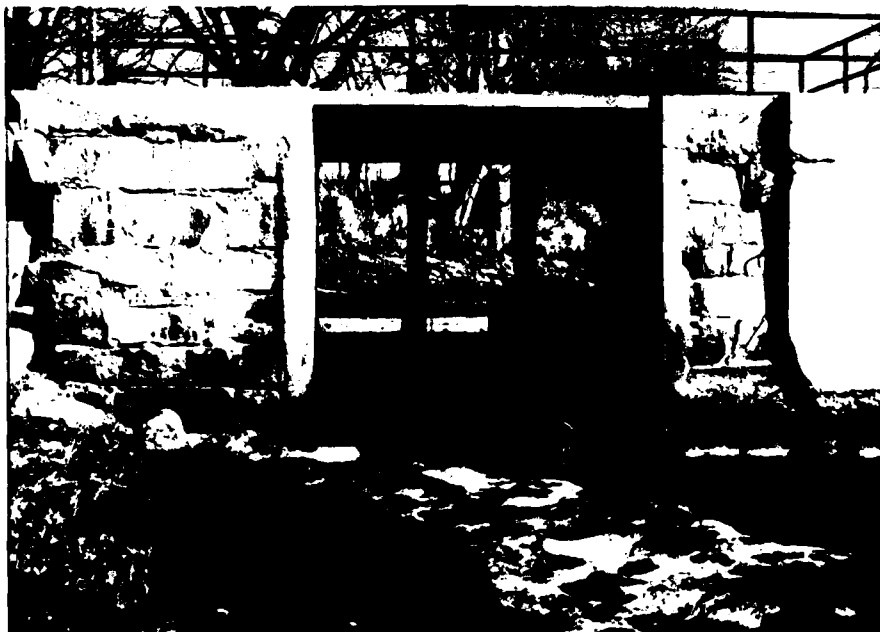
The embankment section at the west end of the dam has a concrete core wall which is 12 inches wide and which extends on a dogleg alignment about 28 feet from the stoplog spillway structure to the west abutment. A drawing dated 1962 indicates that this wall was to be founded on ledge and that a "stone fill" was to be placed on the downstream slope of the embankment. The top of the wall was visible at the time of the inspection and appeared to be in good condition. The downstream slope is paved with hand-placed cut stone as shown in Photo 9.

PHOTO NO. 9 - Series of four photos (9, 10, 11 & 12) taken clockwise from discharge channel showing right abutment, sluiceway structure, spillway structure and right abutment.

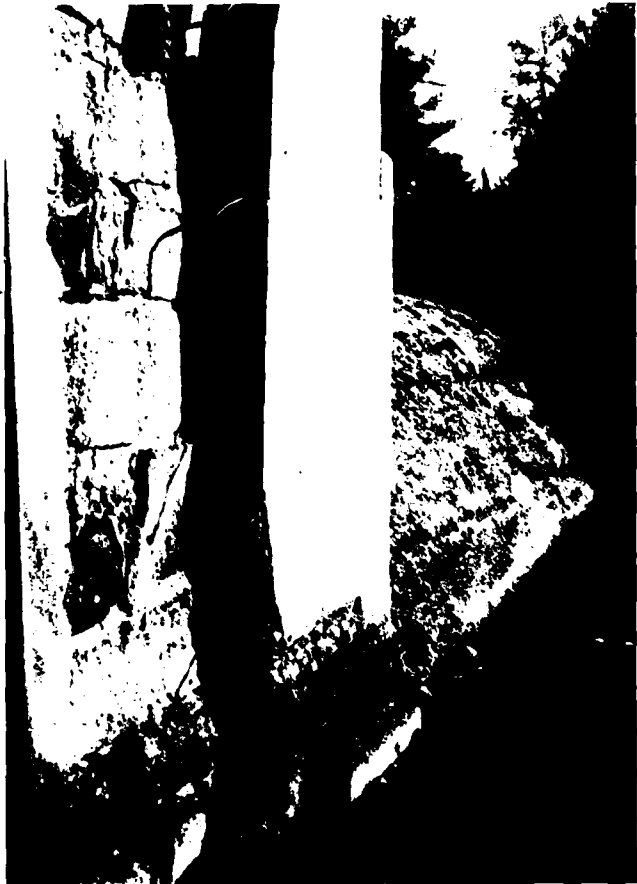
PHOTO NO. 13 - Close-up of sluiceway wall structure. Note exposed reinforcing steel.

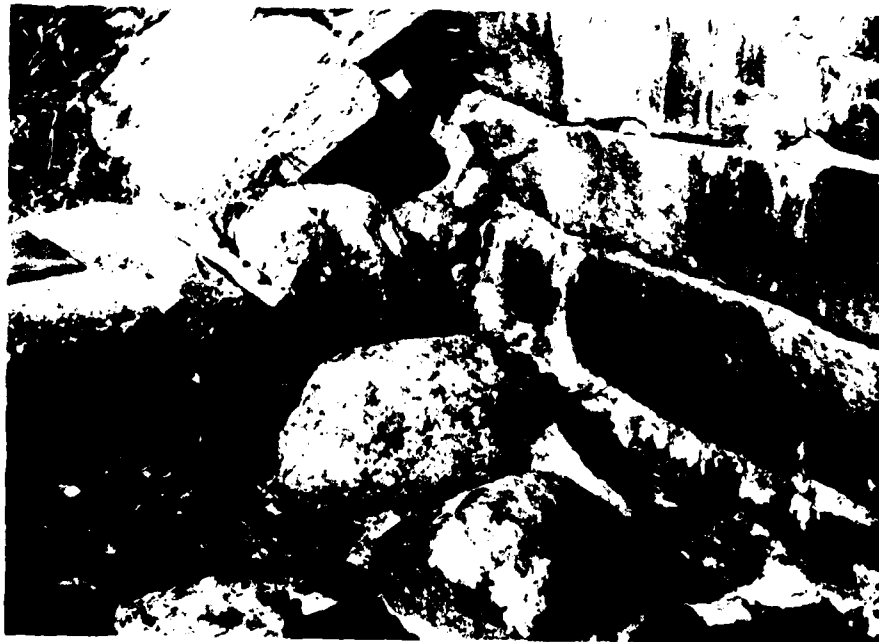
Minor seepage is occurring at the toe of the embankment section close to the east end of the concrete dam and also at the toe of the other embankment section close to the spillway structure at the west end of the dam. Neither of these seepages is considered to be an immediate hazard to the structural stability of the embankment sections.

PHOTO NO. 16 - Series of two photos (16 & 17) taken clockwise showing minor seepage at right abutment.

The owner should engage a qualified engineer to investigate the seepage conditions where the embankment sections abut the concrete section of the dam and to design remedial or control measures as needed. Due to the dam's small size
