CONNECTICUT RIVER BASIN
HANOVER, NEW HAMPSHIRE

UPPER RESERVOIR DAM

NH 00049

PHASE I INSPECTION REPORT NATIONAL DAM INSPECTION PROGRAM

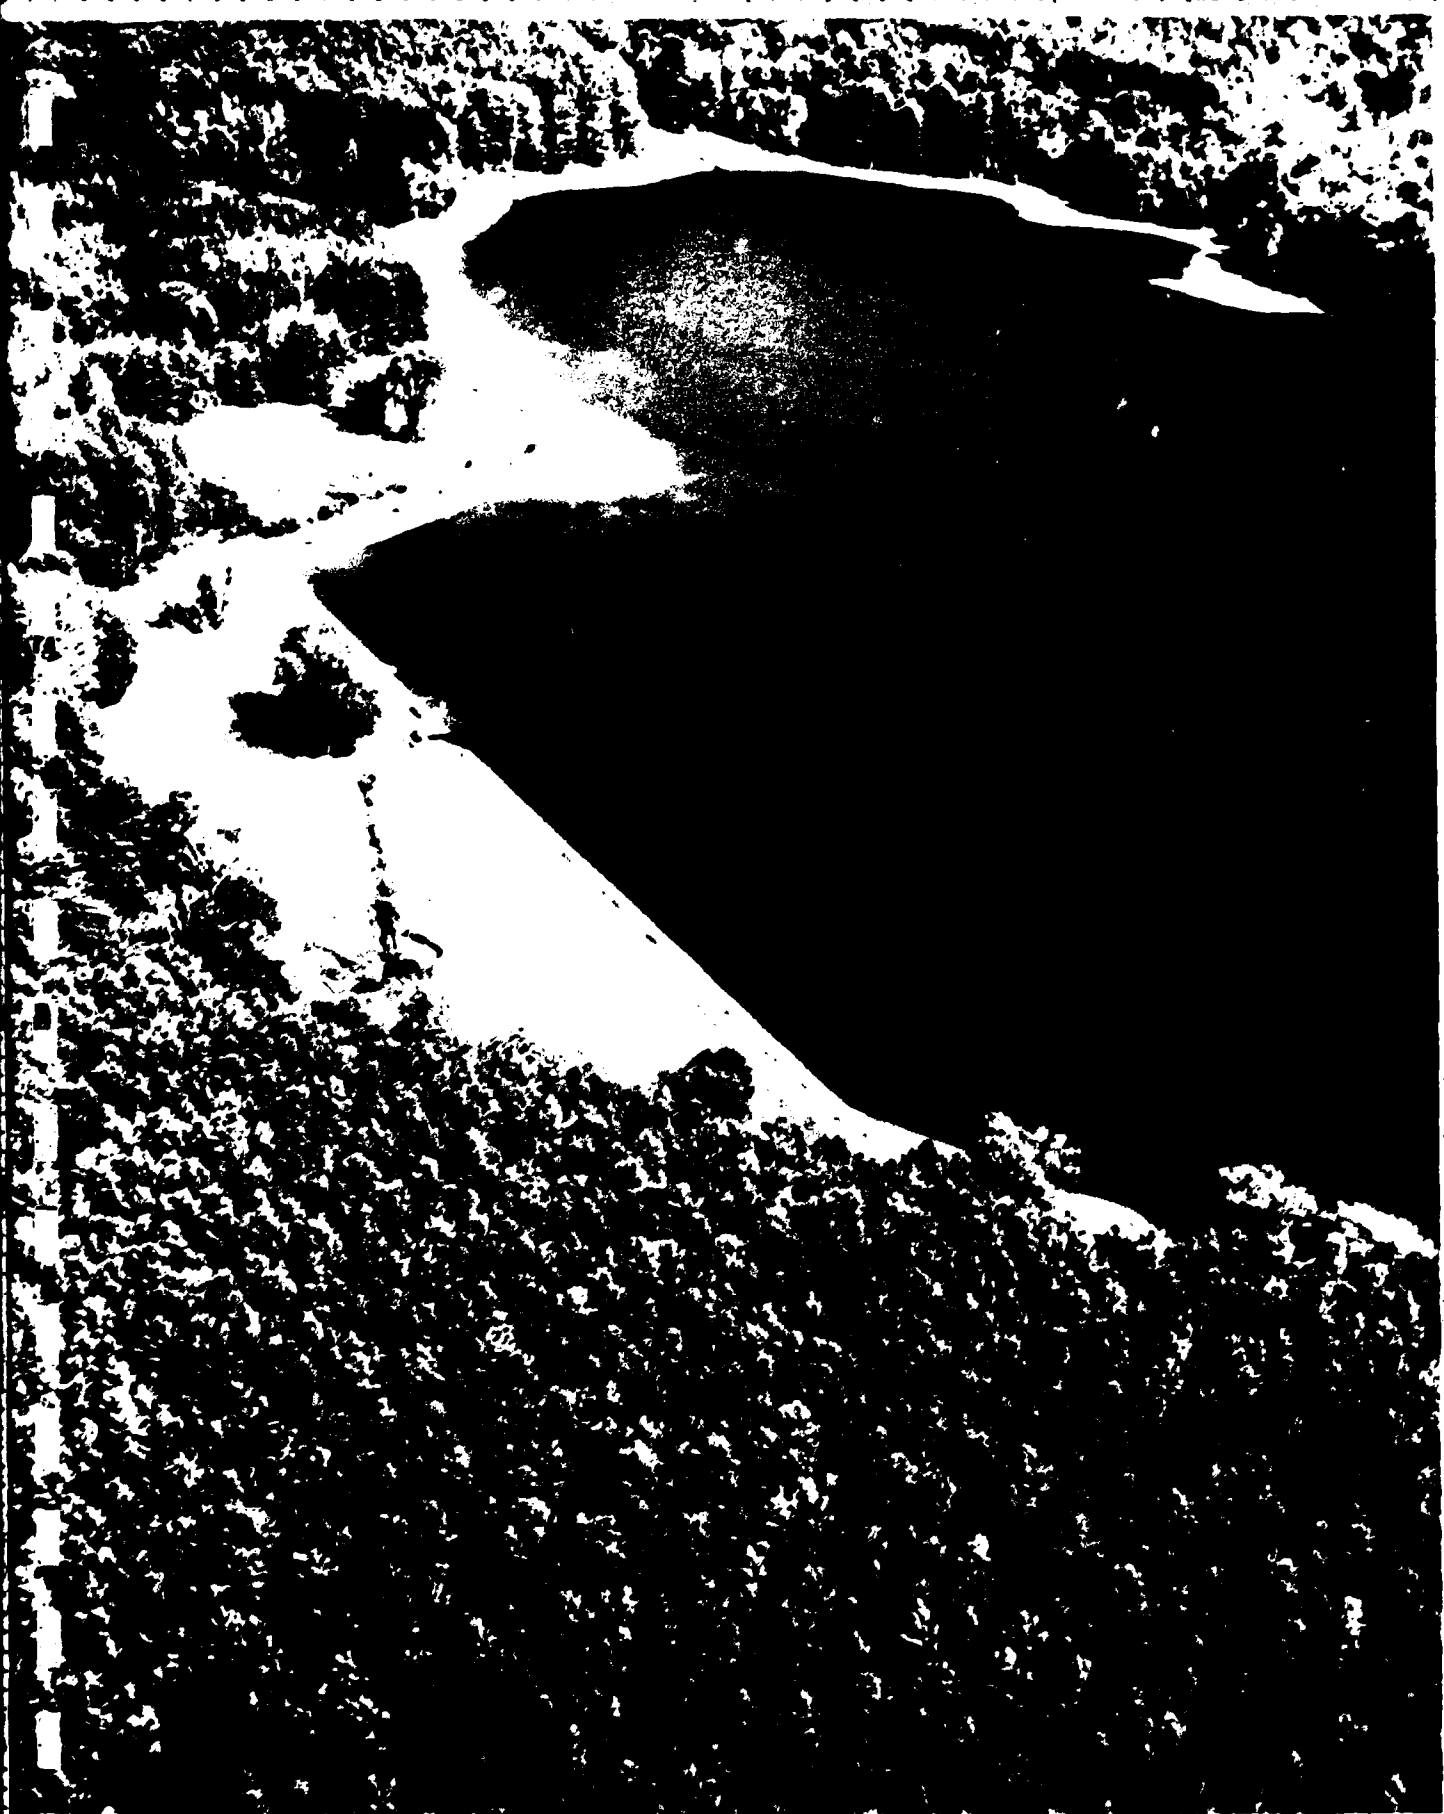
Upper Reservoir Dam - Overview from above left abutment

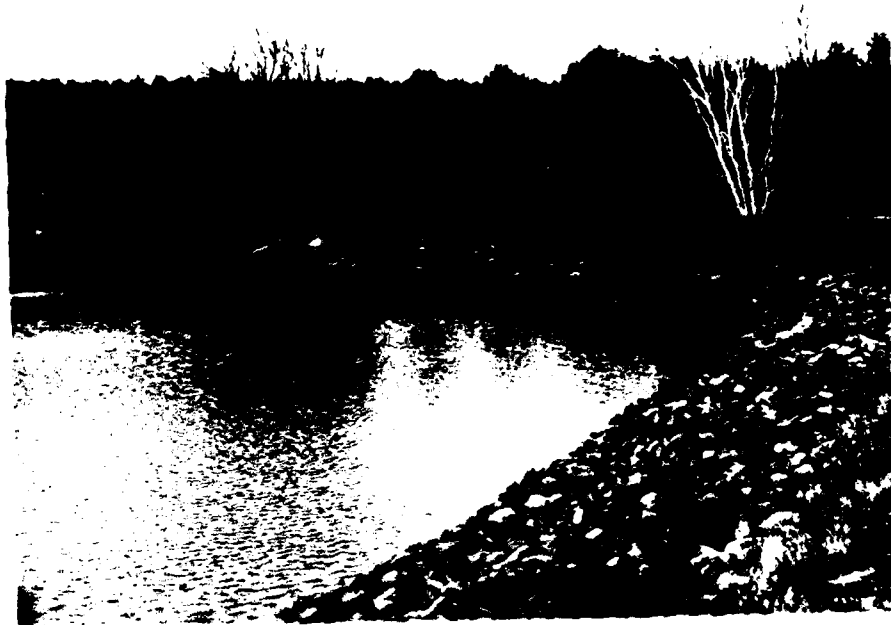
PHOTO NO. 2 - Upstream face as viewed from right end of dam.

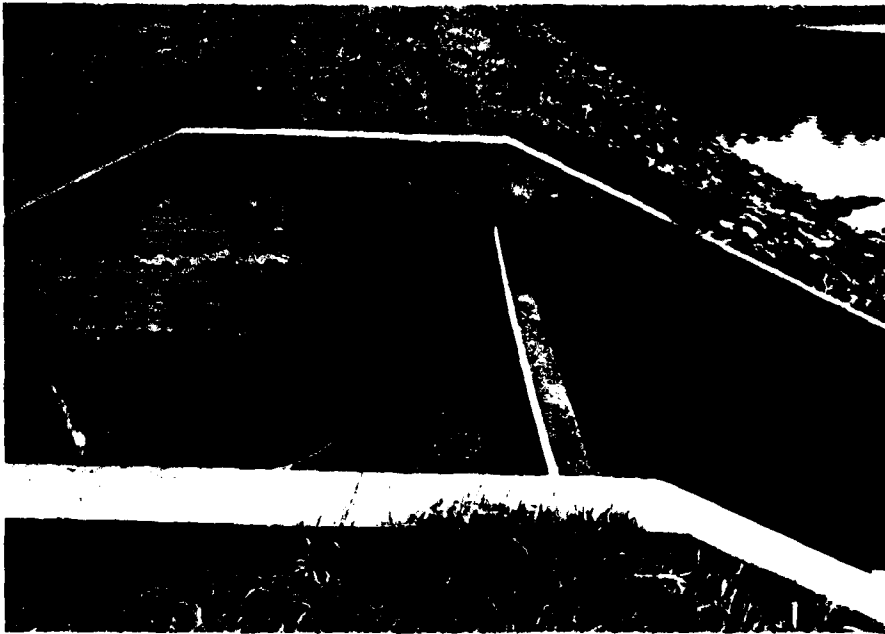
The spillway structure, shown in Photo Nos. 9, 10 & 11, consists of a gravity concrete weir structure and two training walls. The spillway crest is in good condition. The concrete training walls are also in good condition except for two cracks in the right wall and one insignificant crack in left wall as seen in Photo No. 12. The wingwalls and flashboards are in excellent condition. (Photo No. 10). However, there is no means of removing the flashboards during high water without exposing personel to hazardous conditions.

PHOTO NO. 10 - View of spillway weir crest.
