PROVIDENCE RIVER BASIN  
WOONSOCKET, RHODE ISLAND

HARRIS POND DAM  
RI 03901

PHASE I INSPECTION REPORT  
NATIONAL DAM INSPECTION PROGRAM

FEBRUARY, 1979

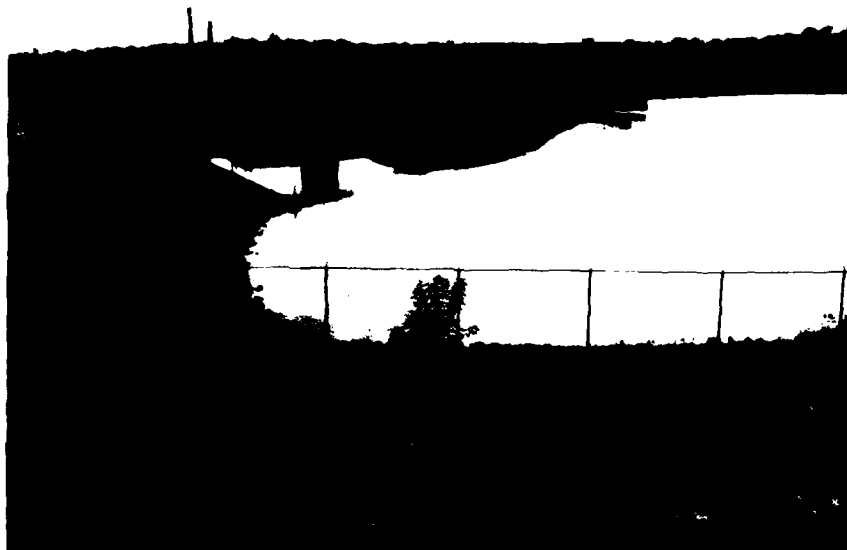
Overview from Precious Blood Cemetery at left abutment

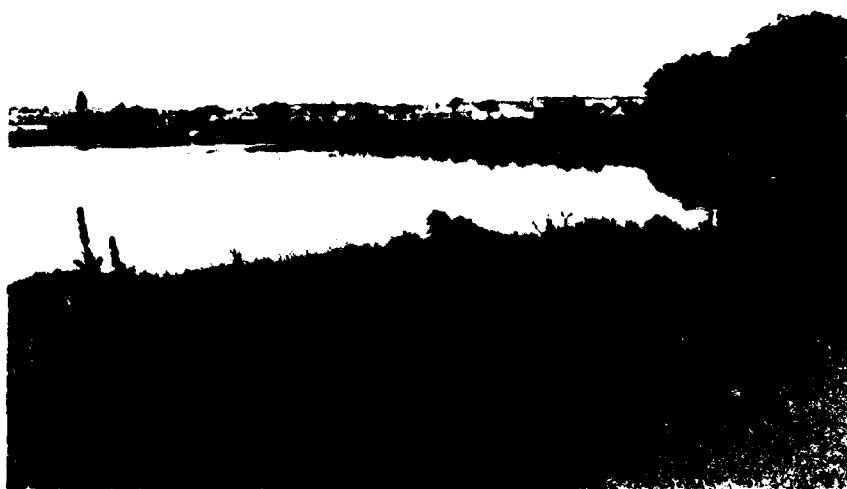
Overview from right abutment

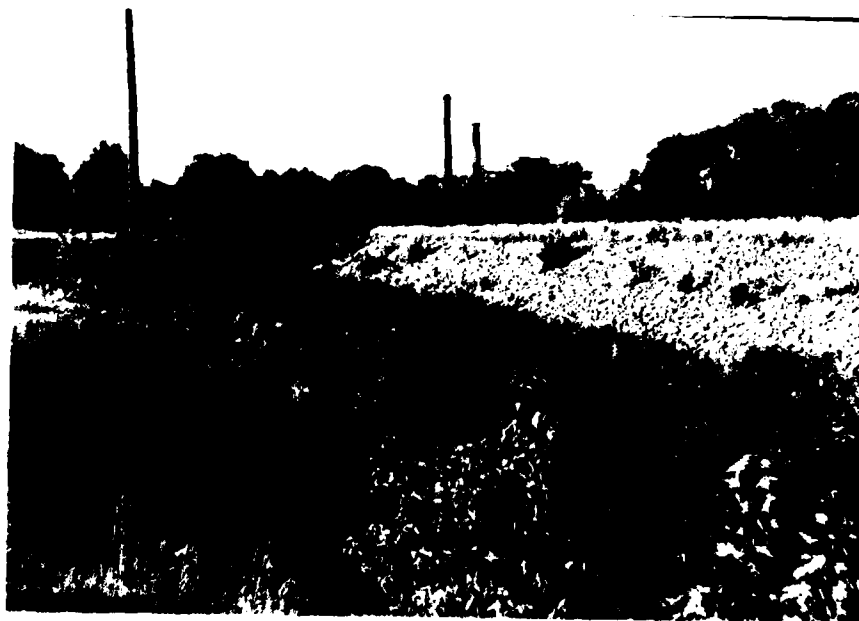
2. Mill River channel looking upstream from E. School Street.

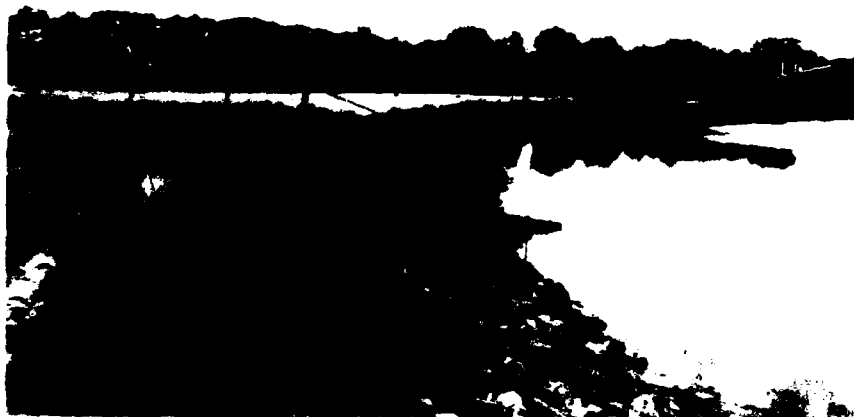
Riprap on the upstream slope of the dike and the crest paving on the dike is in good condition, except for some widely spaced shrinkage cracks in the pavement (Appendix C, Photo No. 4). Trespassers have displaced some riprap locally to form stepping stones around the fence. No seepage was observed along those parts of the downstream toe of the dike which were not paved over by the parking lot surfacing.

4. Upstream slope of dike at right abutment.

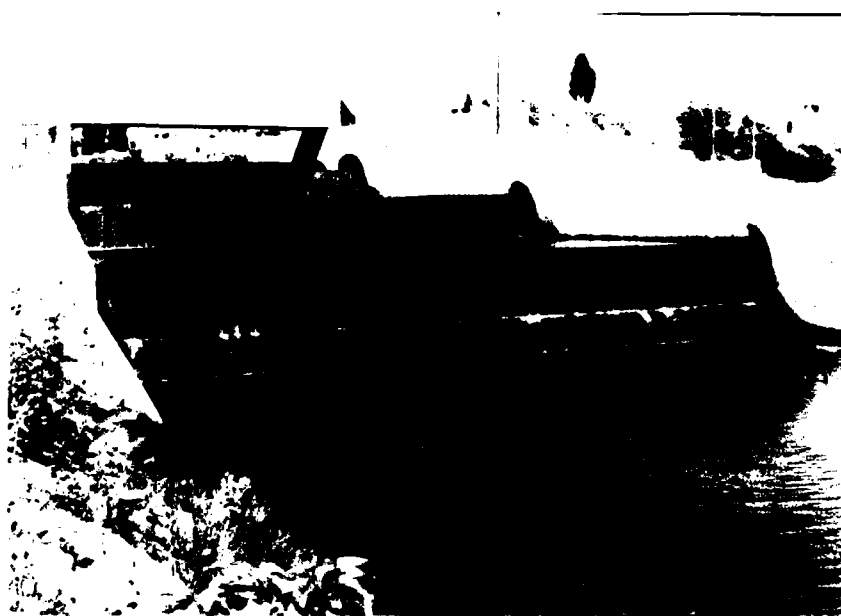
The spillway is founded on an earth knoll with undetermined overburden depth to bedrock. The spillway inlet channel is lined with a 3 ft. thick impervious earth blanket protected by a riprap surfacing. The downstream channel floor slabs are underlain with a gravel blanket and a sewer pipe drainage system. With about 1 in. of flow over the spillway crest and in the spillway channel, no seepage flow from the outlets of the underdrainage system could be observed (Appendix C, Photo No. 6).

6. Stilling basin from right side of downstream channel.

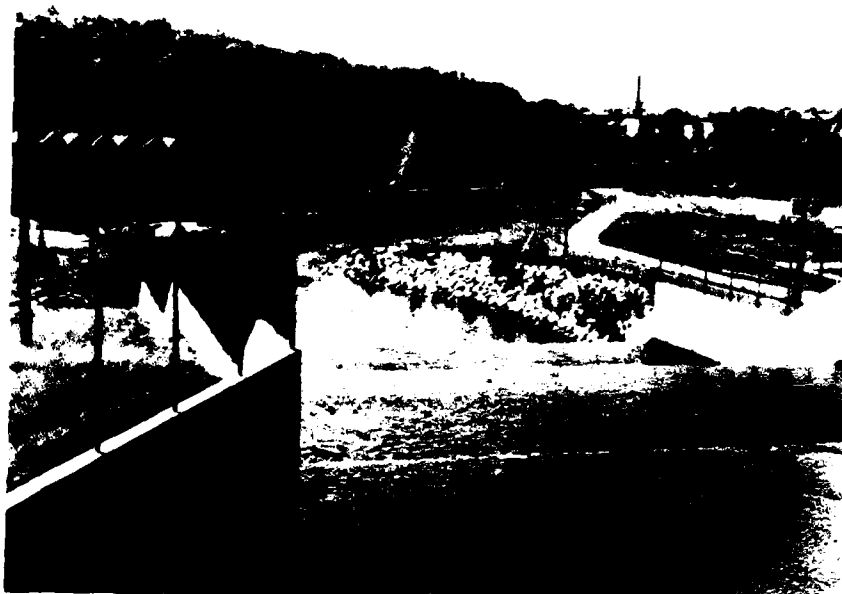
9. Stilling area and downstream channel from spillway bridge.
