MERRIMACK RIVER BASIN  
LYNDEBOROUGH, NEW HAMPSHIRE

SOUHEGAN RIVER WATERSHED  
DAM NO. 8  
NH 00474  
NHWRB 147.28

PHASE I INSPECTION REPORT  
NATIONAL DAM INSPECTION PROGRAM

AUGUST 1985

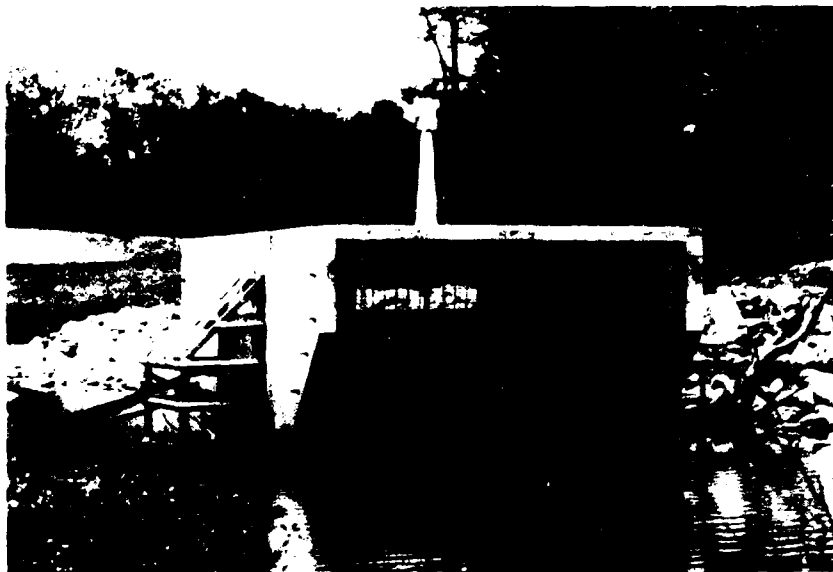
The structure is in good condition with no evidence of spalling, cracking, or efflorescence. The sluice gate bench stand is in good condition. The hand crank has been removed from the site to prevent unauthorized use. The trash racks are in good condition but are clogged with debris.

3. View of drop inlet structure showing high and low stage trash racks

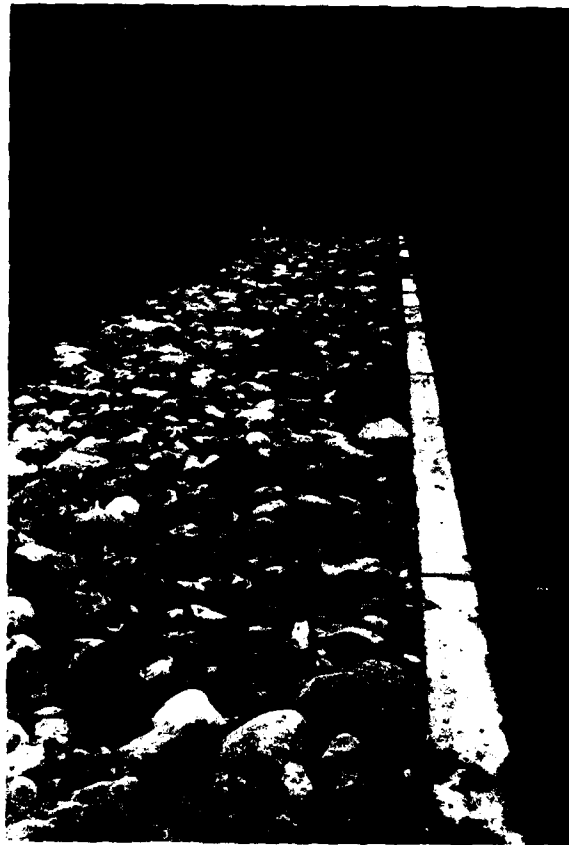
The emergency spillway sill is in good condition with some minor spalling of the exposed surface.

7. View of emergency spillway showing  
concrete sill with rock rip rap
