PAWTUXET RIVER BASIN  
CRANSTON, RHODE ISLAND

CRANSTON PRINT WORKS POND DAM  
RI 00701

PHASE 1 INSPECTION REPORT  
NATIONAL DAM INSPECTION PROGRAM

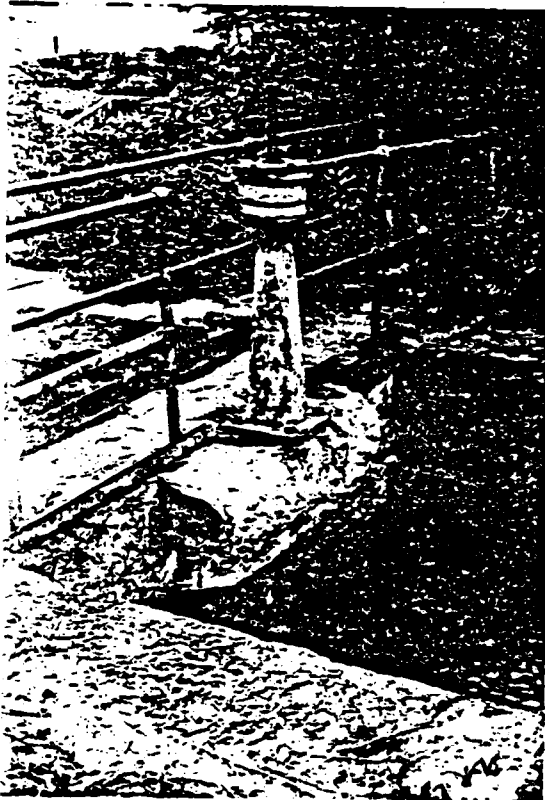
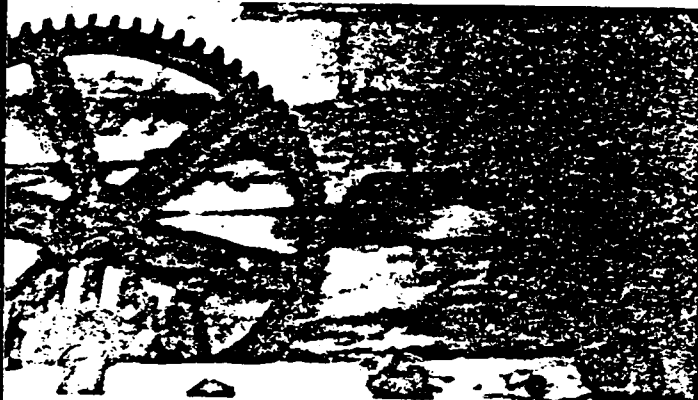
↑ Dismantled remains of "rack & pinion" type  
gear mechanism at draw-off gate.

← Operating stand of gate valve to head race.  
(Rodney Hunt)

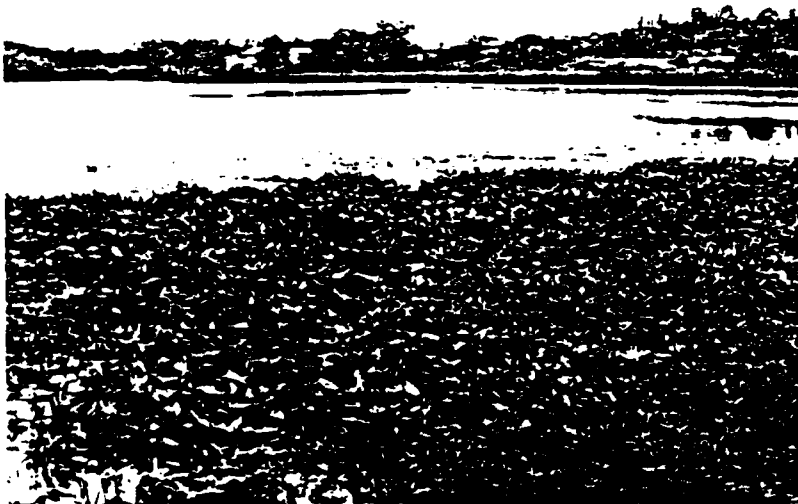
General view looking toward  
Dyer Pond, showing heavy acc-  
umulation of weeds in front of  
crest of spillway.

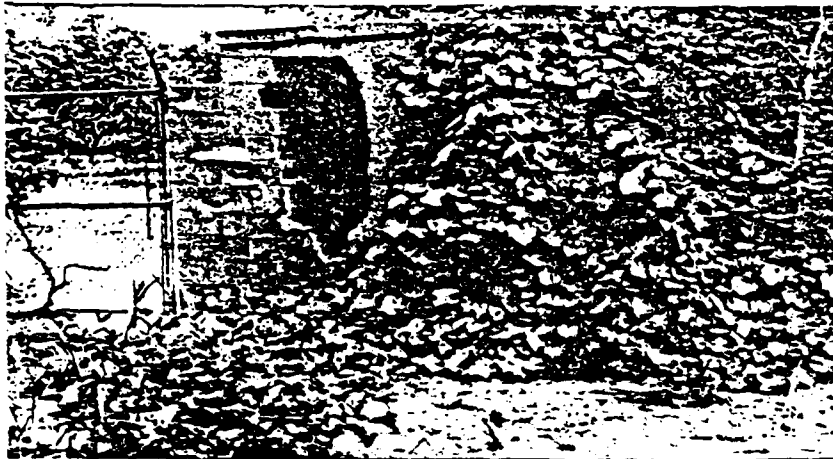
PHOTO #4. Gatehouse, showing busted out wall. Door also currently hanging off it's hinges. Gear mechanism of gates has also been dismantled.

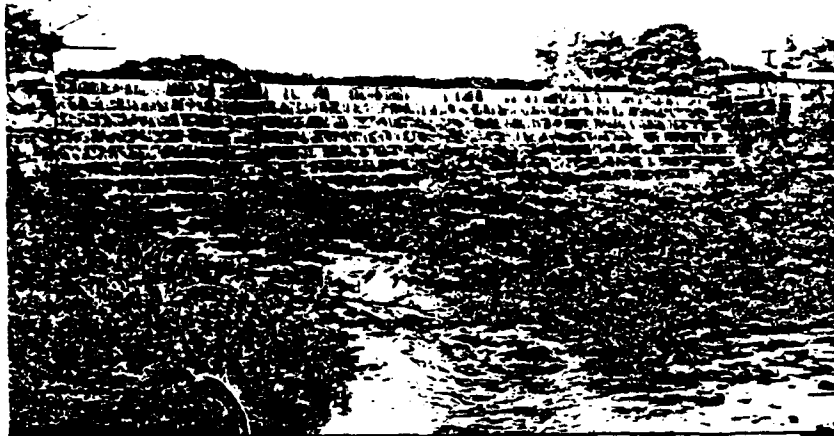
PHOTO #1. General view of stepped masonry face of spillway (also showing growth of vegetation in discharge channel).

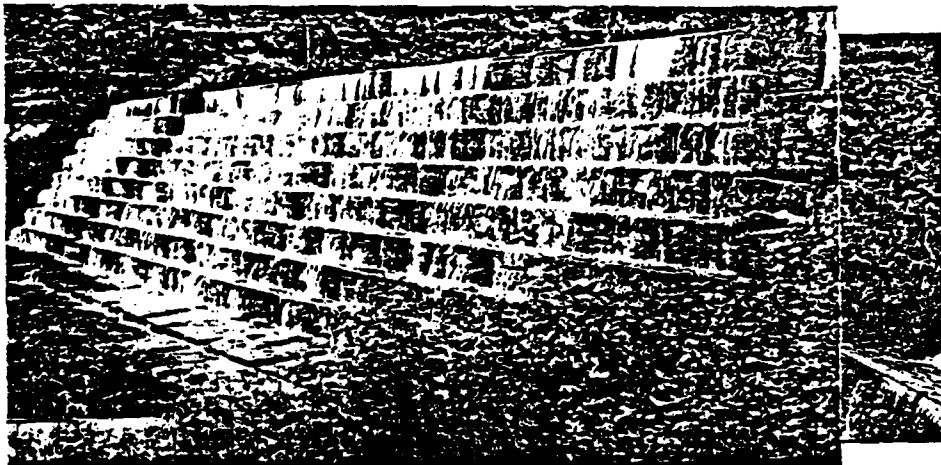
PHOTO #2. Close-up view of stepped masonry face of spillway and stone apron. (UNDER: view across crest also showing heavy growth of weeds. No irregularities noticeable across crest.)
