PISCATAQUA RIVER BASIN,
DEERFIELD, NEW HAMPSHIRE.

FREESES POND DAM
(NH - 00472),
NHWRB-61.02,

PHASE I INSPECTION REPORT
NATIONAL DAM INSPECTION PROGRAM

MAY 1979

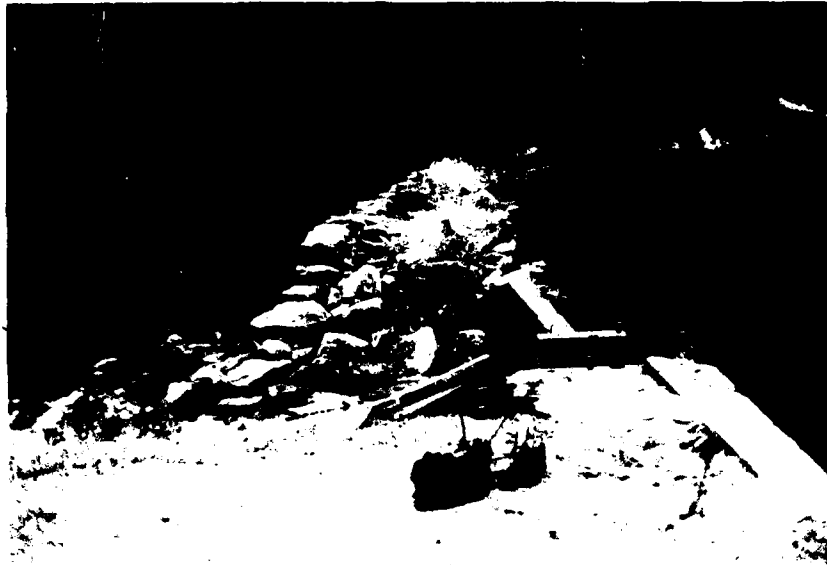
1
VIEW TO WEST ALONG DAM

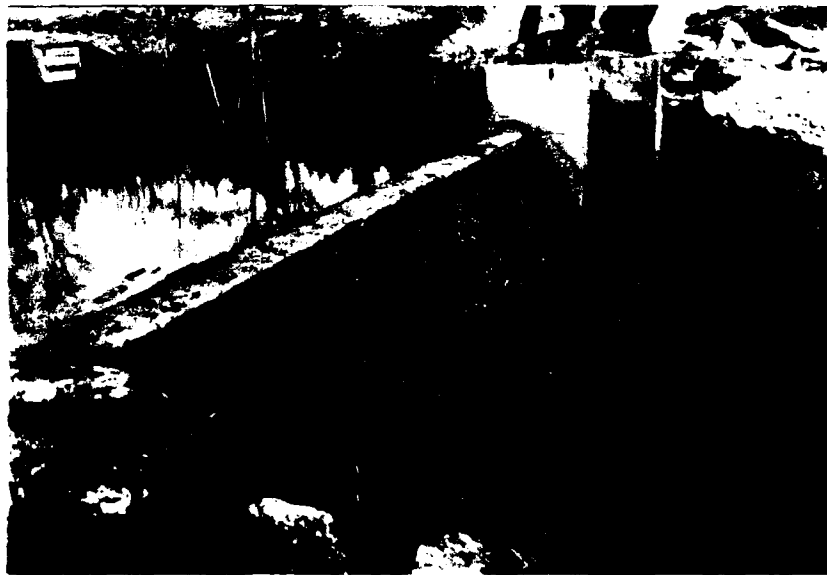
- (c) The spillway section of the dam appears to be in good structural condition (see Photograph #2). Minor leakage is occurring at the joint between the concrete and bedrock but appears insignificant.

- (d) The junction between the stop log outlet and the easterly embankment is in poor condition. The concrete training wall is spalled and eroded and erosion of the embankment has occurred (see Photograph #2).

The junction between the stop log outlet and the easterly embankment is in poor condition (see Photograph #2). In this area the concrete training wall is badly deteriorated and embankment materials have eroded. Seepage is occurring through the dam at this junction.

2
CONCRETE SPILLWAY AND STOP LOG STRUCTURE:
NOTE EROSION OF FAR ABUTMENT.

- (1) Repair the concrete training wall east of the outlet structure.
- (2) Repair or replace the stone masonry training wall west of the spillway.
- (3) Replace missing capstones and re-establish erosion protection for the embankment sections of the dam.
- (4) Repair or replace stop logs and put the controlled outlet into an operable condition.
- (5) Provide for 24 hour surveillance of the structure during anticipated high flow conditions.
- (6) Develop a formal warning system and implement its use in the event of an emergency.
- (7) Have the dam inspected by qualified engineers once every year.
- (8) Remove debris from the downstream channel.
