RICHELIEU RIVER BASIN  
WOODBURY, VT

EAST LONG POND DAM  
VT 00185

PHASE I INSPECTION REPORT  
NATIONAL DAM INSPECTION PROGRAM

APRIL 1980

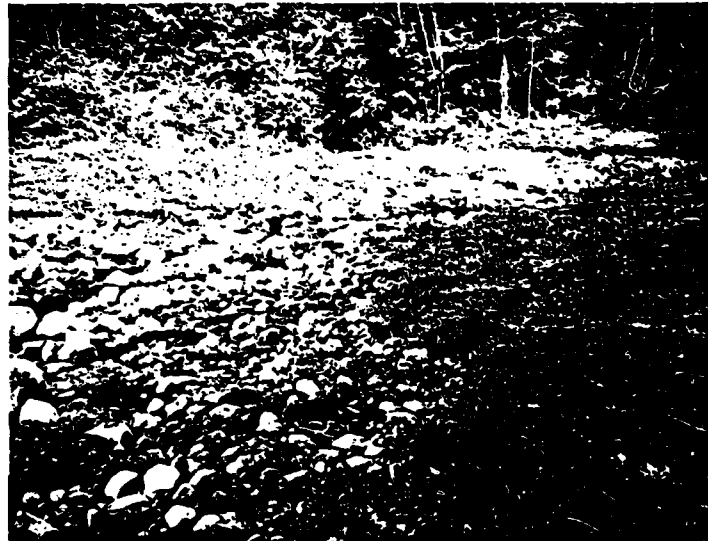
REPAIR TO EMERGENCY SPILLWAY EXIT CHANNEL

(REPLACED STONEFILL & REPAIR OF EROSION DRAINAGE  
FROM 1973 FLOOD)
