CONNECTICUT RIVER BASIN  
LUDLOW, VT

JEWELL BROOK DAM SITE NO. 5  
VT 00017

PHASE I INSPECTION REPORT  
NATIONAL DAM INSPECTION PROGRAM

APRIL 1980

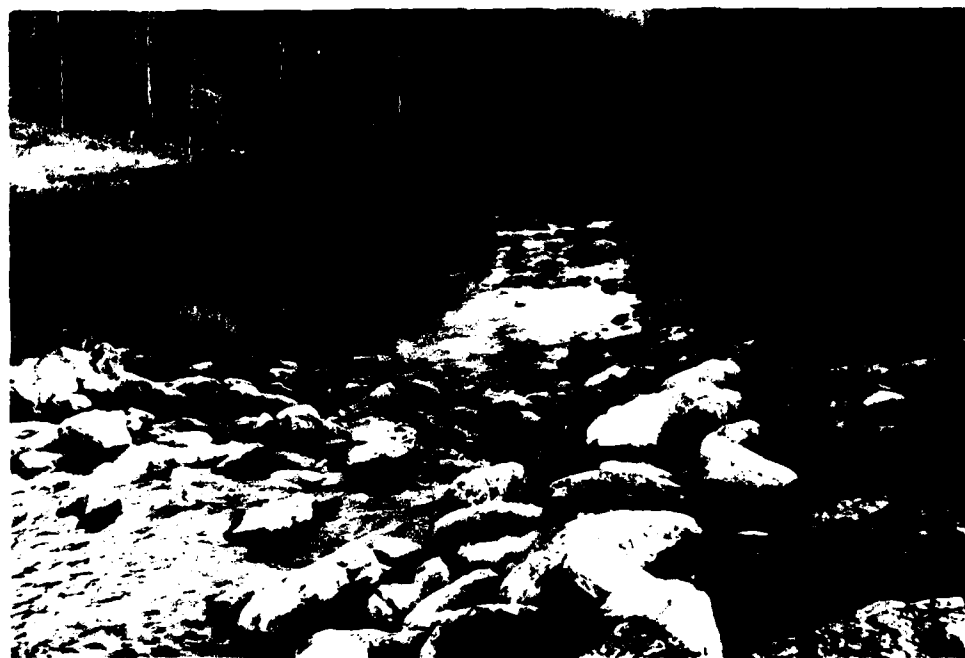
e. Downstream Channel. The downstream channel is a natural channel with cobbles and boulders along the channel floor (Photo 24). There were no loose rocks or trees overhanging the channel.

#24 DOWNSTREAM CHANNEL
