CONNECTICUT RIVER BASIN
WHITINGHAM, VERMONT

JACKSONVILLE POND DAM
VT 00148

PHASE I INSPECTION REPORT
NATIONAL DAM INSPECTION PROGRAM

JANUARY 1981

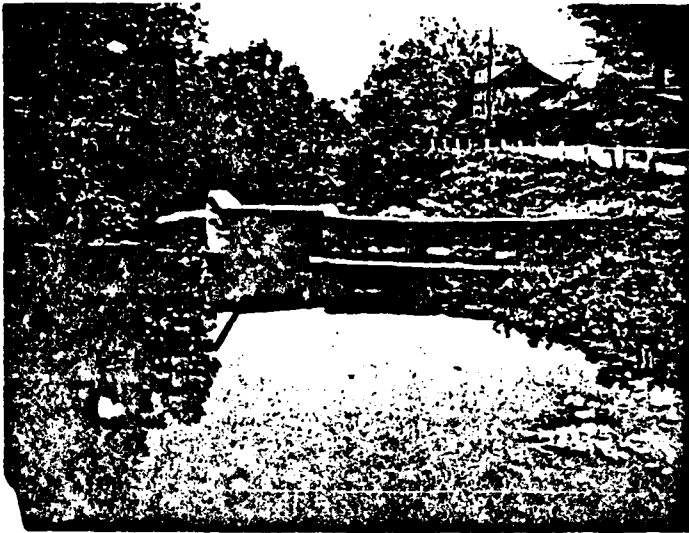
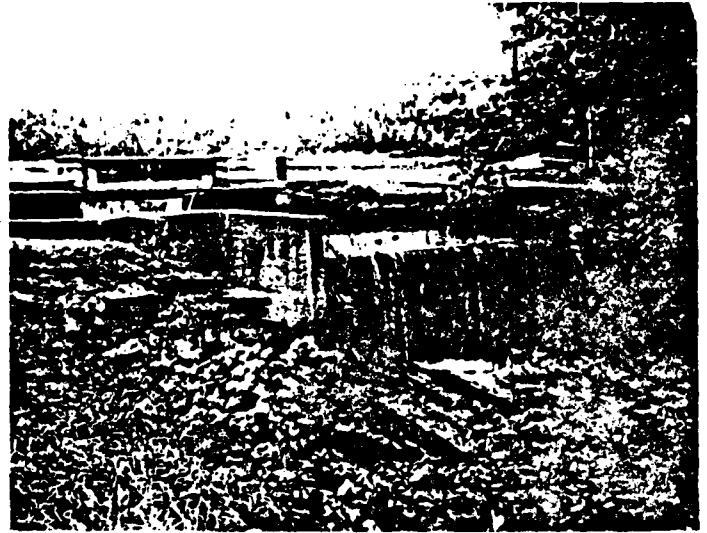
At the bottom of the new sluice wall adjacent to the 3' wide opening in the headwall, there is a cavity in the concrete about one foot square and a foot deep and a pile of sand and aggregate that has fallen and washed out of it. The concrete is crumbly and appears to have little cement in it. Water is leaking through the cavity and causing the sand and aggregate to wash out. The wall is about 2' thick (from a top measurement) at this point and the cavity is about 7' below pond (and spillway) level. The pond is filled in to about a 2' depth at this point. The failure appear

CAVITY IN WALL
