AD-A157 289 NATIONAL PROGRAM FOR INSPECTION OF NON-FEDERAL DAMS  
HAROLD E WATSON RESER. (U) CORPS OF ENGINEERS WALTHAM  
MA NEW ENGLAND DIV APR 79

| REPORT DOCUMENTATION PAGE | | READ INSTRUCTIONS<br>BEFORE COMPLETING FORM |
|---|---|---|
| 4. TITLE (and Subtitle)<br>Harold E. Watson Reservoir Dam<br><br>NATIONAL PROGRAM FOR INSPECTION OF NON-FEDERAL DAMS | | 5. TYPE OF REPORT & PERIOD COVERED<br>INSPECTION REPORT |
| 20. ABSTRACT (Continue on reverse side if necessary and identify by block number)<br><br>This dam is a zoned earth embankment dam which is 760 ft. long and 38 ft. high. The dam is considered to be in good condition. To assure the long term performance of the dam there are several items which require attention. The dam is intermediate in size with a significant hazard potential. Additional remedial measures should be implemented by the owner within a two year period after receipt of the Phase I inspection report. | | |

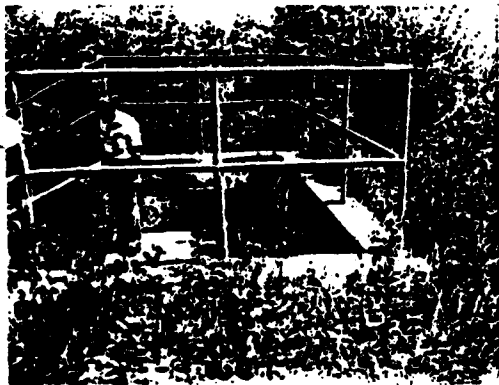
PHOTO #5. Concrete outlet structure.
