PAWTUXET RIVER BASIN
CRANSTON, RHODE ISLAND

CURRAN UPPER RESERVOIR DAM
RI 00702

PHASE 1 INSPECTION REPORT
NATIONAL DAM INSPECTION PROGRAM

MARCH 1980

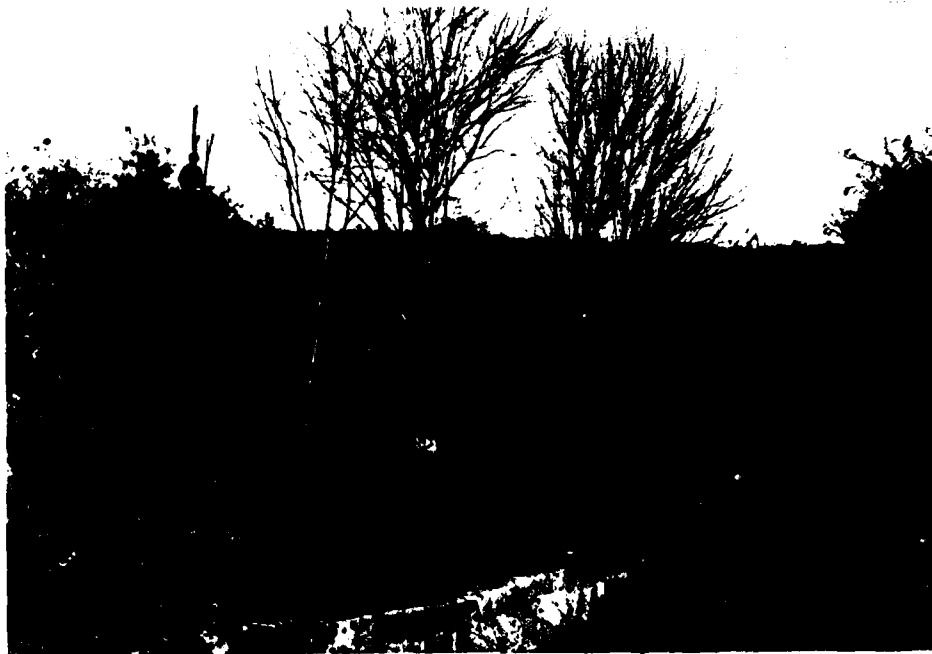
The downstream slope is overgrown with trees and bushes. Some of the larger trees can be seen in Photos C-3 and C-4. Access stairs have been built on the slope in two locations. Extensive seepage was observed at the toe of the slope primarily between Sta 8+00 and 9+00 and between Sta 3+00 and 5+50. In some of the seepage areas the lower footage of the slope appeared soft and wet, even though no seepage could be observed flowing out of the slope. The seepage exiting out of the toe could be observed after clearing the cover of leaves. (See Photo C-11). At about Sta 4+25, there is standing rust-colored water and vegetation typical of wet areas. The seepage flows downstream and to the right towards the outlet channel which is the natural streambed. Some animal burrows exist on the slopes (Photo C-15).

PHOTO C-3 Downstream slope of dam taken from right abutment

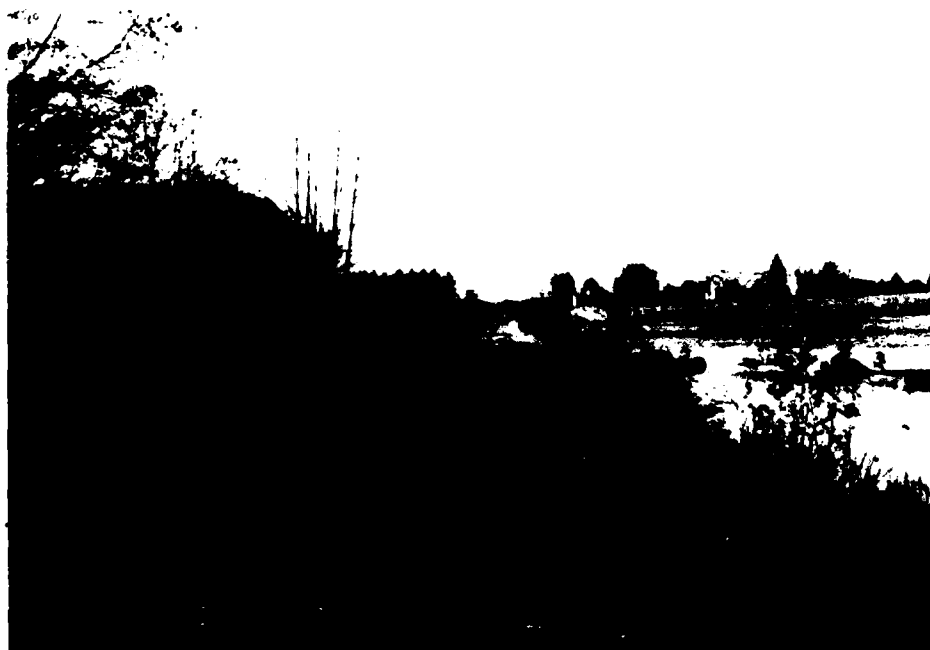
PHOTO C-6 Crest of dam looking from right abutment

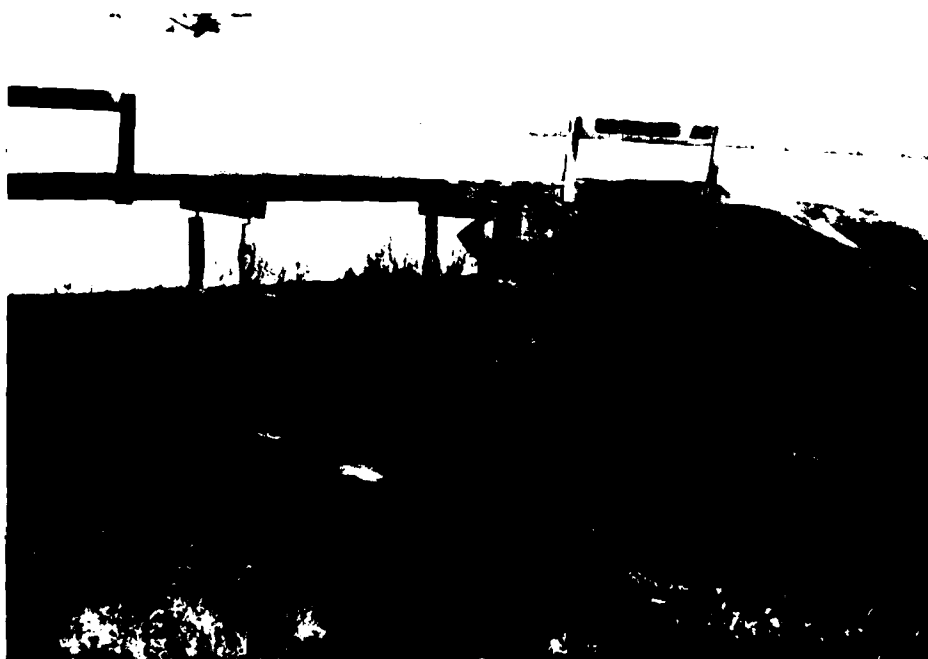
PHOTO C-10 Spillway looking upstream at left training wall

- a. Design repairs to the spillway training walls and weir and to the walls of the spillway channel. Consideration should be given to seepage control measures behind the left wall of the spillway channel that is located along the toe of the dam.
- b. Investigate the significance of the extensive seepage observed along the toe of the dam. In particular, investigate whether the seepage at the headwall for the blow-off pipe is related to possible flow along the outside of the pipe. Design and construct remedial measures, as required.
- c. Remove trees, stumps, and other vegetation from the upstream and downstream slopes. Fill holes left by tree stumps with appropriate soils. Install slope erosion protection on the downstream slope and stone armor protection on the upstream slope.
