NATIONAL PROGRAM FOR INSPECTION OF NON-FEDERAL DAMS  
SITE 1 - BASIN BROOK. (U) CORPS OF ENGINEERS WALTHAM MA  
NEW ENGLAND DIV FEB 80

| REPORT DOCUMENTATION PAGE | | READ INSTRUCTIONS<br>BEFORE COMPLETING FORM |
|---|---|---|
| 4. TITLE (and Subtitle)<br><br>Site 1- Basin Brook Dam<br>NATIONAL PROGRAM FOR INSPECTION OF NON-FEDERAL DAMS | | 5. TYPE OF REPORT & PERIOD COVERED<br>INSPECTION REPORT |

I wish to take this opportunity to thank you and the Water Resources Board for your cooperation in carrying out this program.

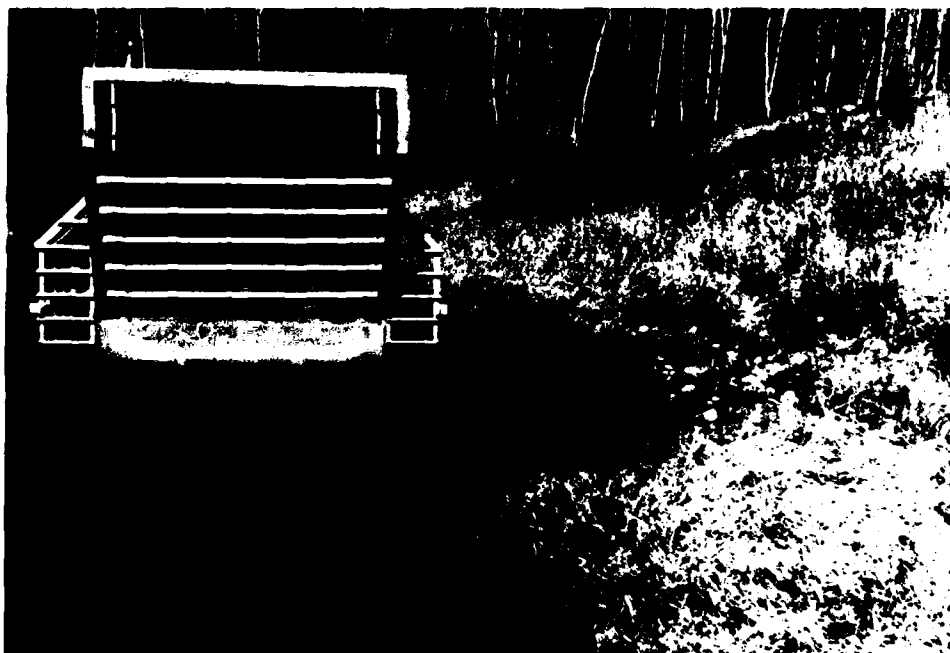
There has been minor erosion and sloughing at the toe of the upstream slope, between the principal spillway and the dam embankment, Photo No. 3. The erosion has cut into the toe of the slope at one point leaving a vertical bank approximately 12 to 15 in. high over a width of about 8 ft. Near the right end of the embankment, a small path about 6 in. deep and 2 ft. wide has been worn by foot traffic and rainfall. Overall, the upstream slope appears to be in good to excellent condition.

3. Toe of upstream slope adjacent to principal spillway

1. Place well-graded crushed stone fill at the toe of the upstream slope in the area experiencing erosion and sloughing. It is suggested, that due to the limited extent of the erosion, this work be done by manual means so that the slope is not subjected to heavy equipment traffic. The performance of the crushed stone fill should be monitored for evidence of any further erosion and/or sloughing. If the repair is observed not to be effective, the owner should then investigate the means of establishing erosion control in the failed area. This investigation should be conducted under the direction of a registered professional engineer.

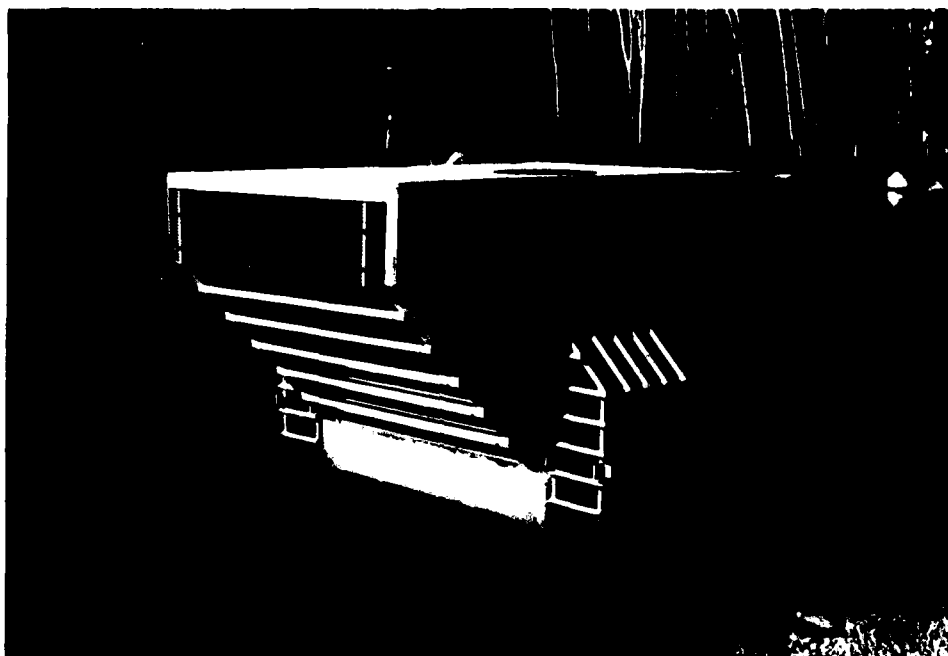
c. Appurtenant Structures. In general, the principal spillway is in good condition, Photo No. 8. The inlets were clear of obstructions and the bar racks were undamaged and intact with only minor surface rust. Although the gate operator for the reservoir drain was not tested, nothing was observed which would indicate potential difficulty in operating the gate. The interior ladder appeared to be in good condition, Photo No. 9.

8. Principal spillway
