# Special Report 85-2

Cold Regions Research &  
Engineering Laboratory

## *Survey of ice problem areas in navigable waterways*

Jon Zufelt and Darryl Calkins

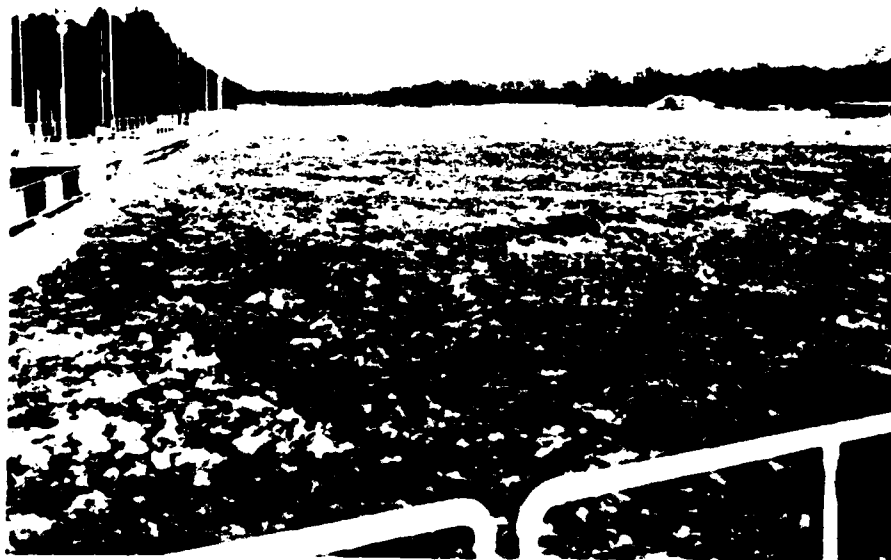
Broken ice carried downstream by the river current or wind often accumulates in the upper lock approach, causing delays (Fig. 1). Separate ice lockages often must precede the locking of downbound tows, and flushing ice during these ice lockages is difficult. Occasionally a tow must back out of the lock after entry, because the ice doesn't compact in the chamber as much as expected, preventing the tow from fully entering the lock chamber and thus causing further delays. Upbound tows may have to limit their size to be assured of enough power to push through the accumulations of ice. During periods of low traffic, these accumulations sometimes freeze in place, causing further delays and difficulty in operating the upper gates. Air bubbler curtains have been used at some installations to deflect ice from the lock ap-

Figure 1. Ice in upper lock approach.

proach. Towboats sometimes align their barges to act as a deflector wall while awaiting downbound lockage. Some locks are equipped with emergency bulkheads that are placed in the small lock chamber to act as spillways, flushing ice from the upper approach. One respondent cited that with greater towboat approach velocities, the ice is pushed to the sides of the incoming barges, rather than being directed forward into the lock chamber.

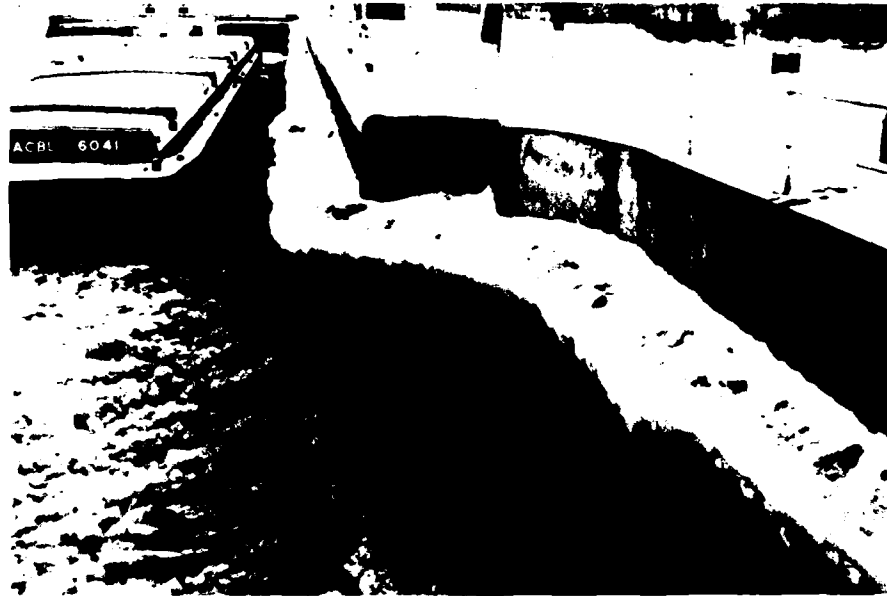
Figure 3. Ice buildup on lock walls and miter gate recesses.

During extremely cold weather, and with fluctuating water levels in lock chambers, ice will build up on the lock walls and miter gates, forming a collar (Fig. 3). This collar is thickest at the upper pool level. Sufficient buildup can occur on the walls to restrict the gates from being fully opened, thus limiting the width of tows and presenting the potential for gate damage. Even where the buildup is minimized or controlled in the gate recesses, ice on the chamber walls can be thick enough to restrict tow widths. The most common methods for removing ice buildups on lock walls and miter gates are chipping and steaming. Less labor-intensive means include electric heaters on gates and wall recesses and the application of copolymer ice coatings. Ice coatings are reported to work well on lock walls but have had limited success when applied to the miter gates.

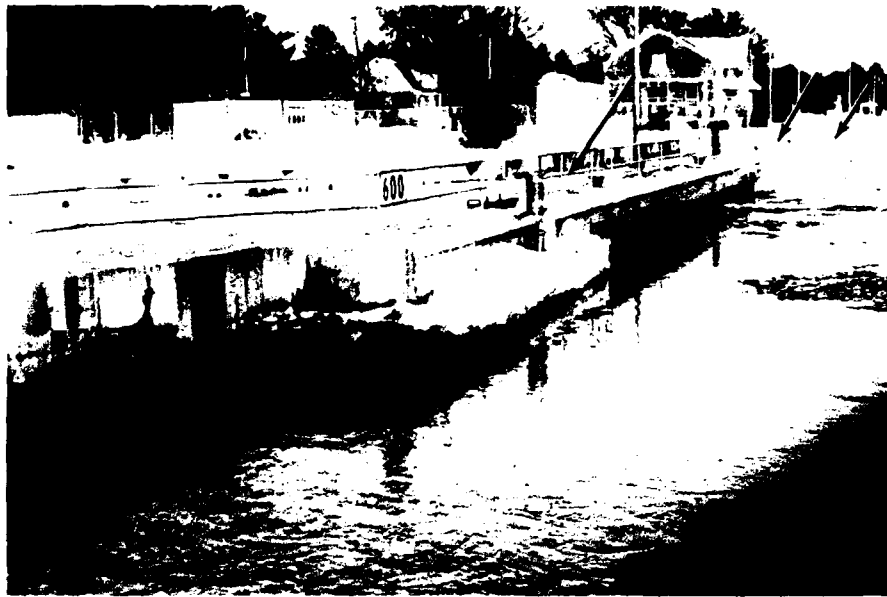
Ice pieces may jam between the floating mooring bitts and the lock wall, rendering the bitts inoperative. Ice layers may build up on the wheels or track of a bitt (Fig. 4), causing it to freeze in place and/or jump upward unexpectedly from a submerged position. Usually, bitts are tied off at the top of the lock wall and remain unavailable for winter use. Oil-fired hot water heaters have been used to keep floating mooring bitts free of ice accumulations. One facility has achieved good results from applying copolymer ice coating to the tracks and wheels of their bitts.

Figure 4. Floating mooring bitts jammed by ice accumulations.

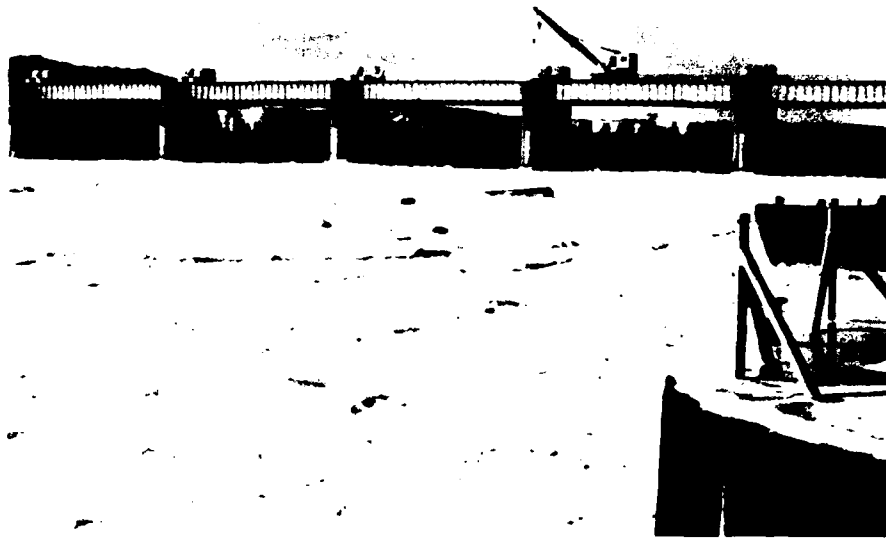
Broken ice carried downstream usually accumulates at the navigation dam (Fig. 5). During periods of low flow, normal gate openings are small and will not pass this ice. Low tailwater presents a problem of excessive scour if gates are raised high enough to pass the ice. In colder weather these accumulations will freeze in place, making it necessary to break up the ice in order to start it or keep it moving. Towboats provide assistance to the lock and dam facilities in this respect. Some lock and dam facilities have been equipped with submergible tainter gates, specifically designed for passing ice and drift. At a few installations, the gates are rarely used in the sub-

Figure 5. Ice buildup behind dam spillway gates.

merged settings due to excessive vibrations, which could cause damage to the gate and supporting structure of the dam. Some of these submergible gates have been retrofitted to prevent them from being used in the submerged position. Other lock and dam facilities report no problems with operating their gates in the submerged position. Three installations on the Monongahela River are equipped with split-leaf tainter (movable crest) gates designed for passing ice and debris. The gates are reported to work well, but during periods of low flow, towboat assistance is required to break up the ice behind the dam and start it moving. One facility reported that an emergency bulkhead placed over a roller gate bay passes ice well. Another lockmaster rotates the openings of the dam gates to keep the ice moving.

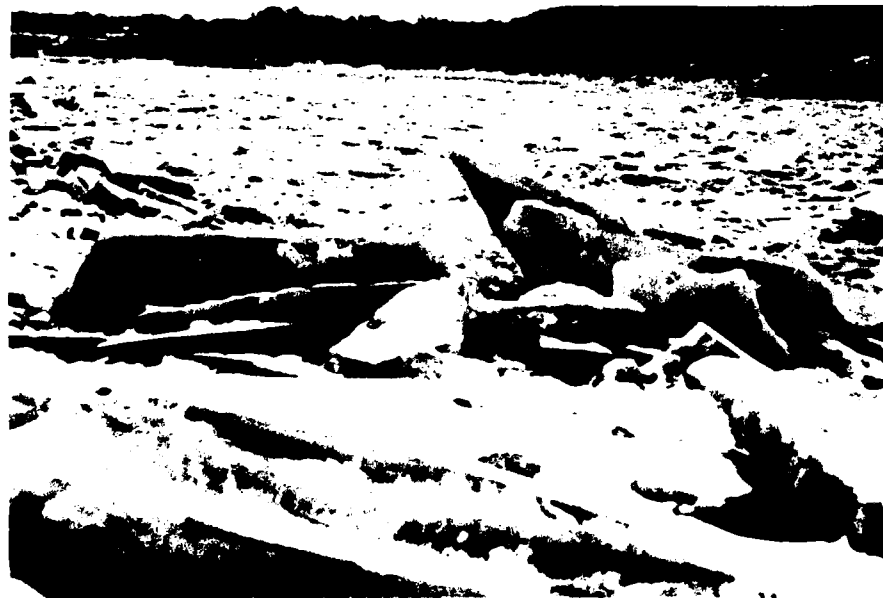
The channels around islands, bends, and other constrictions tend to accumulate thick deposits of ice (Fig. 8). During significant ice periods these accumulations may form jams, which can cause scouring and eroding of bed and banks. Navigation can be interrupted or delayed and structural damage is possible, especially during breakup of the jam. Minor jams may raise the water level upstream, while major jams can cause severe flooding. Tows must limit their size in some problem areas.

Figure 8. Section of Ohio River showing severe accumulation of ice in navigation channel.
