AD-A157 515

NATIONAL PROGRAM FOR INSPECTION OF NON-FEDERAL DAMS
STILES POND DAM (VT 0... (U) CORPS OF ENGINEERS WALTHAM
MA NEW ENGLAND DIV OCT 79

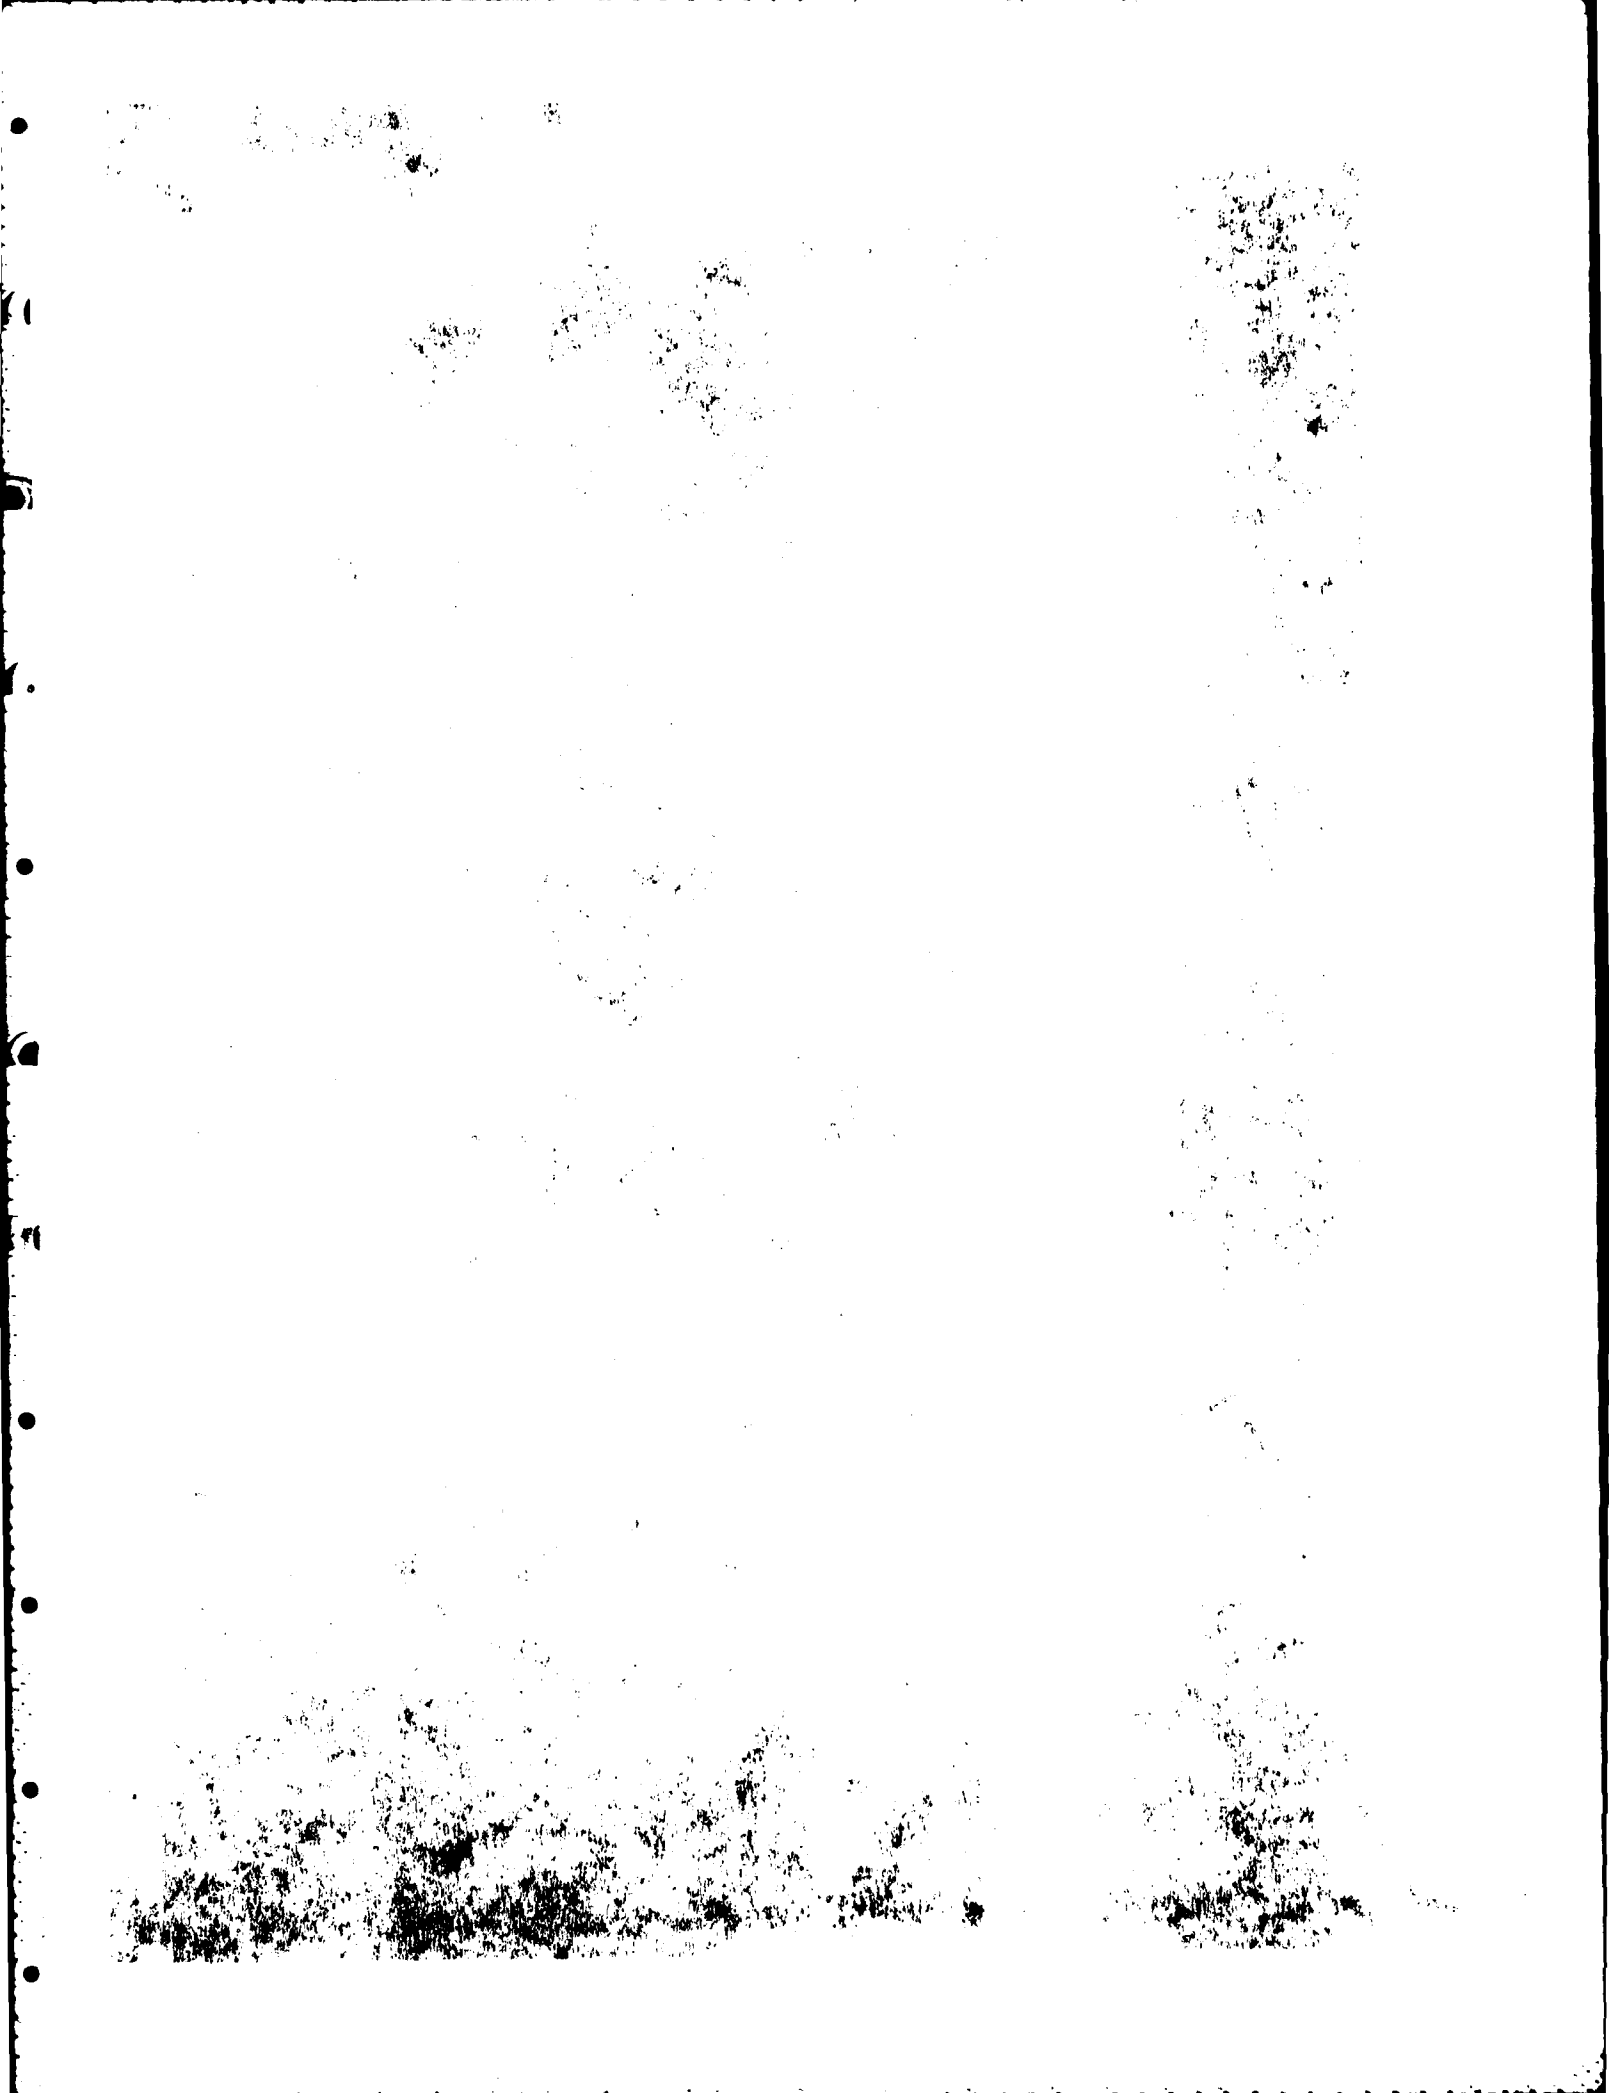
<u>Section</u>	<u>Page</u>
7. ASSESSMENT, RECOMMENDATIONS AND REMEDIAL MEASURES	7-1
7.1 Dam Assessment	7-1
a. Condition	7-1
b. Adequacy of Information	7-1
c. Urgency	7-1
d. Need for Additional Investigation	7-2
7.2 Recommendations	7-2
7.3 Remedial Measures	7-2
7.4 Alternatives	7-2
