CONNECTICUT RIVER BASIN
CAVENDISH, VERMONT

KNAPP BROOK SITE NO. 2
VT. 00077

PHASE I INSPECTION REPORT
NATIONAL DAM INSPECTION PROGRAM

MARCH 1980

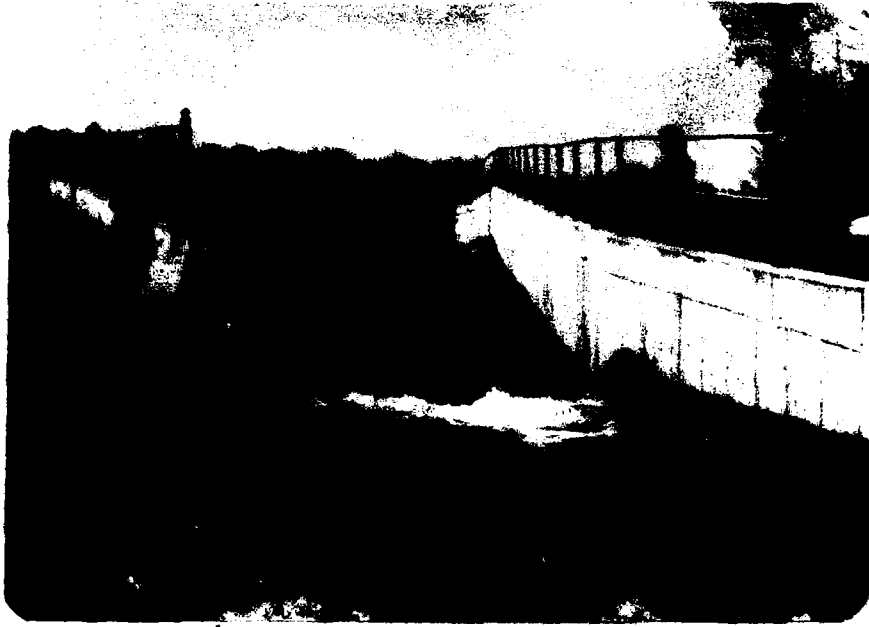
#7. CHUTE INTO KNAPP BROOK SITE NO. 1 POND.
