BLODGETT DAM
VT 00117

PHASE I INSPECTION REPORT
NATIONAL DAM INSPECTION PROGRAM

DEPARTMENT OF THE ARMY
NEW ENGLAND DIVISION, CORPS OF ENGINEERS
WALTHAM, MASS. 02154

OCT, 1980

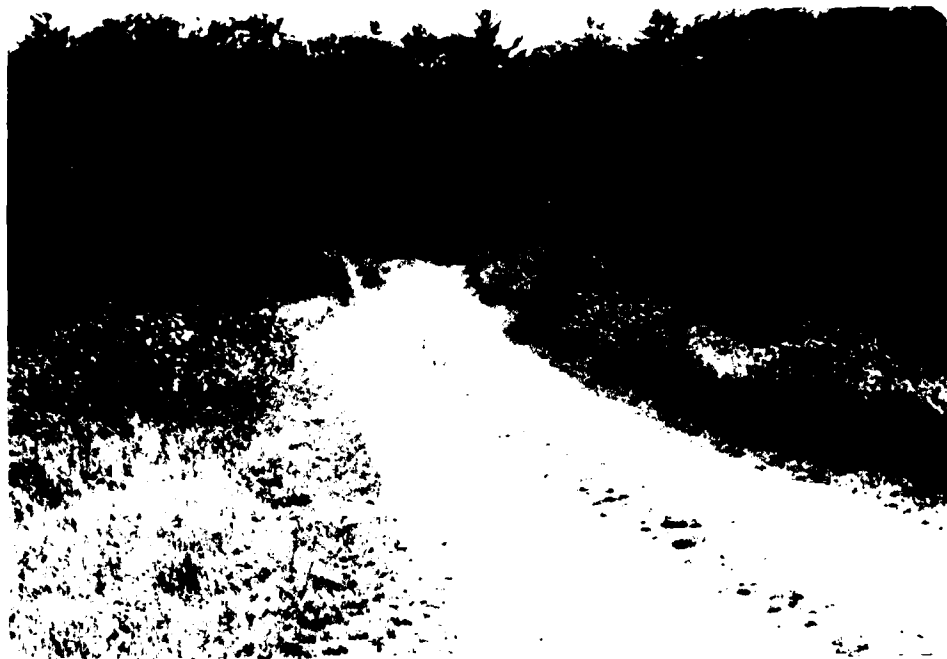
The crest of the dam is generally about 15 feet wide and has an unpaved roadway as shown in Photo 4. The crest is wider, on the downstream side, at the location of the natural knob. As shown in Photo 5, the downstream slope is covered with tall grass and brush and scattered small pine trees. Water was observed seeping from beneath the 18 inch diameter outlet pipe which exits at the downstream toe of the dam adjacent to the right abutment, seen in Photo 6. Clear seepage was observed downstream of the 6 inch diameter outlet pipe from the foundation drainage system as shown in Photo 7; a rust-colored pool of water, shown in Photo 8, was observed downstream from this seepage area. The SCS drawings for the Blodgett Dam indicate that a rock fill toe drain and blanket drain are located in the downstream toe of the dam at the location of the two seepage areas. The rock toe could not be discerned in the field.

(4) Crest of Dam, Looking Toward Right Abutment.

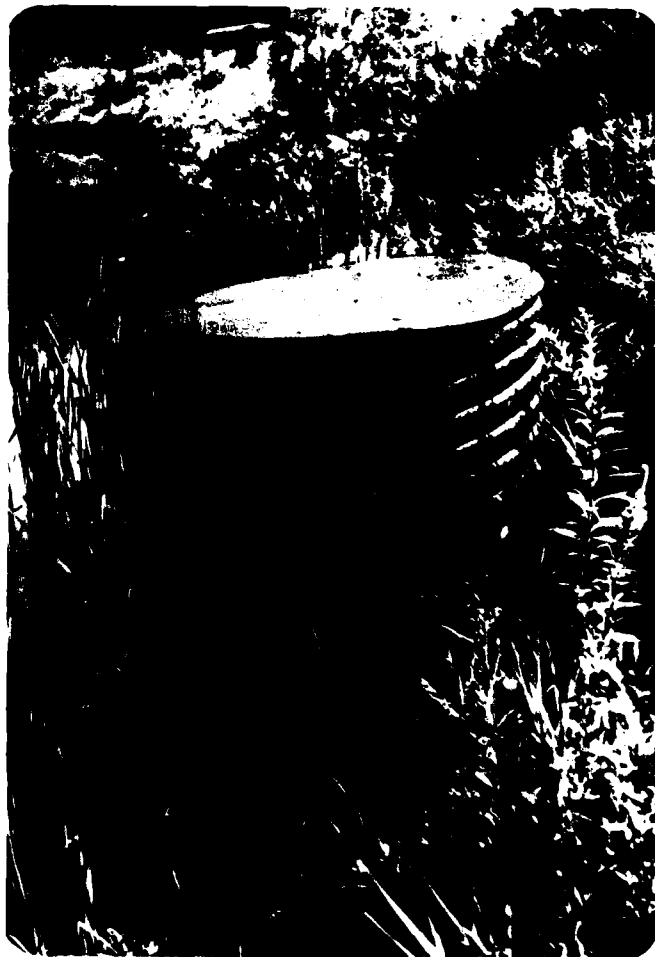
An 18" diameter low level outlet pipe passes through the dam and exits at the downstream toe of the dam at the contact with the right abutment as seen in Photo 6. The low level outlet is controlled by a slide gate housed in a steel well assembly on the upstream dam face as shown in Photo 12. The low level outlet appears in good condition and is reported operable.

(12) Low Level Outlet Gate Housing.
