**RICHELIEU RIVER BASIN  
STOWE, VERMONT**

**LAKE MANSFIELD DAM  
VT 00100**

**PHASE I INSPECTION REPORT  
NATIONAL DAM INSPECTION PROGRAM**

**MARCH, 1979**

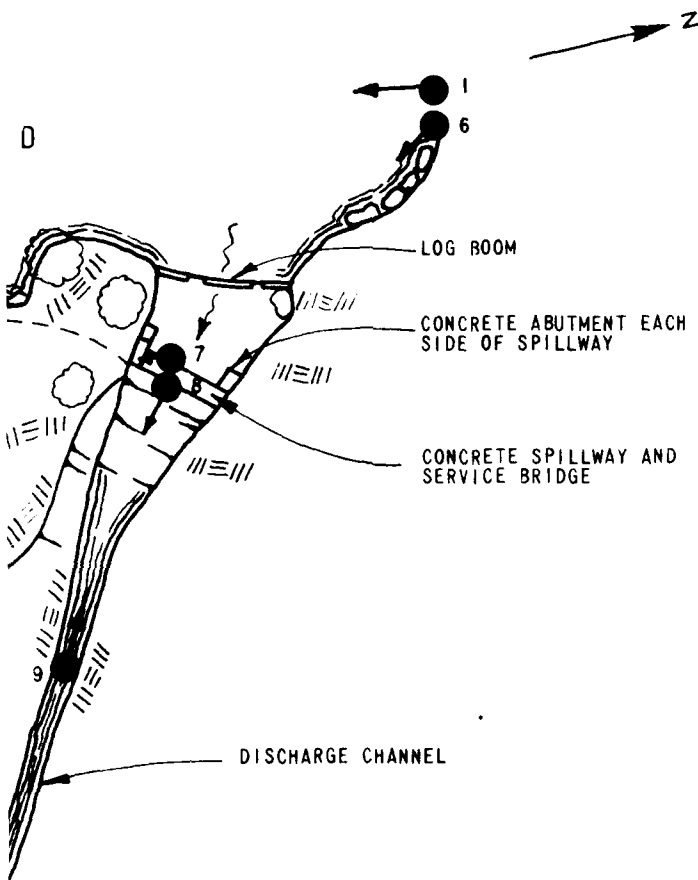
In Figure 1, it can be seen that wet zones are prevalent downstream from the toe of the dam, chiefly in locations where the downstream toe drains had been installed. The two wet zones on the right side could be caused by seepage through the dam, but may also be due to the natural stream that was flowing down the slope of the natural ground on the right side and downstream from the dam. A wet zone shown in Figure 1 to the left of the low-level outlet conduit is at a higher elevation than the water in the conduit. This wet zone is likely to be caused by seepage through the dam that is not collected in the downstream drains.

- 1 ICICLE ON DS INVERT IS CLEAR. NO FLOW.
- 2 1-3 GPM VERY RUSTY WATER. WAS COVERED WITH STONES WHICH WERE MOVED TO OBSERVE WATER.
- 3 NO WATER EVIDENT
- 4 FILLED WITH WATER. FROZEN. NO FLOW.
- 5 3-6 GPM FLOW. CLEAR BUT RUSTY STAINED ZONE DOWNSTREAM AS SHOWN.
- 6 WET ZONE. NO FLOW OBSERVED.
- 7 SMALL STREAM EMERGING FROM NATURAL HILL. PROBABLY A CONTINUATION OF STREAM BELOW RIGHT ABUTMENT.
- 8 SMALL SEEP << 1 G.P.M.
