CONNECTICUT RIVER BASIN  
LYNDON, VT

INSTITUTE POND DAM  
VT 00216

PHASE I INSPECTION REPORT  
NATIONAL DAM INSPECTION PROGRAM

DECEMBER 1980

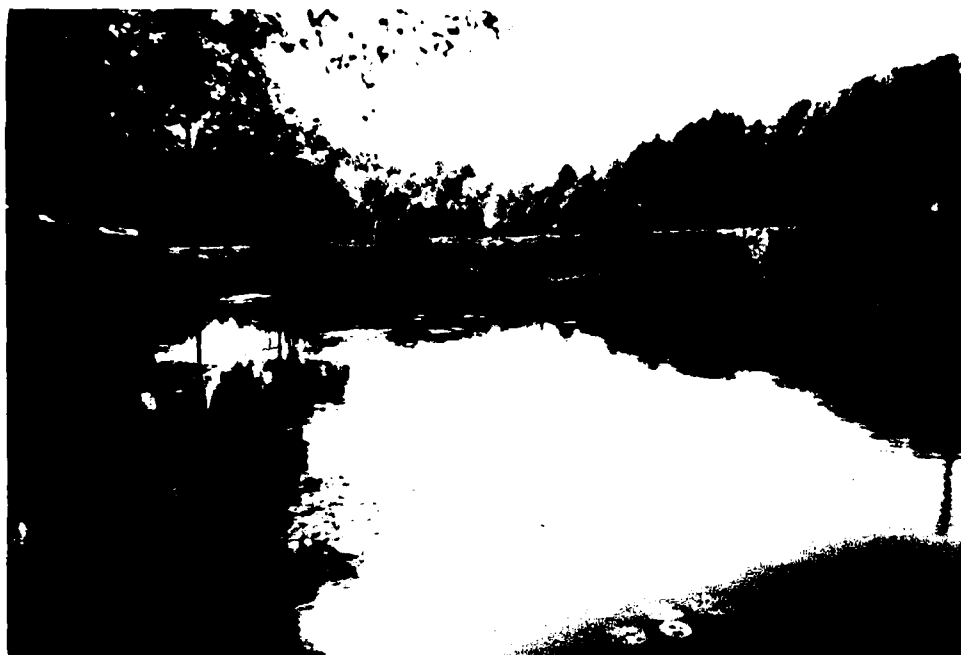
d. Reservoir Area. The water impounded by the dam is divided into two ponds by a road embankment (State Aid Highway #9). The two ponds are connected by a 48-inch culvert (Photos 2 & 3, see Possible Flood Damage Map - Appendix D). The water appears to be rather shallow in both ponds, as a result of sedimentation. The storage volume and surface area of the two ponds combined, at spillway crest elevation are 28.6 acre-feet and 2.6 acres, respectively and are divided almost equally between the ponds (see Appendix D, page 2 of 31). Trees are overhanging the right side of the pond next to the approach channel for the spillway at the right end of the dam.

#3 - Road Embankment, State Aid Highway #9, upstream side of road (notice 48 inch culvert)(Photo location on Possible Flood Damage Area Map - Appendix D)

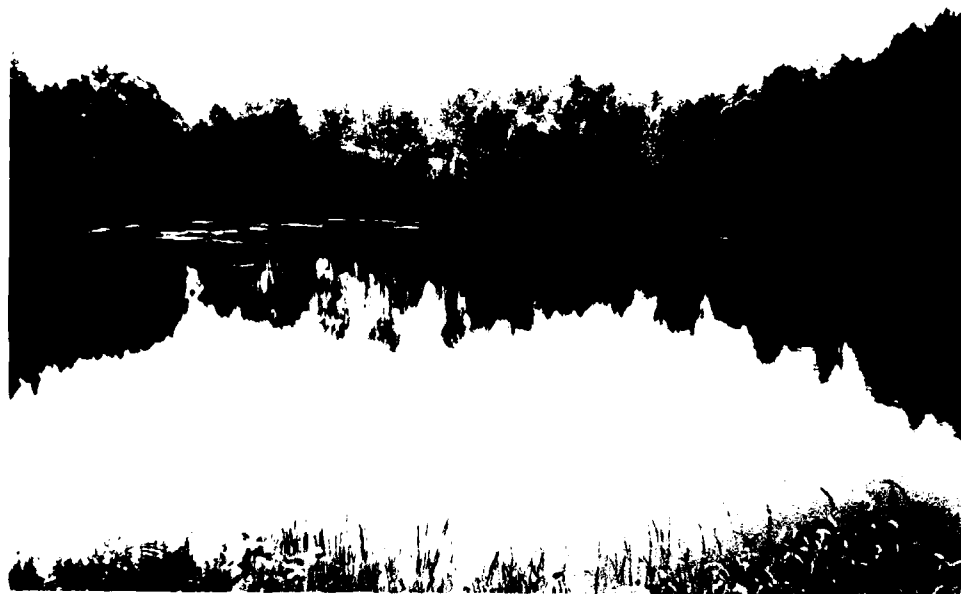
#1 - Crest of Dam, from State Aid Highway #9(notice  
48 inch culvert, discharge end, lower left corner)  
(photo location on Possible Flood Damage Area Map-  
Appendix D)

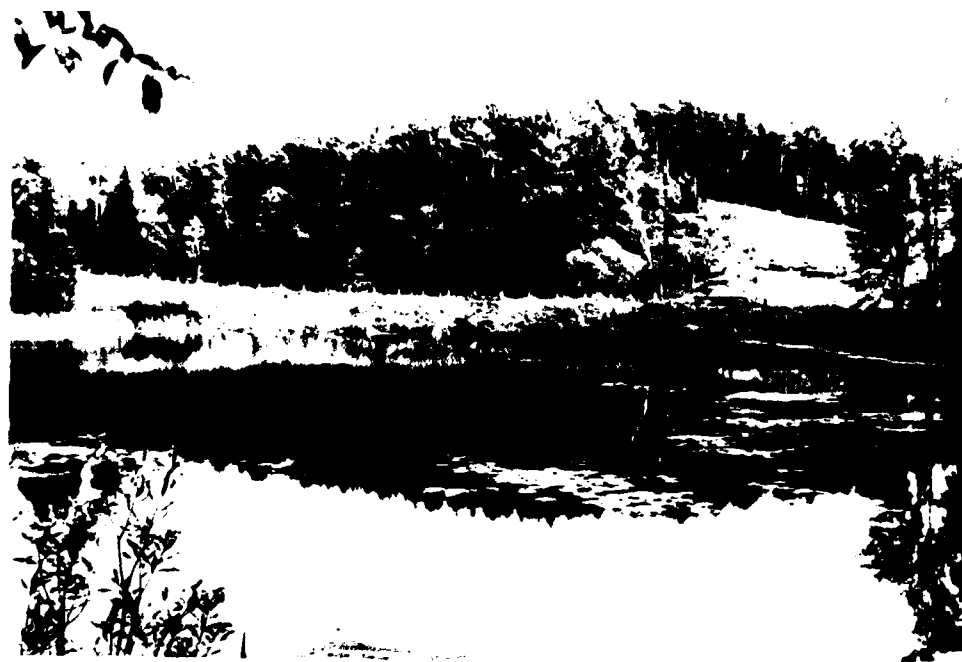
#2 - Road Embankment, State Aid Highway #9, from crest of  
Dam (notice 48 inch culvert)
