MISCELLANEOUS PAPER GL-85-21

# CRATER REPAIR OF NORTH AUXILIARY AIRFIELD, SOUTH CAROLINA

Samuel J. Alford and Albert J. Bush III

August 1985

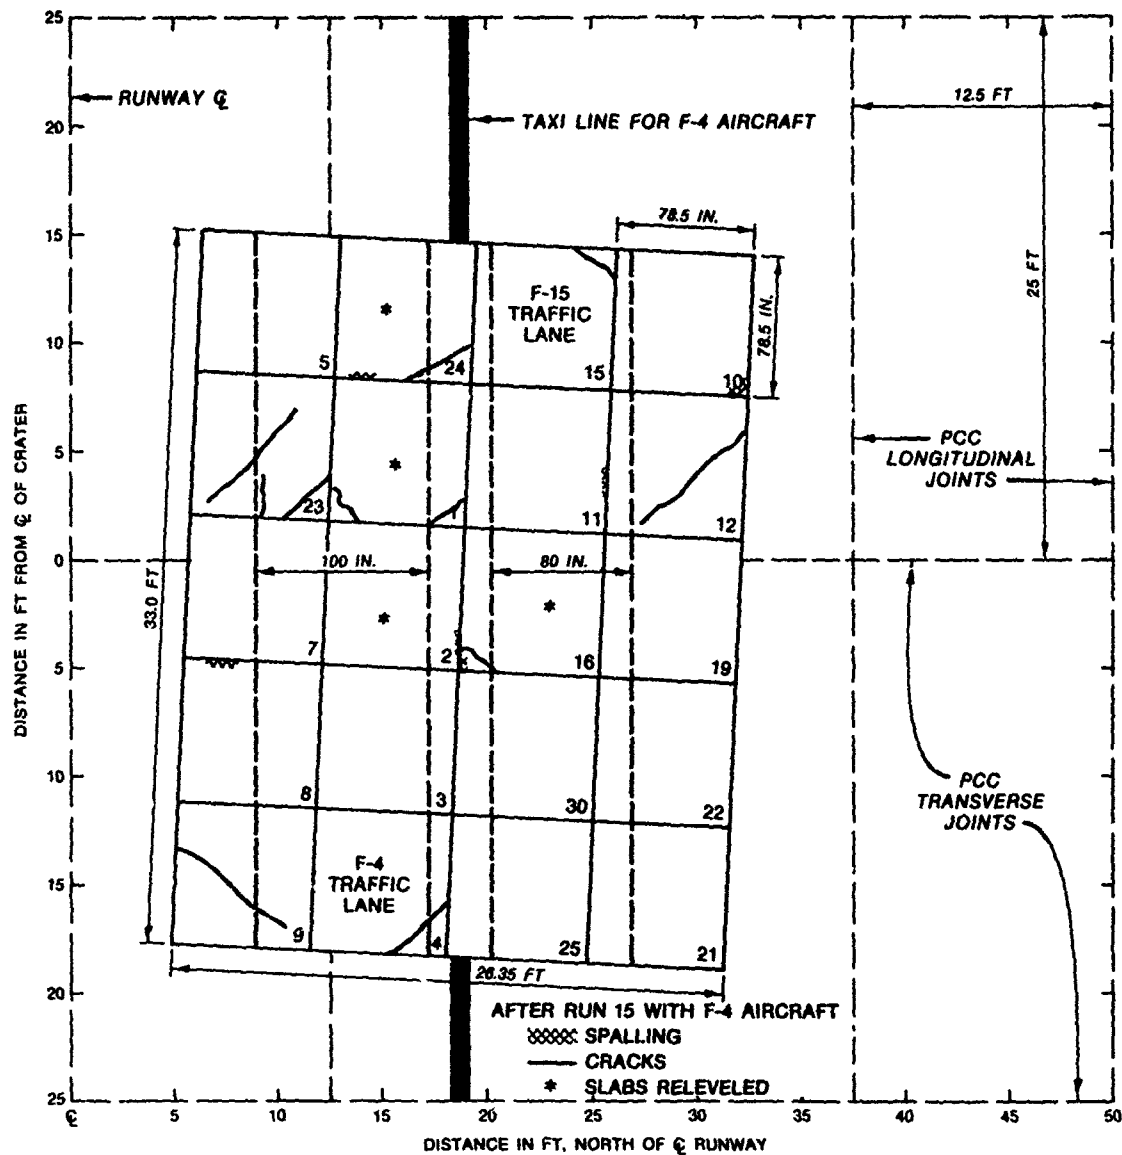
Figure 14. Defects in slabs after run 15, F-4 aircraft

20. After run 15 of the aircraft traffic, four slabs were removed and releveled (Figure 14). One slab was removed because the sag measurement exceeded the 2-in. sag criterion (Table 4) two were removed because the sag measurement was 1.75 in. (close to the 2-in. criterion), and one was removed to allow replacing of the Silikal patch (west end of crater) which failed under traffic.

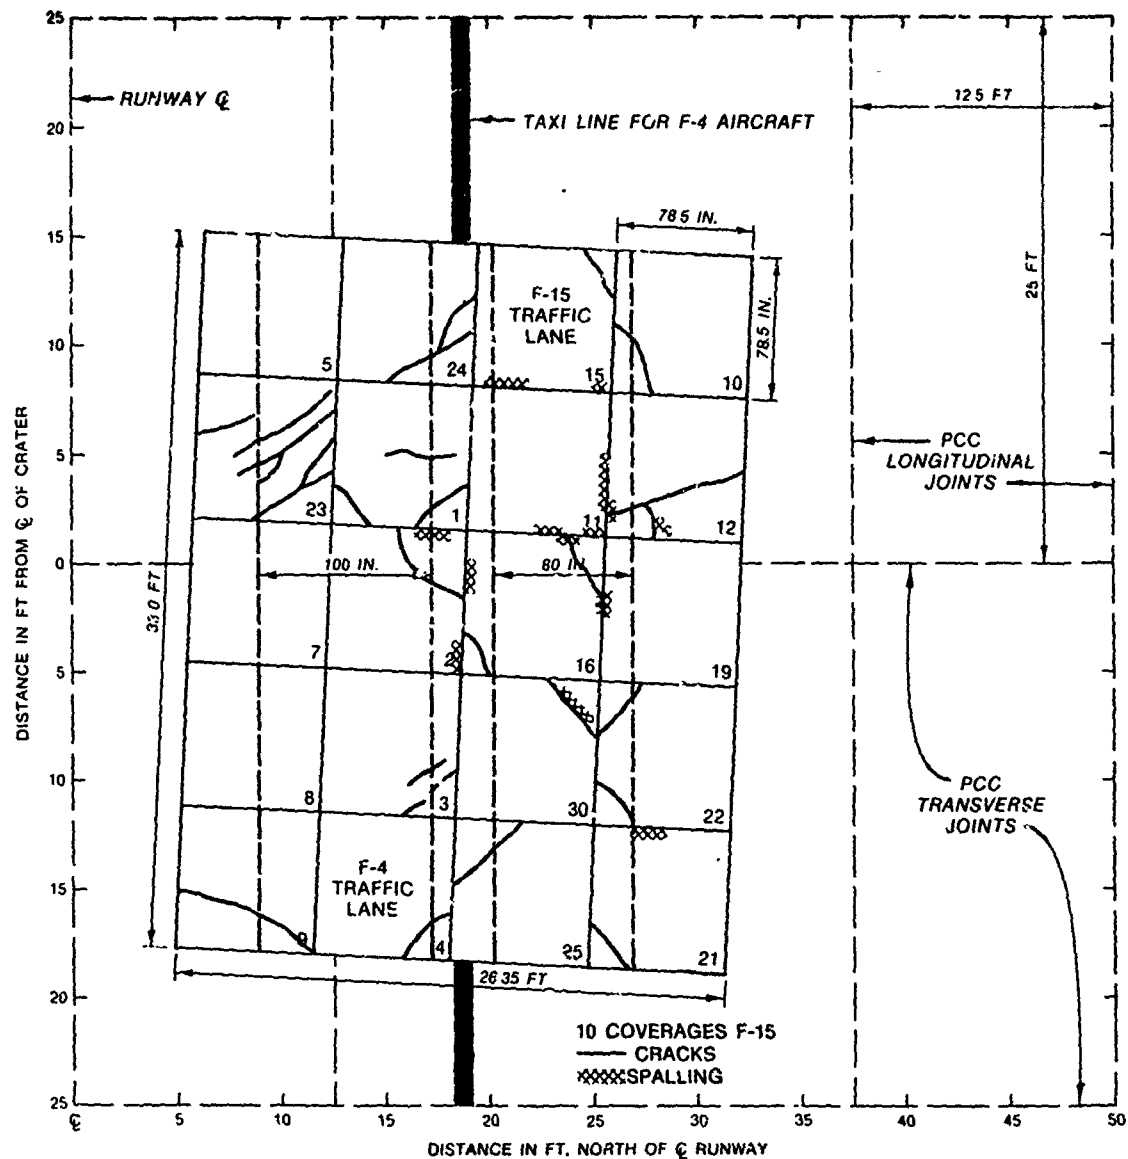
Figure 36. Defects in slabs after 10 coverages of F-15 traffic

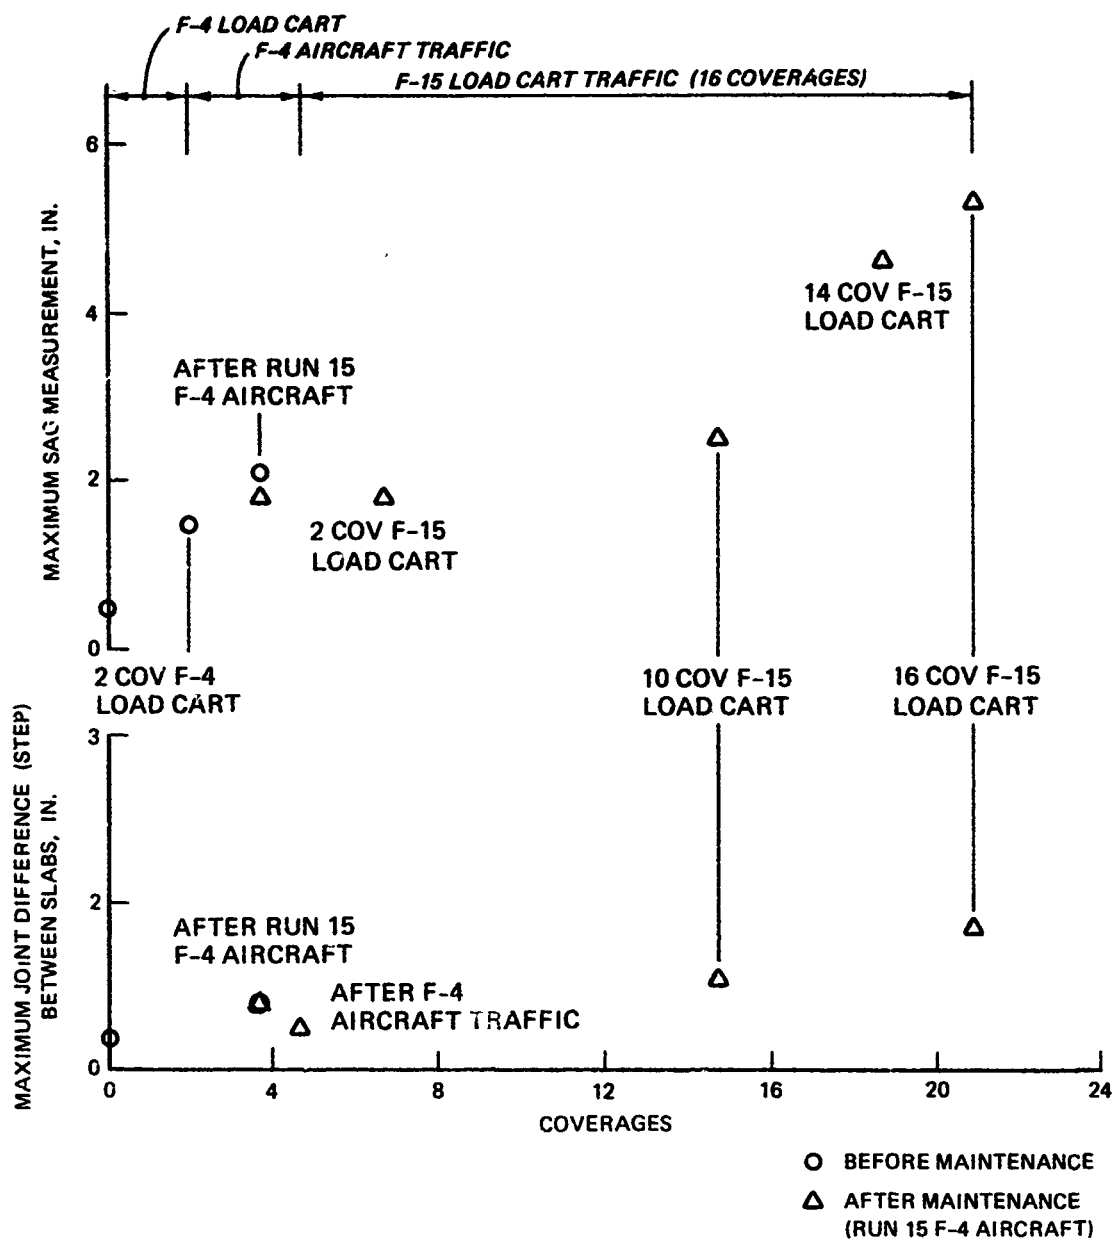
sag measurement had increased to 4.63 in. (Table 4). This measurement was made without the load wheel on the repair. Photo 31 shows the sag measurement along with the spalling on slabs 16, 19, 11, and 12. Traffic was stopped after 16 coverages when a maximum sag of 5.25 in. was measured (Photo 32). The maximum sag measurements and the maximum joint difference (step) between the slabs recorded during all phases of traffic applied on the north side of the crater repair (F-15 traffic lane) are plotted and shown in Figure 37. Photo 33 is a general view of the traffic lane and Photo 34 shows the traffic with a 10-ft straightedge across the traffic lane after the 16 coverages. Figures 28 through 34 contain profile data after the 16 coverages. Figure 38

Figure 37. Maximum sag measurements and maximum joint difference (step) between the slabs for the north side of the crater repair (F-15 traffic lane)

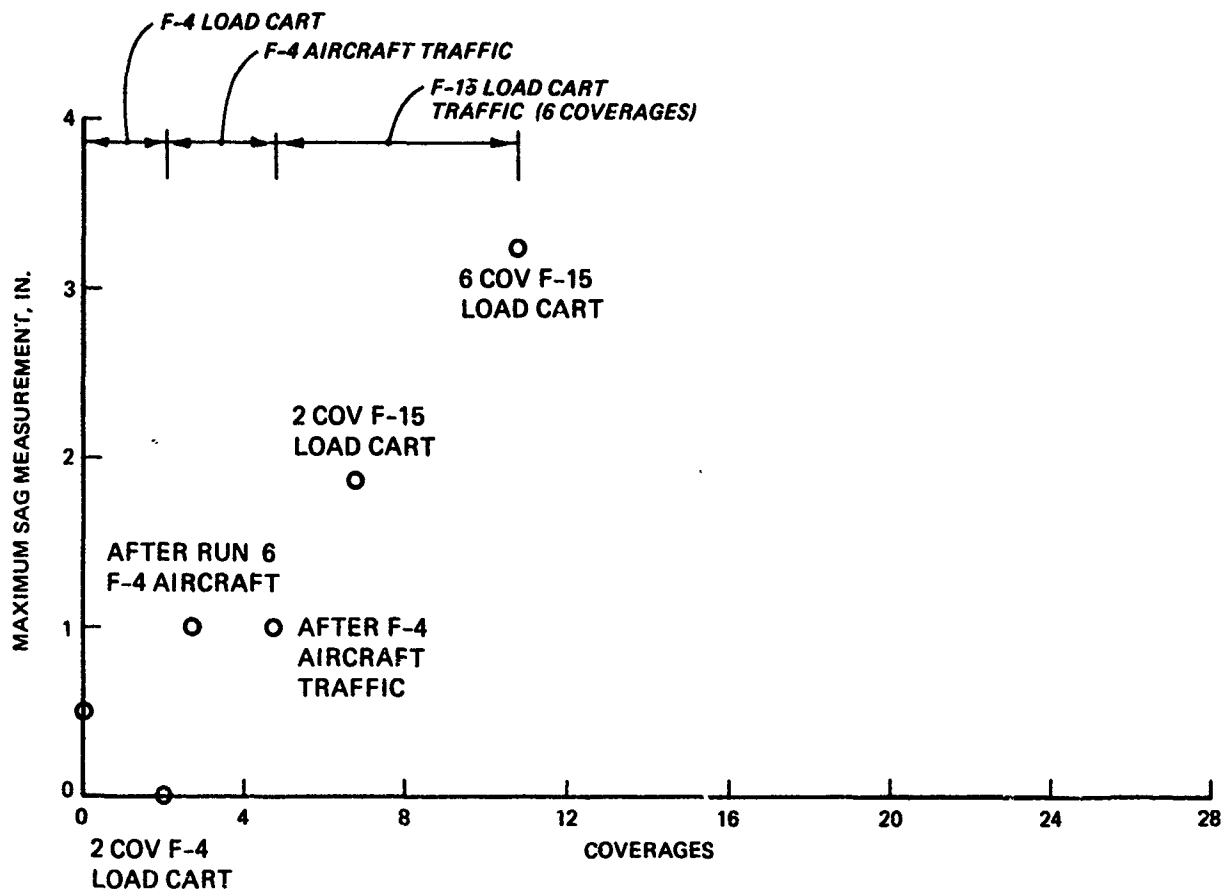
FOD cover. After two coverages, three tears were detected on the hinge which was in the center of the traffic lane and one tear was located 1 ft south of the hinge. The tears on the hinge were 1, 2, and 5 ft in length. The 5-ft tear was the only one of these tears that was completely through both plies of fiberglass. Although the 5-ft tear was completely through the FOD cover, the base course material remained intact and there was no FOD problem. The tear 1 ft south of the hinge was 1 ft long and only in the top ply of the fiberglass. Photo 45 is a general view of the traffic lane after two coverages. The sag measurement increased from 1.0 to 1.88 in. at this coverage level. The profile and cross-section data measured after two coverages of traffic and shown in Figures 73 through 76 indicate consolidation in the crater fill materials. Between two and four coverages, a lost profile bushing, used in anchoring the FOD cover, was discovered under the FOD cover. The bushing was lost under the FOD cover when the cover was replaced after the F-4 aircraft traffic and was discovered when the neck of the bushing punctured the FOD cover. As can be seen in Photo 46, the puncture is located about 8 in. to the right of the ruler and just above the 5-ft tear. The puncture was approximately 1.25 in. in diameter and appeared to be the only damage caused by the bushing even though it was located close to the tear. Traffic was stopped after four coverages so that the 5-ft tear which had increased to 6 ft in length could be patched. The patch consisted of one layer of fiberglass, 19 by 75 in. (Photo 46), which was saturated with polyurethane that had been catalyzed 2 weeks earlier and then placed over the tear. After patching, traffic was continued beginning at the edge of the traffic lane, and on the first pass of the load cart, the patch started to work loose. After four passes, the patch was completely loose. During these four passes of traffic, the closest the load wheel came to the patch was about 16 in. Although the patch had come loose, traffic was continued; and after six coverages, sag measurements were taken. The maximum sag measured at this time was 3.25 in. The maximum sag measurements recorded during all phases of traffic applied on the north side of the crater repair (F-15 traffic lane) are plotted and shown in Figure 77. Photo 47 shows the traffic lane, with a 10-ft straightedge, after the six coverages. The 6-ft-long tear which was patched after four coverages of traffic had increased to 18 ft in length (Photo 48) after six coverages. This 18-ft tear was completely through the FOD cover; however, the base course material was still intact. Five additional tears were observed in the traffic

Figure 77. Maximum sag measurements for the north side of the crater repair (F-15 traffic lane)
