# TRAY PACK IMPROVED DURABILITY PACKAGING ROUGH HANDLING TEST RESULTS

RICHARD D. CUMMINGS

JUNE 1983  
FINAL REPORT  
1 JANUARY 1983 TO 30 JUNE 1983

UNITED STATES ARMY NATICK  
RESEARCH AND DEVELOPMENT CENTER  
NATICK, MASSACHUSETTS 01760-5000  
FOOD ENGINEERING LABORATORY

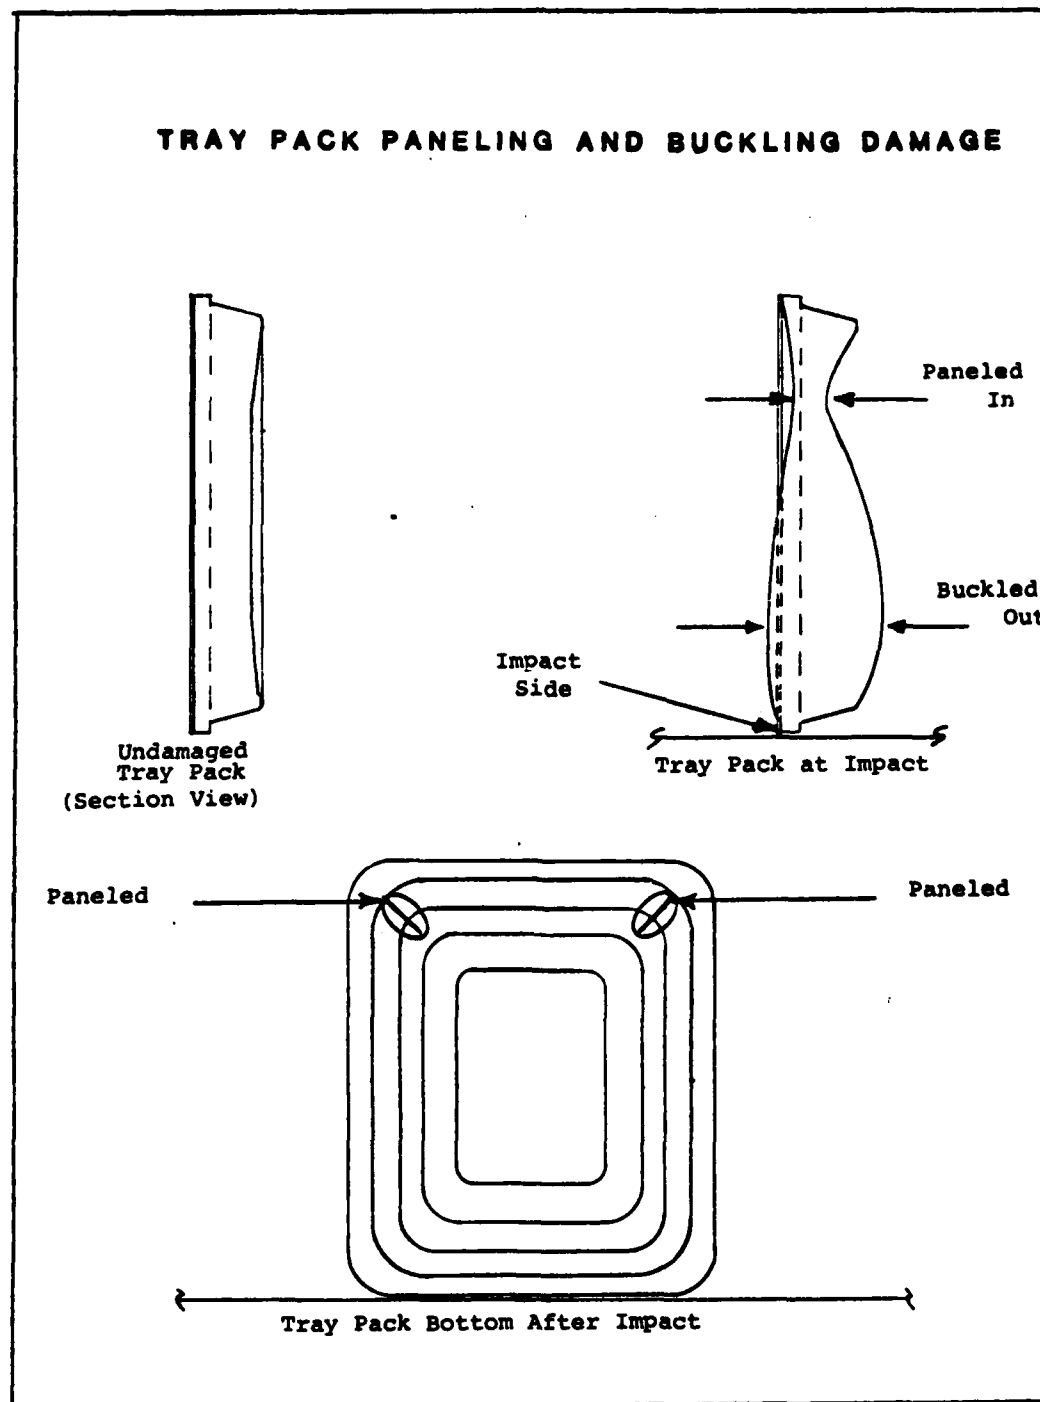
Buckling and paneling of the Tray Pack top and bottom are depicted in Figure 4. The causes of this damage are a combination of the vacuum in the container and the hydrodynamic forces generated by acceleration of the fluid (food) in the container. The vacuum in the container is generated during the food filling and sealing process and is a function of the type of food being packed and the amount of food packed in the container. The hydrodynamic forces generated by acceleration are caused by dropping and side impact of the Tray Pack during manual handling of the Tray Pack and during shipping and handling of Tray Packs in shipping containers and assembling into unit loads.

Buckling and paneling of the Tray Pack sides is caused by hydrodynamic forces within the Tray Pack when the Tray Pack is dropped on its bottom or its side. When the Tray Pack is dropped on its bottom, either inward paneling or outward buckling can occur, depending on the level of vacuum in the container and the amount of top and bottom reinforcement. When the Tray Pack is dropped on its side, outward buckling of the impact side can occur.

Figure 4. Tray Pack paneling and buckling damage

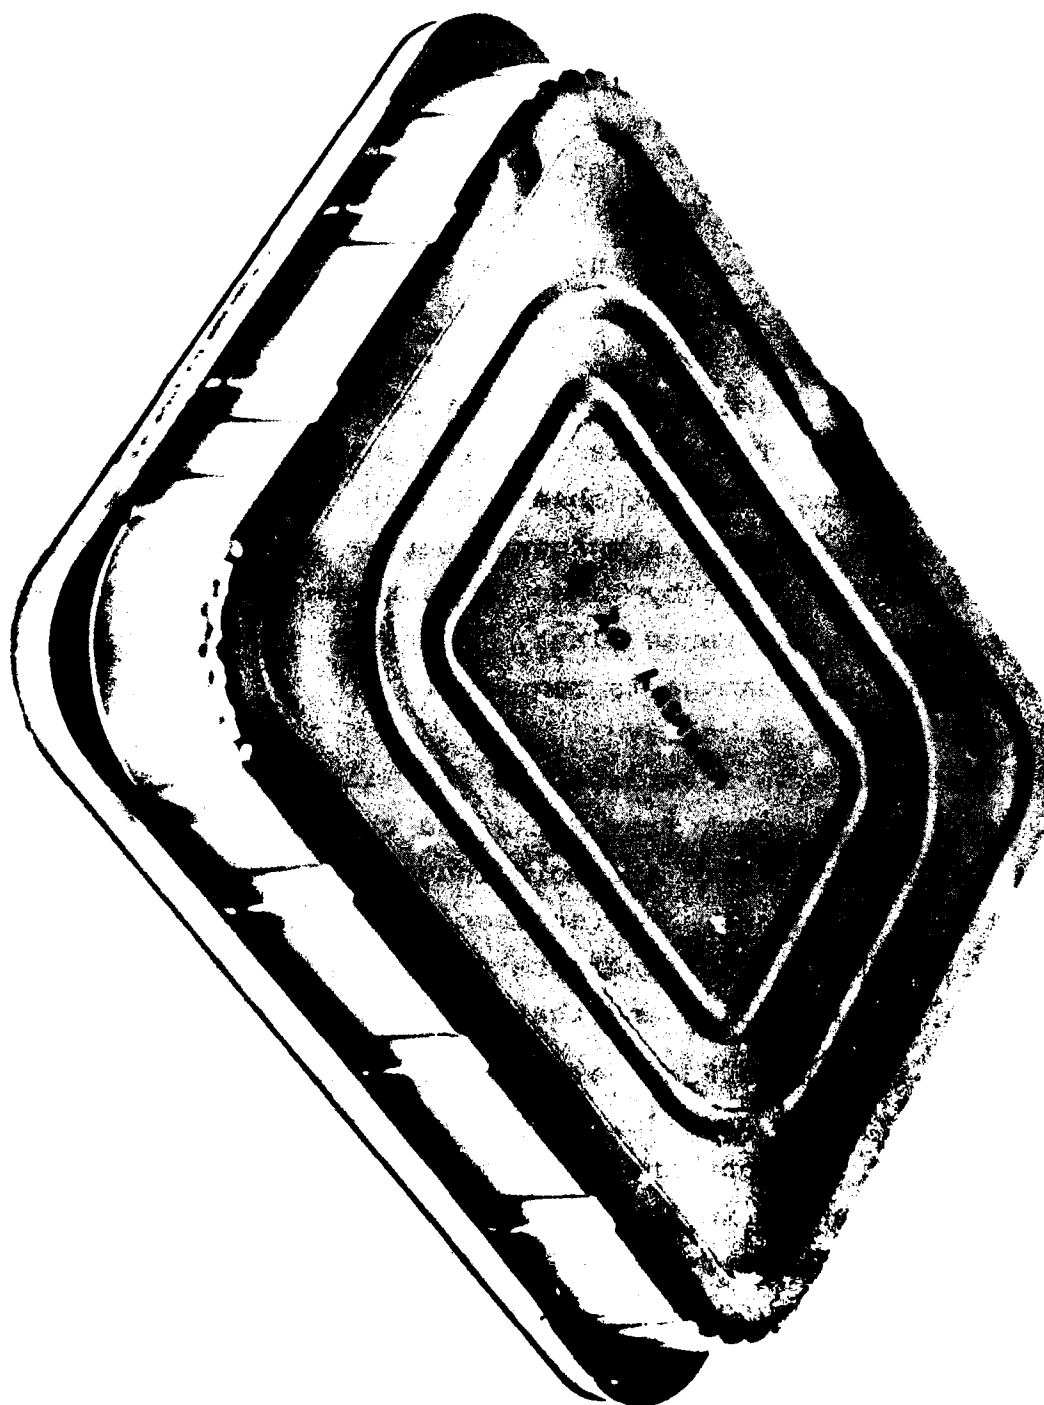
We are not exactly sure of the cause of Tray Pack denting. We do know that it is caused during the process of filling and handling in the food packer's plant and that it is caused by impact of the Tray Pack with some relatively pointed object or objects.

Figure 17. Tray Pack denting damage

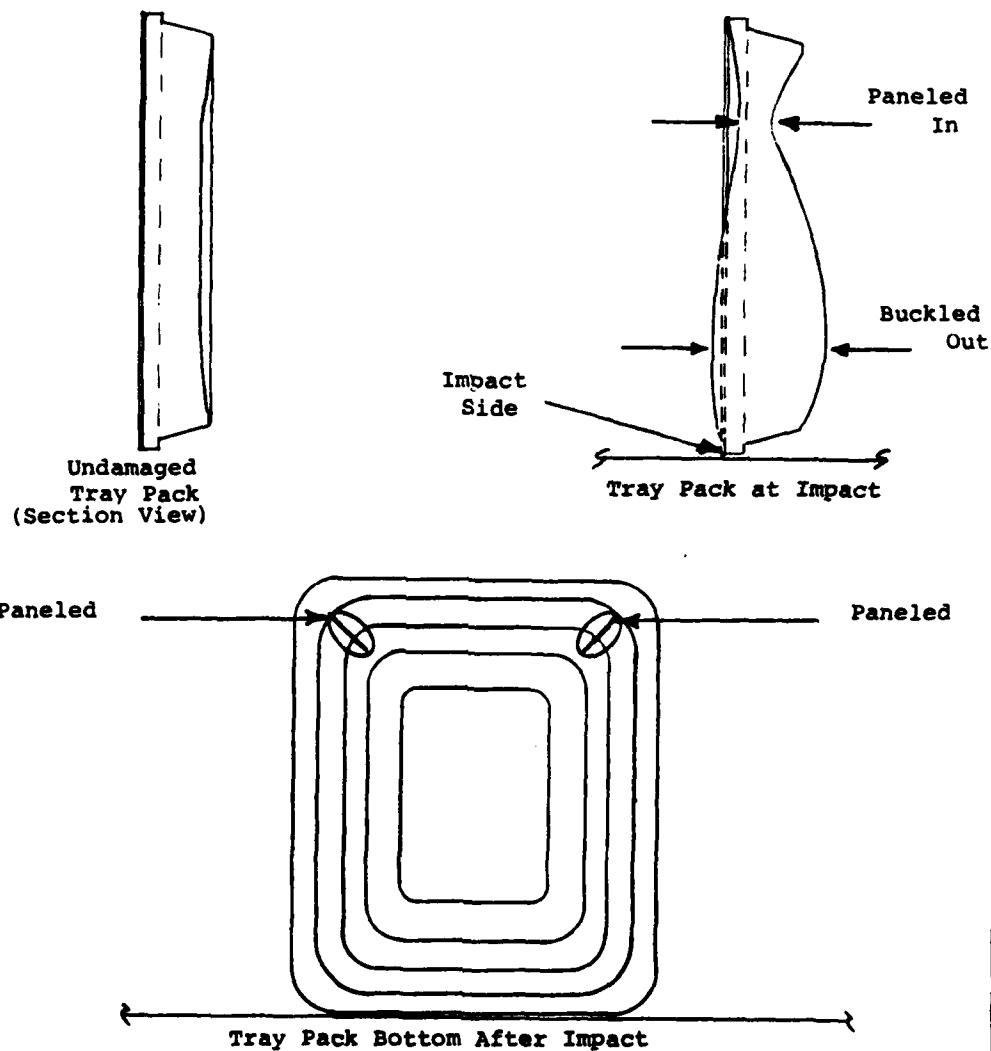
**Figure 22. Tray Pack before and after 2-foot  
side drop on shorter side**

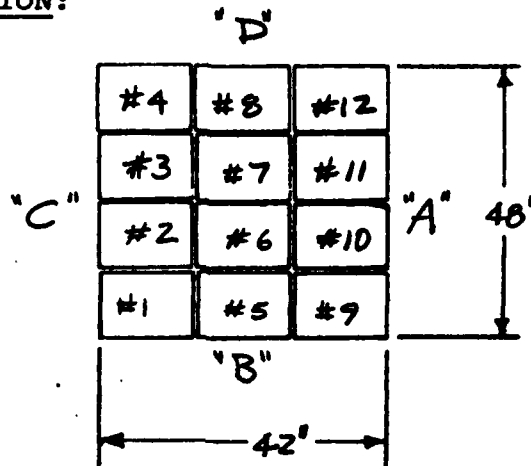
| EDGE | OBSERVATIONS |
|---|---|
| 6" DROP EDGE "A" | FIRST LAYER CARTONS (#19, 110, 111, 112) SIDES BUCKLED AT DROP EDGE. WHOLE STACK SHIFTED, TOP LAYER 3/4", THIRD LAYER 1/2" OPPOSITE DROP END, SECOND LAYER 1" AT DROP END. |
