FINAL REPORT  
QUALITATIVE EROSION AND  
SEDIMENTATION INVESTIGATION  
MALINE CREEK  
CITY AND COUNTY OF ST. LOUIS, MISSOURI

Submitted to  
St. Louis District  
Corps of Engineers  
210 Tucker Boulevard, North  
St. Louis, MO 63101-1986

Prepared by  
Simons, Li & Associates, Inc.  
3555 Stanford Road  
P.O. Box 1816  
Fort Collins, CO 80522

July 30, 1985

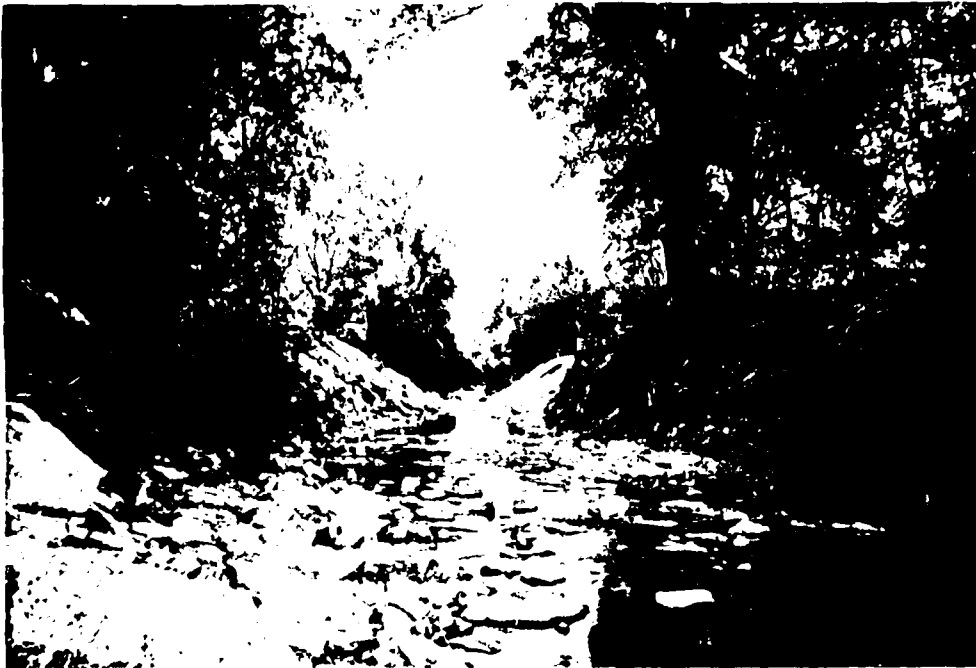
Figure 3.4a. Rubble used for bank protection has fallen into the channel and covers the bed of many parts of Maline Creek.

(Photograph looking downstream from Florissant Road)

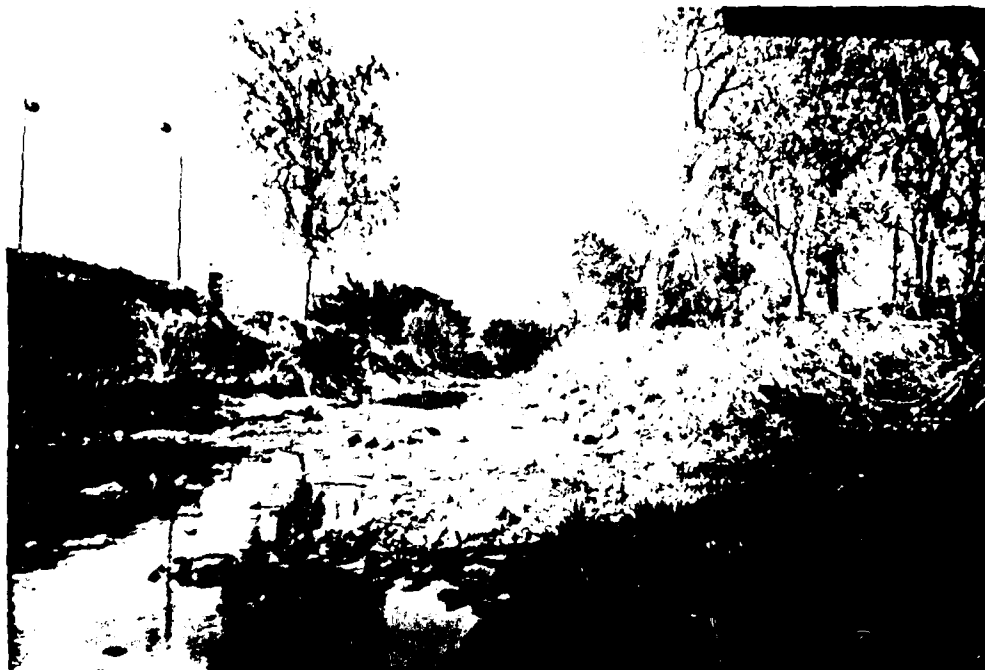
Figure 3.4b. Rubble used for bank protection has fallen into the channel and covers the bed of many parts of Maline Creek.

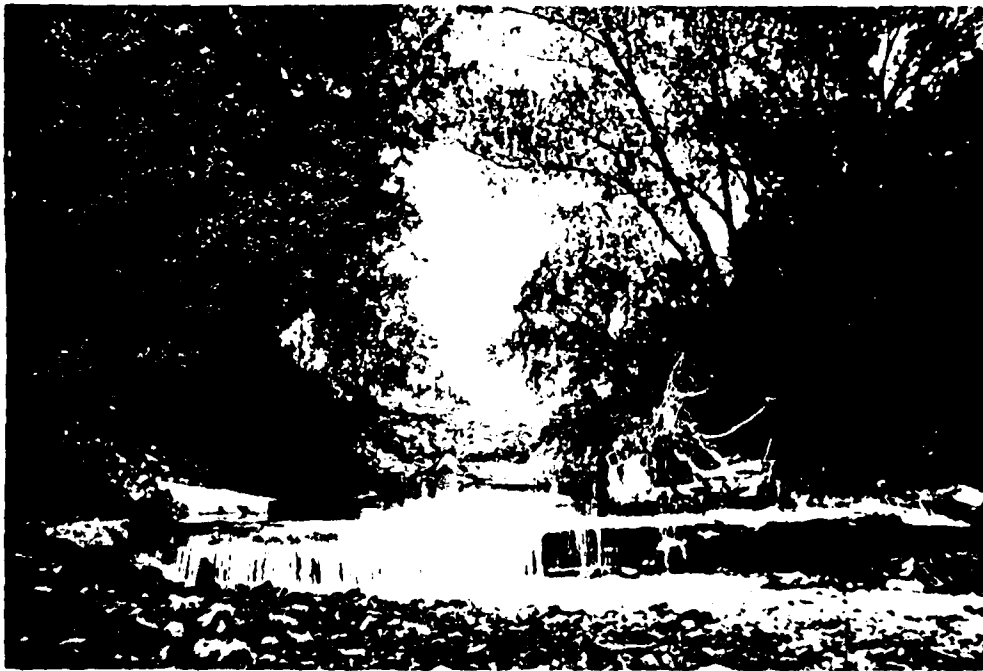
Figure 3.6a. Exposed sewer line encasement.

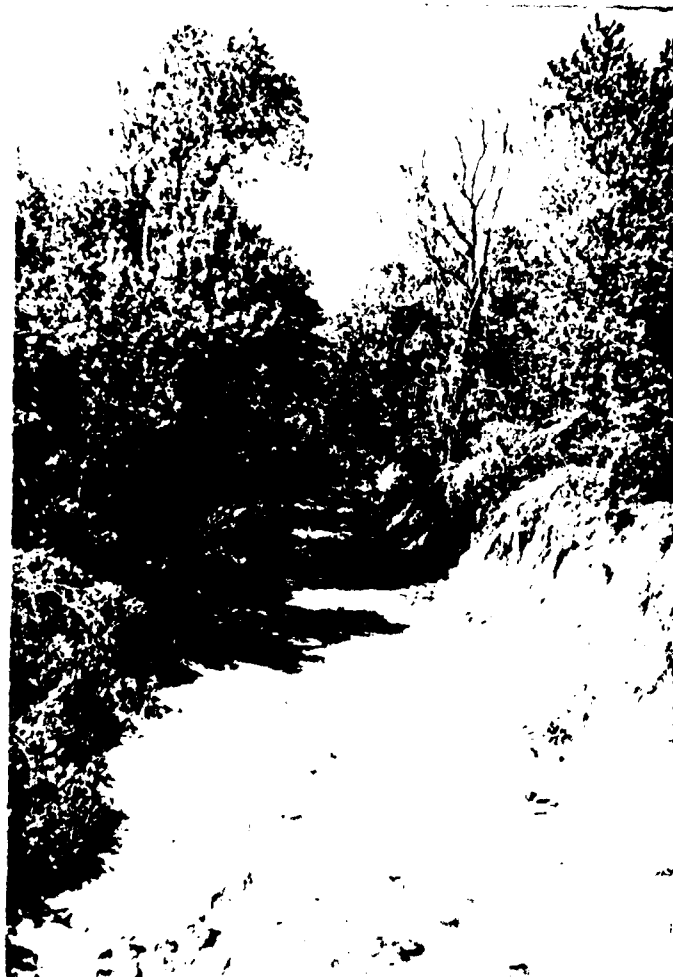
Figure 3.7. Typical banks along Maline and Blackjack Creeks. Upper 10-15 feet is loess. Below this is found a loess material with a much higher clay content.

(Photograph looking upstream along Maline Creek approximately  $\frac{1}{2}$  mile upstream of Florissant Road)

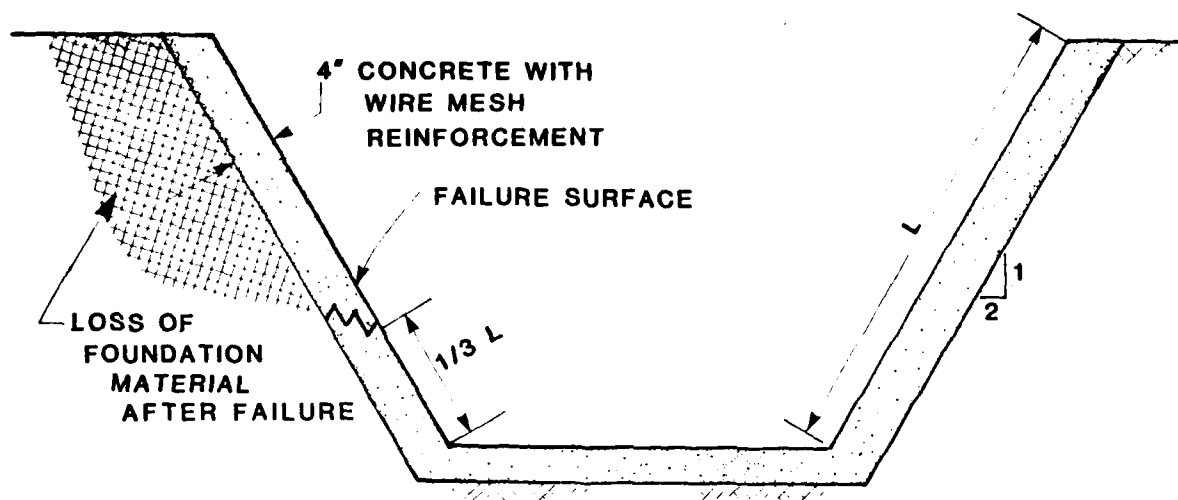
From discussions with the Metropolitan St. Louis Sewer District (MSD) it was learned that in the past they had experienced problems with 2 horizontal to 1 vertical sideslope trapezoidal concrete-lined channels. A common condition was described where the sideslope failed approximately one-third of the distance up the sideslope allowing foundation material to wash out. Figure 4.8 is definition sketch of the problem. MSD said that failures occurred even though adequate weep holes and filters were utilized. They also said that modification of the standard design used for concrete trapezoidal channels seemed to have prevented this problem from occurring. The modification changed using a 4-inch thick wire mesh reinforced sidewall to a 7-inch thick steel reinforced sidewall.

Figure 4.8. Typical failure of concrete trapezoidal channel as described by Metropolitan St. Louis Sewer District.

One possible explanation for the slope failure problem is that loess becomes saturated soil behind the sidewall and exerts enough pressure to cause failure. Weep holes and filters present in the sidewalls cannot adequately drain the loess because of its low permeability. The modified 7-inch steel reinforced sideslope is apparently strong enough to prevent saturation of material used as foundation for the sideslopes.

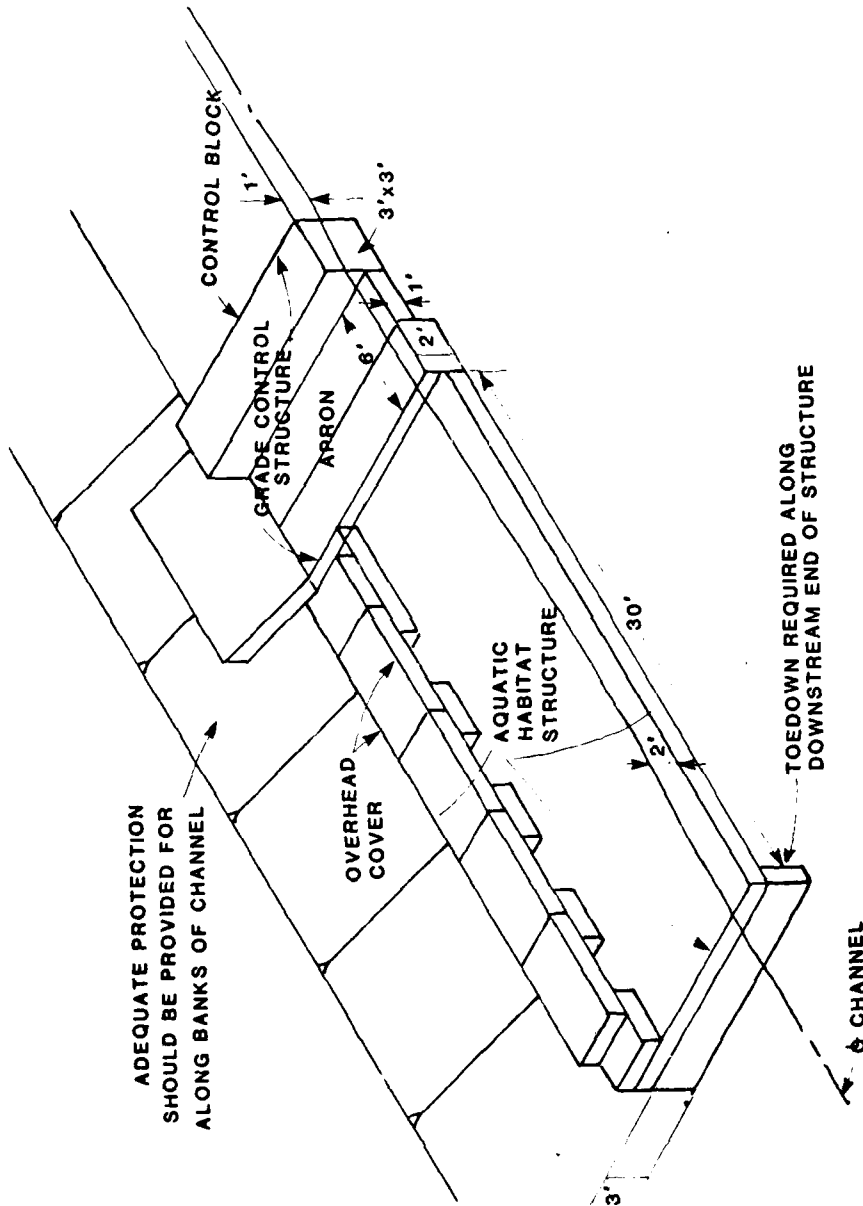
Figure 4.11. COMBINATION AQUATIC HABITAT  
AND GRADE CONTROL STRUCTURE

A review was made of the proposed design for the aquatic habitat structures to determine its potential effect on sediment transport. As seen in Figure 4.11 no bank protection is utilized on the sideslopes of the channel. It is recommended that proper bank protection be provided since the banks are composed of fine loess material, which is highly erodible. Without proper bank protection it is possible that the stream could bypass the structure.

Another recommendation for their design is to toedown the structure at least 3 feet on the downstream side. The purpose of the toedown is to prevent headcutting of the channel underneath the structure.
