Failure Analysis of a Sodium, Inconel 617 Heat Pipe

D. L. Jacobson and J. H. Wang

September 1985

FINAL REPORT FOR PERIOD JUNE 1984 - MARCH 1985

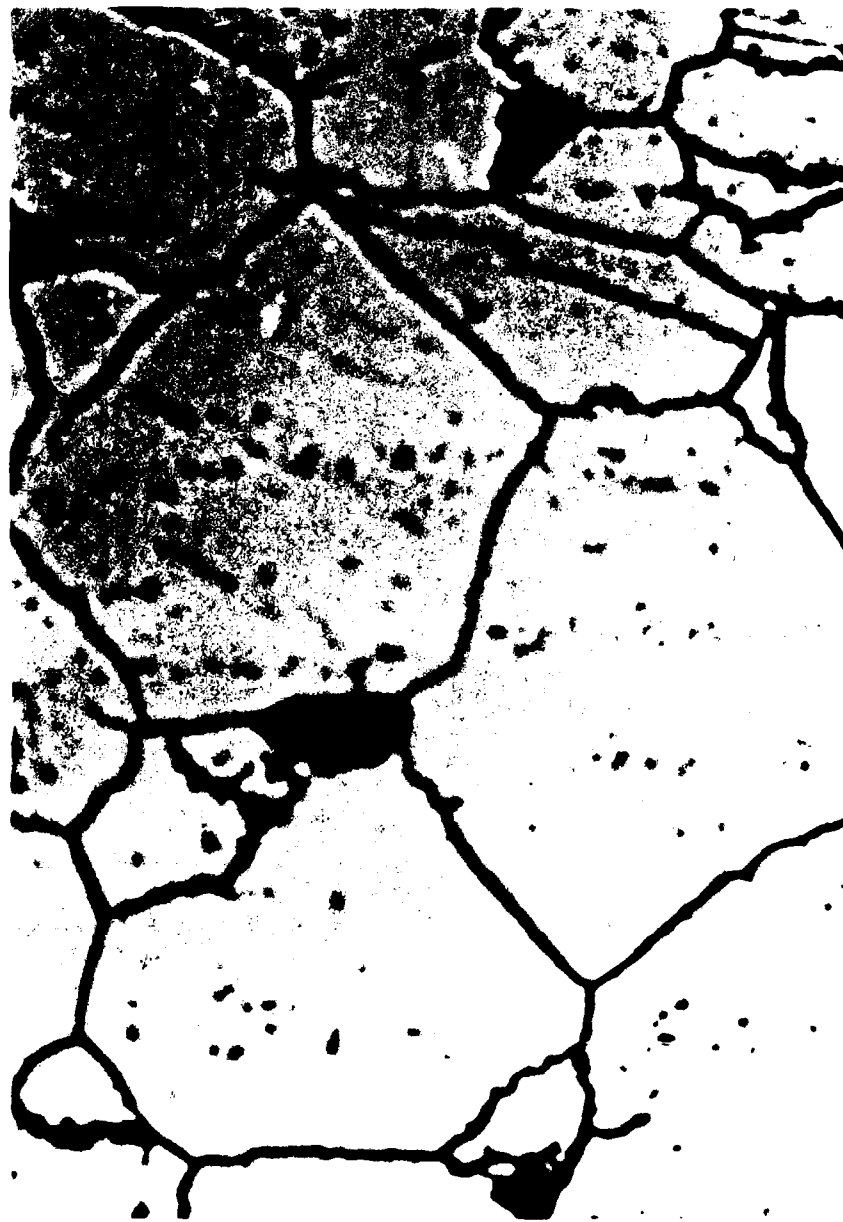
Table 1 gives the nominal composition of I617 which is a face-centered-cubic solid-solution strengthening alloy with a nickel-rich austenitic matrix phase. The microstructure in the cracked region shown in Fig. 11 showed relatively large precipitates at some grain intersections.

Microprobe analyses indicated that the composition was Cr₂₃C₆ which like sigma phase is brittle and will shorten the rupture life of the material. The phase is formed due to improper heat treatment whereby carbides migrate and accumulate at grain boundaries. Grain boundary cracks were found to coincide with these precipitates in many areas. Near the cracked areas microprobe analyses showed elevated levels of chromium and molybdenum. Small black particles in these areas were found to form continuous chains in the grain boundaries. The chains were estimated to be a combination of Cr₂₃C₆ and Mo₆C. Cr₂₃C₆ will form as a precipitate in the grain boundaries during heat treatment in the 1033K to 1253K range. The continuous chain results in fracture paths and low impact properties. Distributed or non continuous chains on the other hand are beneficial in hindering grain boundary cracking.⁵ Titanium carbide chains found in the material were the same throughout. Figure 12 shows precipitation from carbide accumulation.

Figure 11. Evaporator Region Precipitates (400X).

The long term exposure to the high evaporator temperatures caused precipitation of cellular CR₂₃C₆ and other carbides forming continuous carbide chains which result in embrittled grain boundaries. Operation in the sensitizing temperature range resulting in such precipitate chains must be avoided. Microprobe analyses revealed that phosphorous and copper were present in the corroded intergranular material but were not present in the matrix grains. Sulphur and iron were found in elevated amounts compared to the base metal. Analysis of a separated fracture surface also revealed elevated amounts of copper and sulphur with trace amounts of phosphorous and sodium. The phosphorous probably came from original I617 alloy preparation although some phosphorous plus copper may have arisen from brazing materials. Phosphorous and sulphur embrittle the structure and should be avoided.

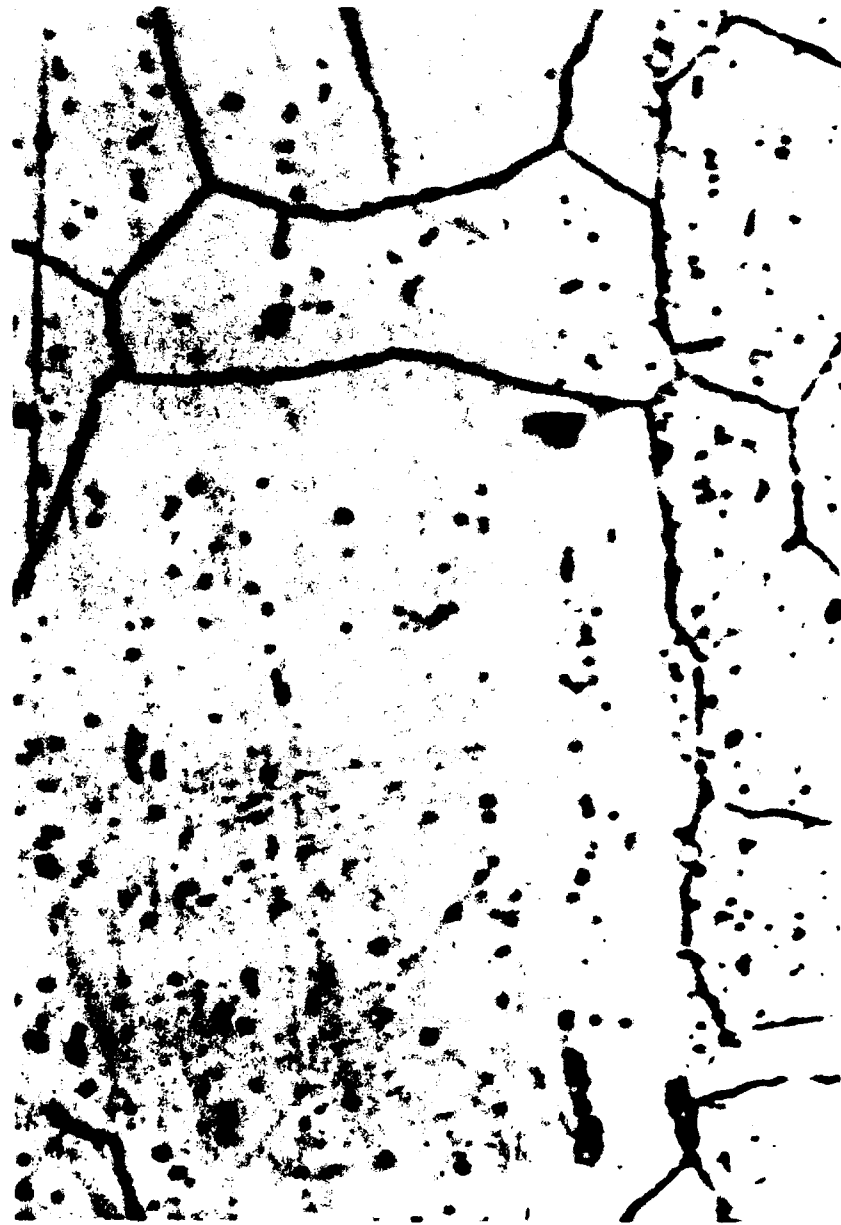
Figure 12. Formation of Precipitates by Carbide Accumulation.

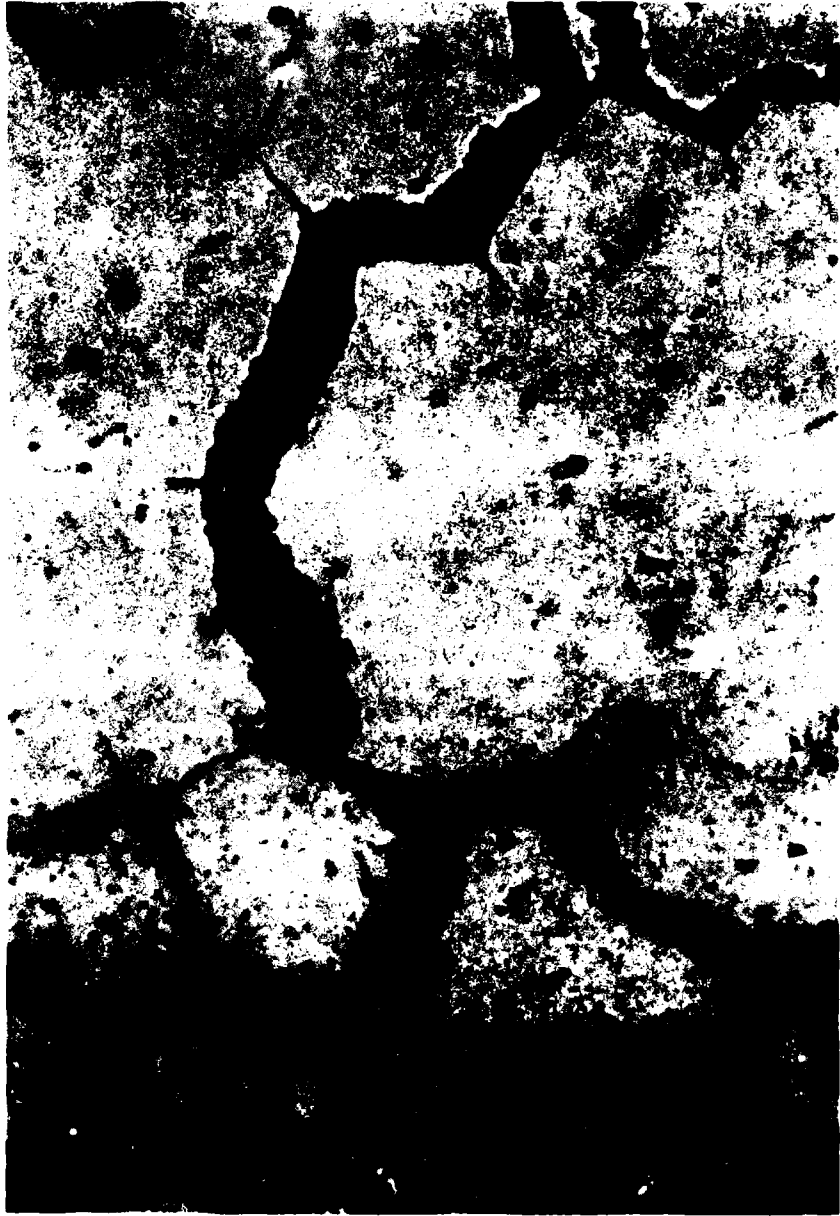
Metallography and SEM micrographs showed extensive intergranular attack. The sodium with its apparent high oxygen content produced the grain boundary penetration. Intergranular attack is shown in Figs. 10, 13 and 14. Part of the metallography and Scanning Emission Microscope (SEM) results were provided by the AFVAL Materials Laboratory.⁶ In some areas, entire grains were found to be separated from the matrix. The associated surfaces were consequently very rough from the corrosion. As seen in the above micrographs the cracks were generated in an intergranular fashion.

Figure 13. Grain Boundary Attack (500X)⁶.
