FAILURE ANALYSIS OF A SODIUM HEAT PIPE WITH INTEGRAL LITHIUM FLUORIDE THERMAL ENERGY STORAGE

D.L. Jacobson and P. Soundararajan

MECHANICAL AND AEROSPACE ENGINEERING
ARIZONA STATE UNIVERSITY
TEMPE, ARIZONA 85287

September 1985

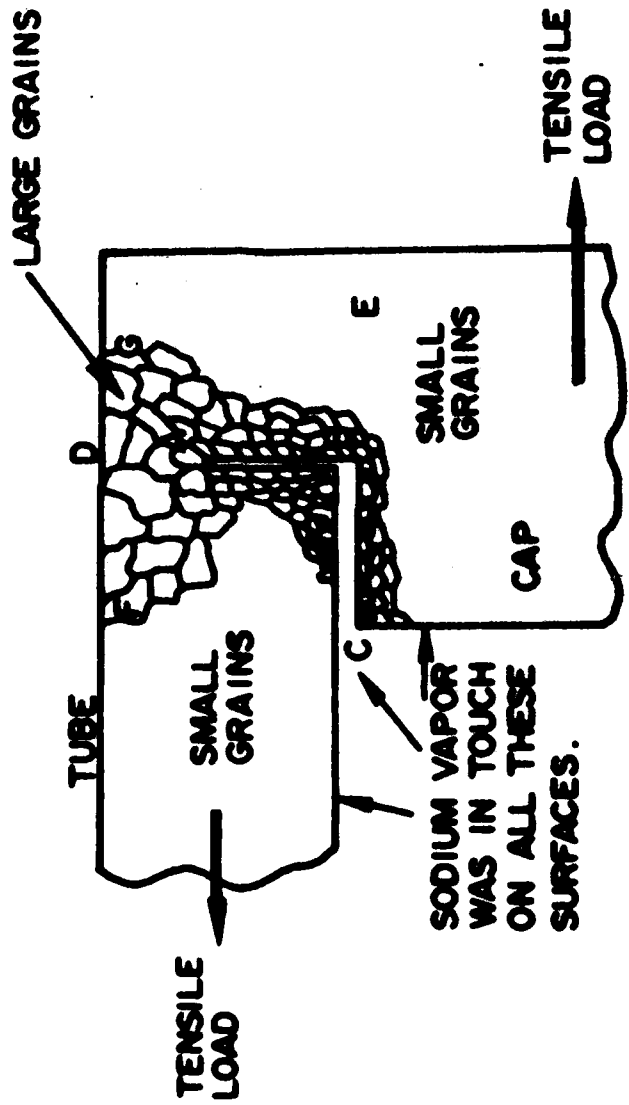
The crack which begins at point A, travels into 49% of the weld depth, A to D, for sample 1.3. It was the longest found. Shorter cracks are also apparent in the section 1 samples along the gap region from B to A with the smallest at point B and growing progressively larger toward A. These cracks tend to run along the grain boundaries. The sketch in Fig. 6a depicts this feature. The gap between tube and cap, from point B to A has been observed in all but one of the samples. It is the unwelded section of contact. This space may have been the result of continuous loading on the cap, but more likely existed at the time of welding. In any case, it allowed liquid sodium, or sodium vapor to easily come into contact with the weld. Also, some widening of the gap at point A (crack base) is apparent. This may be an indication of corrosion. Corrosion is also indicated by the pitting and discoloration (relative darkening) of the grains along the regions C-B and B-A. The weld region extends from A to D (Fig. 6a) and this was made by electron beam.² This type of

Figure 6a. Representative Sketch of Section 1 Sample.

General corrosion of the weld surface at point A in Figure 6a was considered but ruled out following the detailed examination of all section 1 samples. These examinations, previously discussed, showed that the thickness of the unfractured weld region was not the same in all samples; it would have been had general corrosion occurred.^{9,10} The general internal surfaces and wick appeared metallographically to have undergone no corrosive attack. Thus, a failure based solely on general corrosion is not likely.

It is felt that the failure could have been avoided with any number of improved weld designs. The weld thickness was found to be as little as 0.01 in. and could have been thinner elsewhere. In general the 321 S.S., sodium system appeared to perform satisfactorily as evidenced by the absence of corrosion, in general, in the heat pipe. It is important though to provide for high purity sodium and to fabricate the heat pipes with exceptionally clean internal surfaces in order to maintain the sodium purity and obtain maximum life time. The thermal energy storage capsules showed no evidence of corrosive attack on the sodium side. The salt-container corrosion analysis will be reported on later.
