EAST COAST AIR COMBAT  
MANEUVERING RANGE (ECACMR)  
OCEAN TOWER CONSTRUCTION  
COMPLETION REPORT

6a. NAME OF PERFORM. ORG. 6b. OFFICE SYM  
Ocean Engineering  
& Construction  
Project Office  
CHESNAVFACENGCOM

FPO-1-78(4)  
MARCH 1978

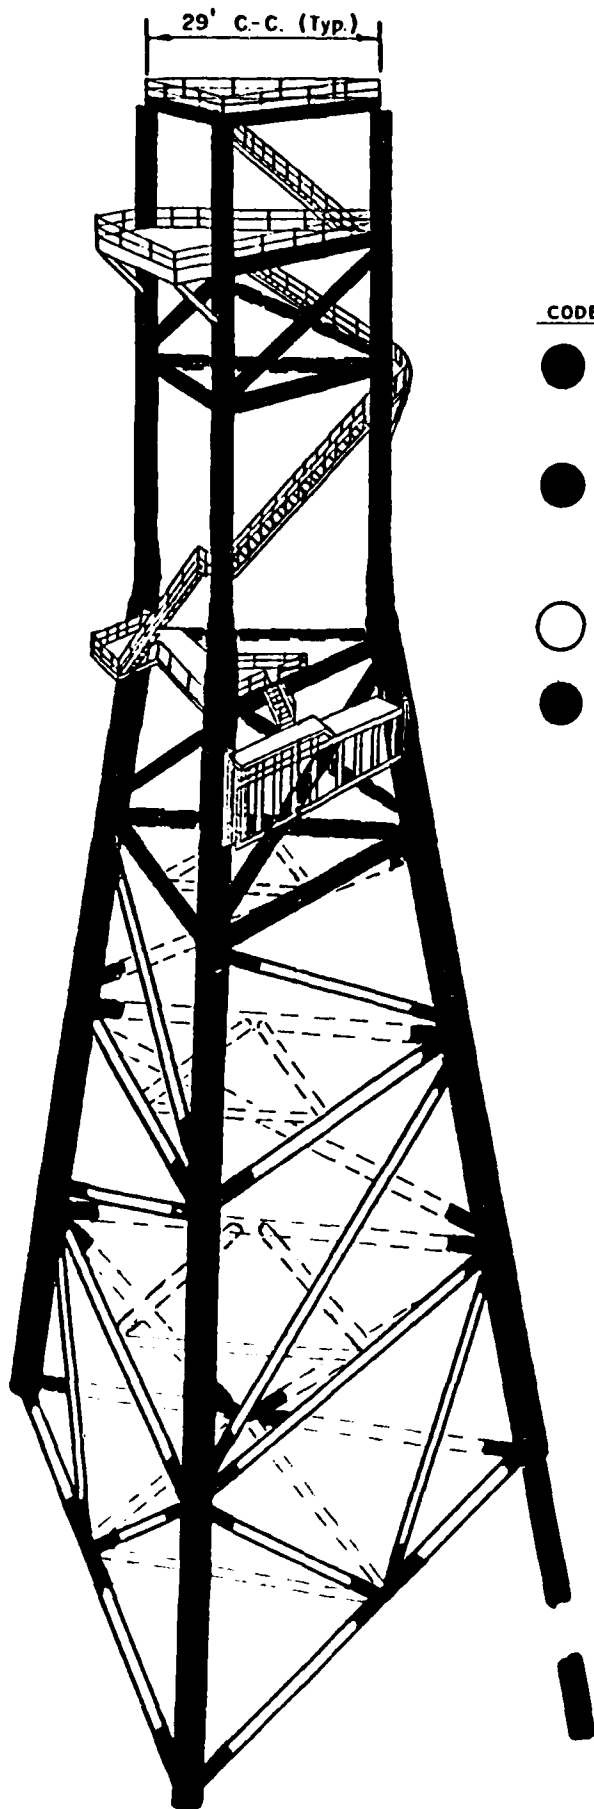
MINIMUM MATERIAL REQUIREMENTS

Based upon a review of the fatigue stresses under design load and the air and water temperatures, CHESNAVFACENGCOM, upon recommendation of the A & E, insisted that all primary bracing members at or above *minus* thirteen feet MLW elevation, and all stub ends of primary bracing members below this level, meet the Charpy requirement. However, waiver of the Charpy requirement for intermediate portions (between stub ends) of primary bracing members below *minus* thirteen feet MLW was granted. A diagram of the required material properties within the structure appears in Figure 6.

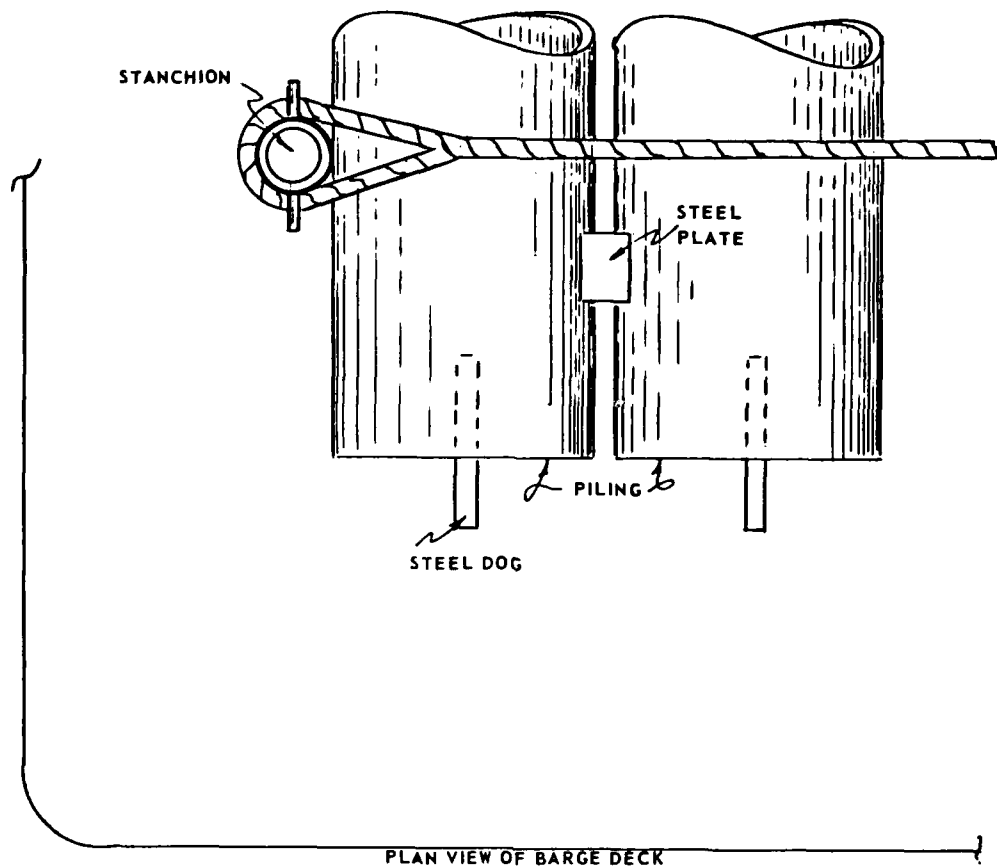
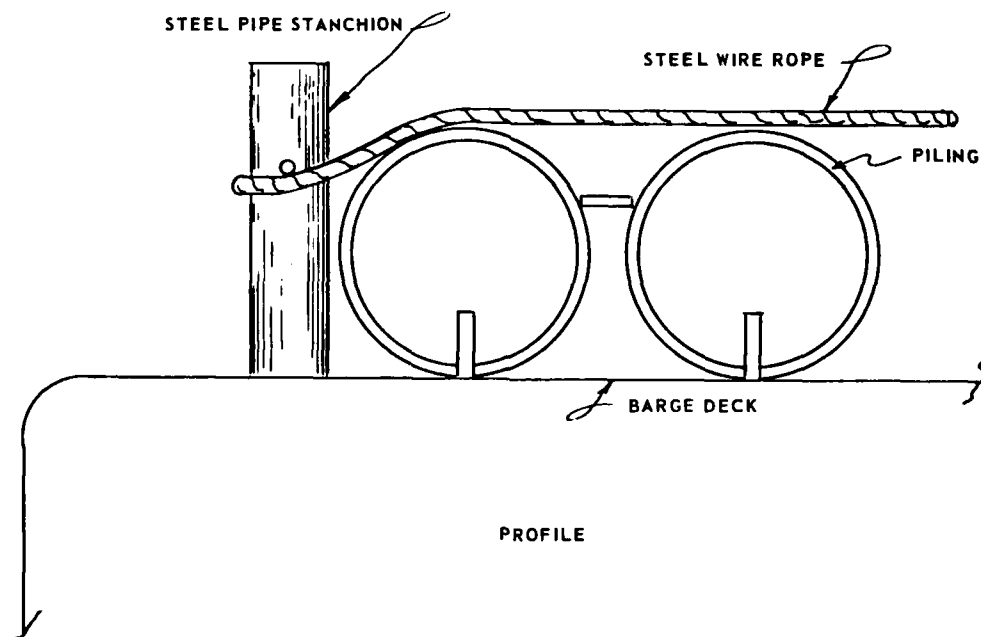
FIGURE 10

SECURING OF PILING TO BARGE DECK FOR TRANSPORT

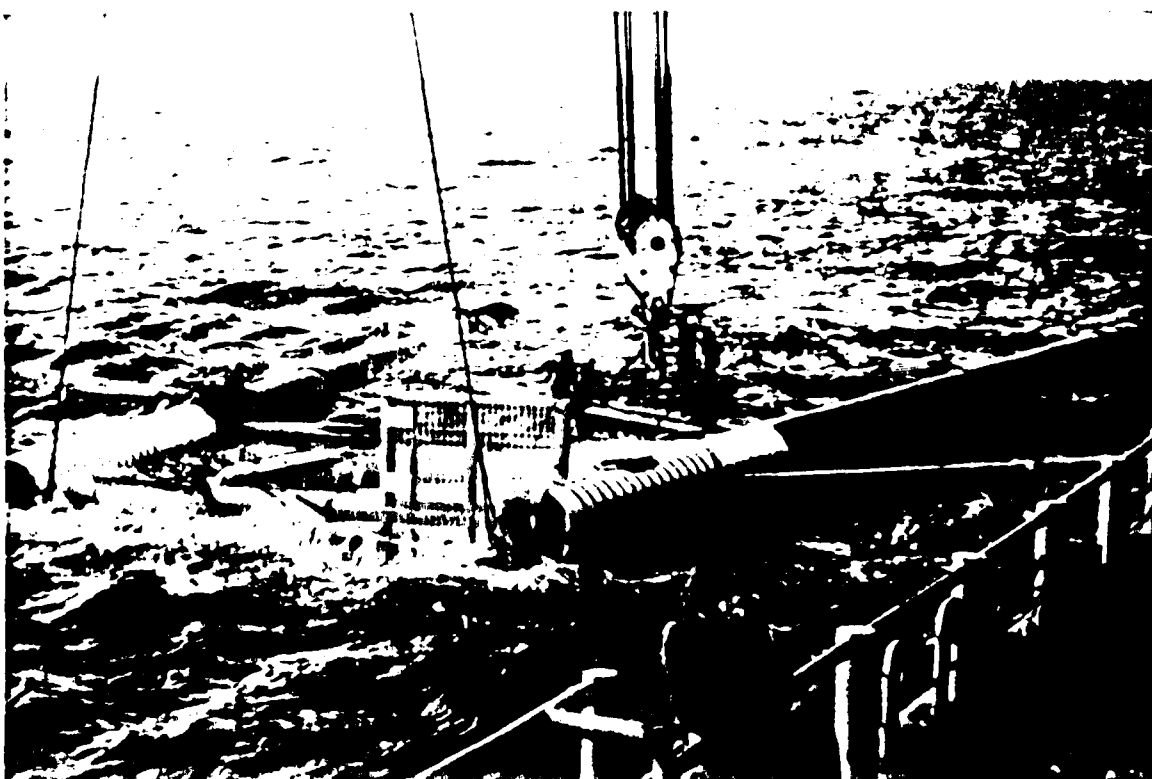
FIGURE 13

DIVERS TRANSFERRING LOAD LINES ON JACKET

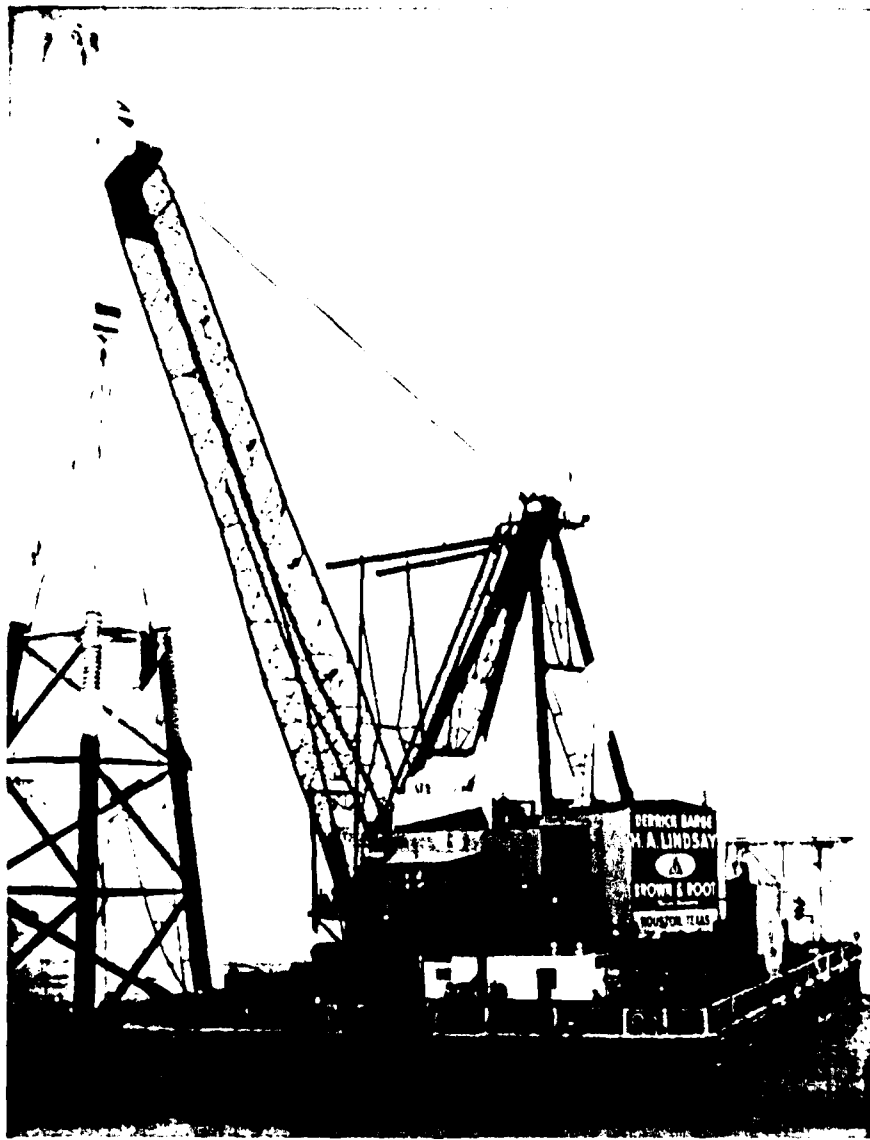
FIGURE 14

CRANE LOWERING A JACKET

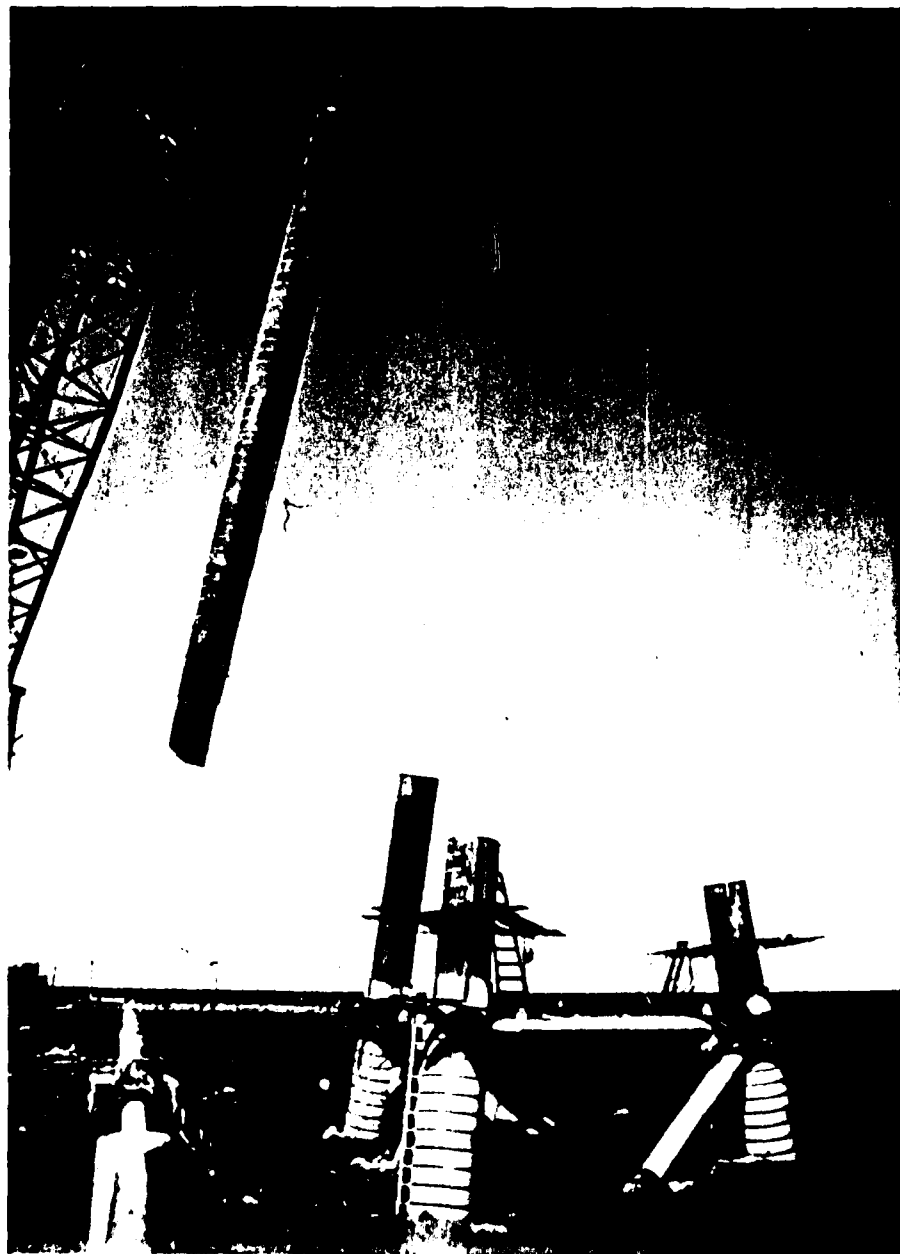
FIGURE 15

STABBING PILES INTO THE JACKETS

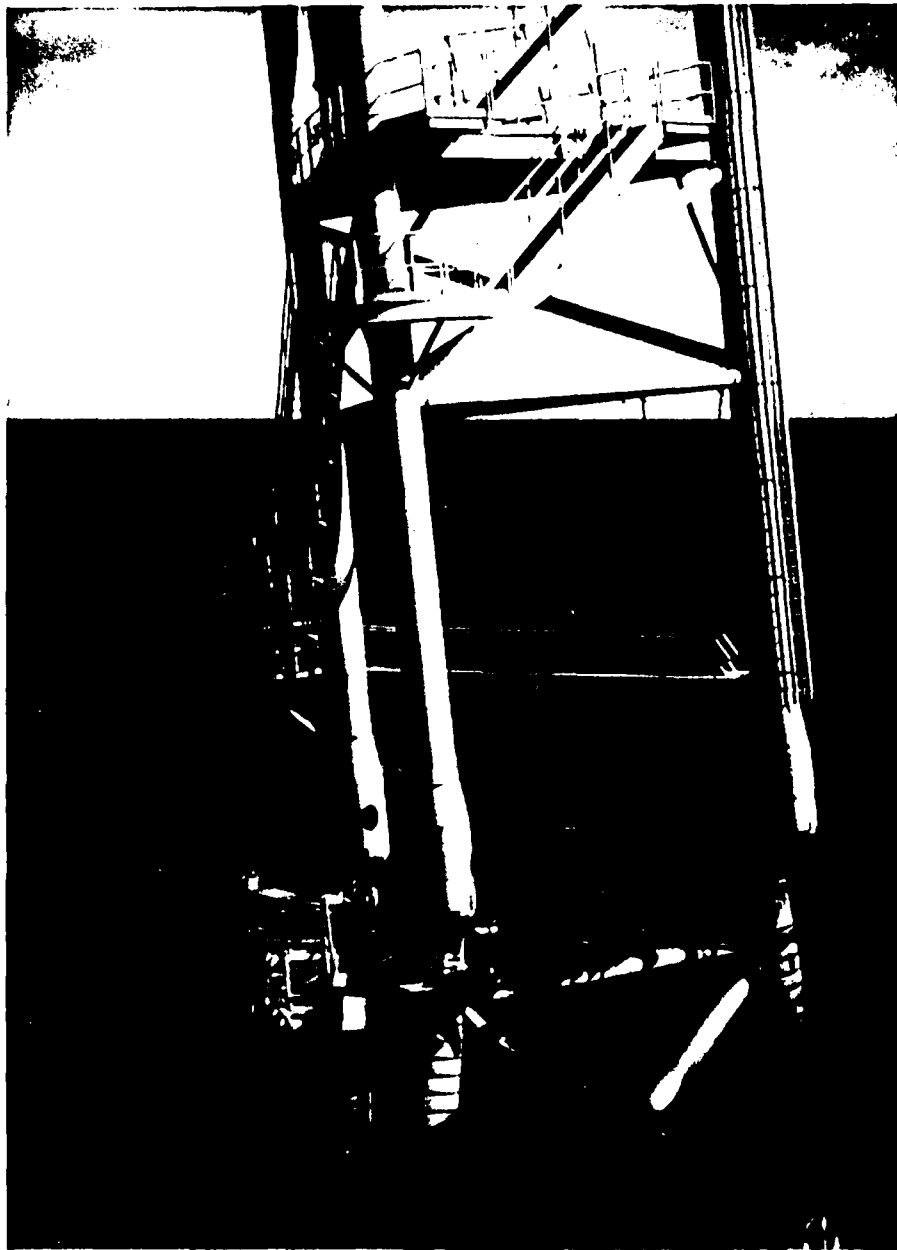
FIGURE 16

SETTING THE SUPERSTRUCTURE

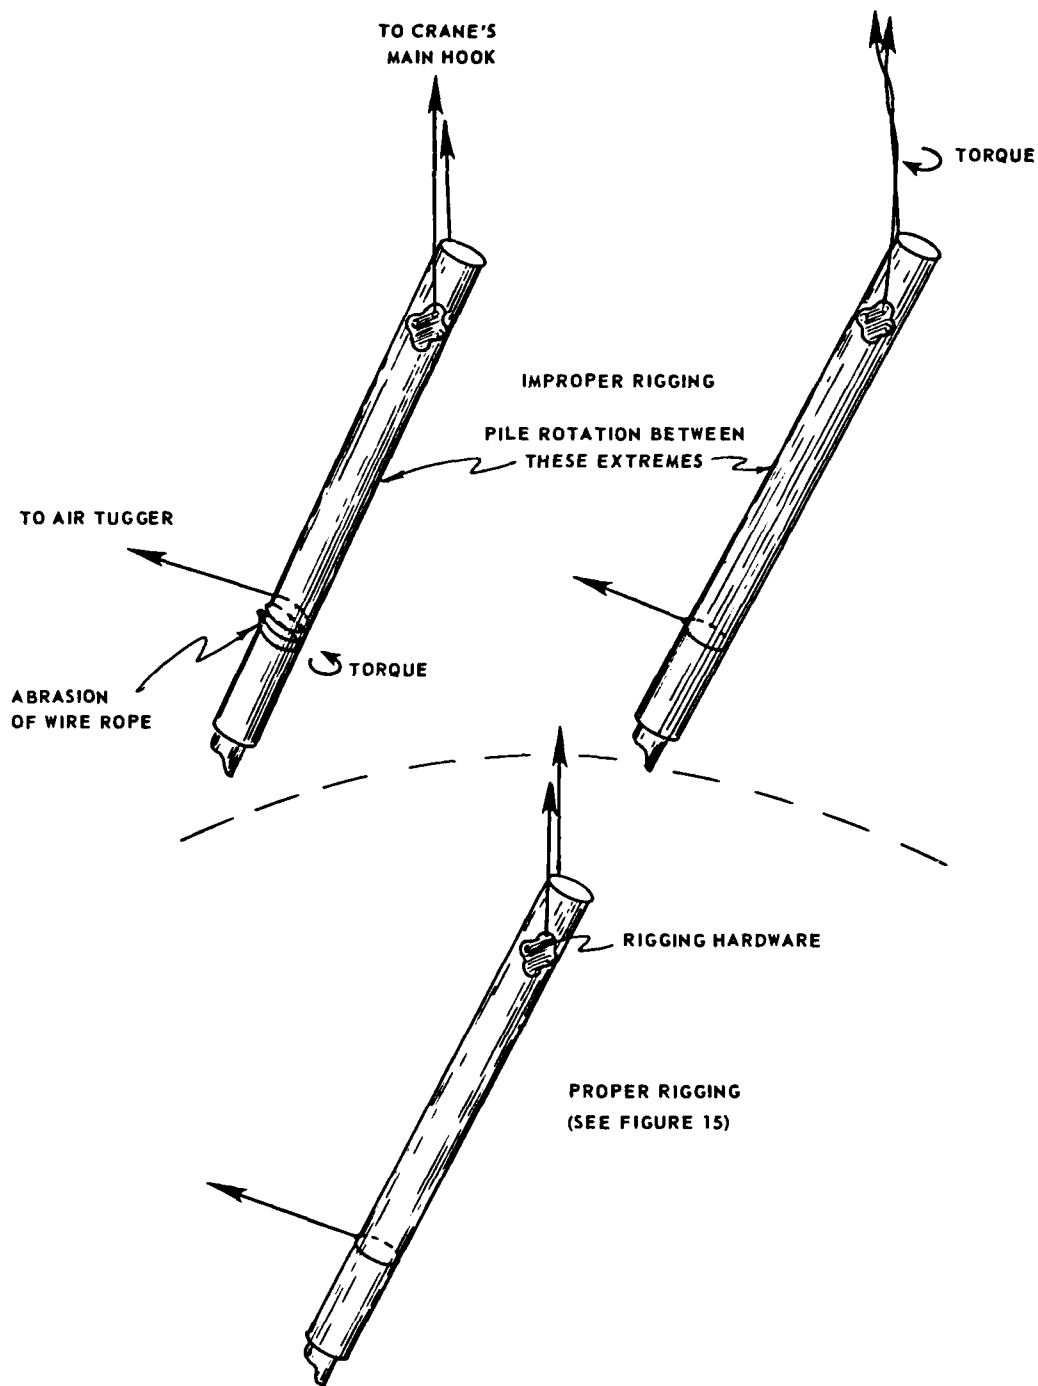
FIGURE 17

RIGGING FOR STABBING PILES
